**PERFORMANCE EVALUATION OF PAVEMENT  
REHABILITATION BY POLYURETHANE FOAM  
INJECTION : A CASE STUDY OF CONCRETE ROADS  
IN SURANAREE UNIVERSITY OF TECHNOLOGY**

**Sangey Pasang**

**A Thesis Submitted in Fulfillment of the Requirements for the**

**Degree of Master of Engineering in Transportation**

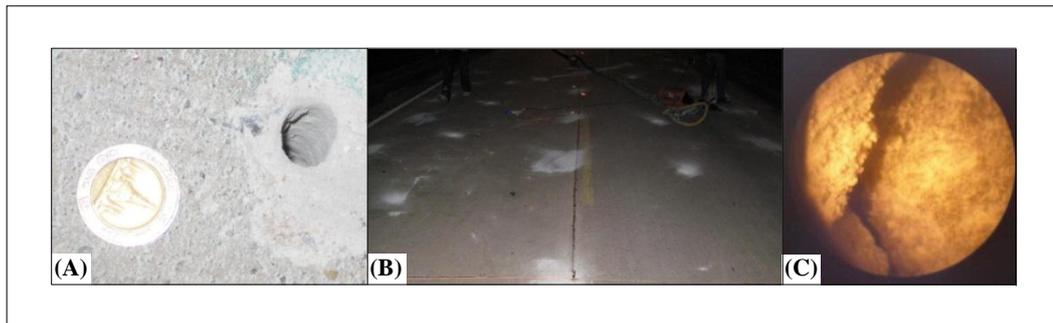
**Figure 4.2** (A) Drill hole for polyurethane injection. (B) Layout of drill hole at site. (C) Voids beneath the pavement as seen through a Flexible Borescope.

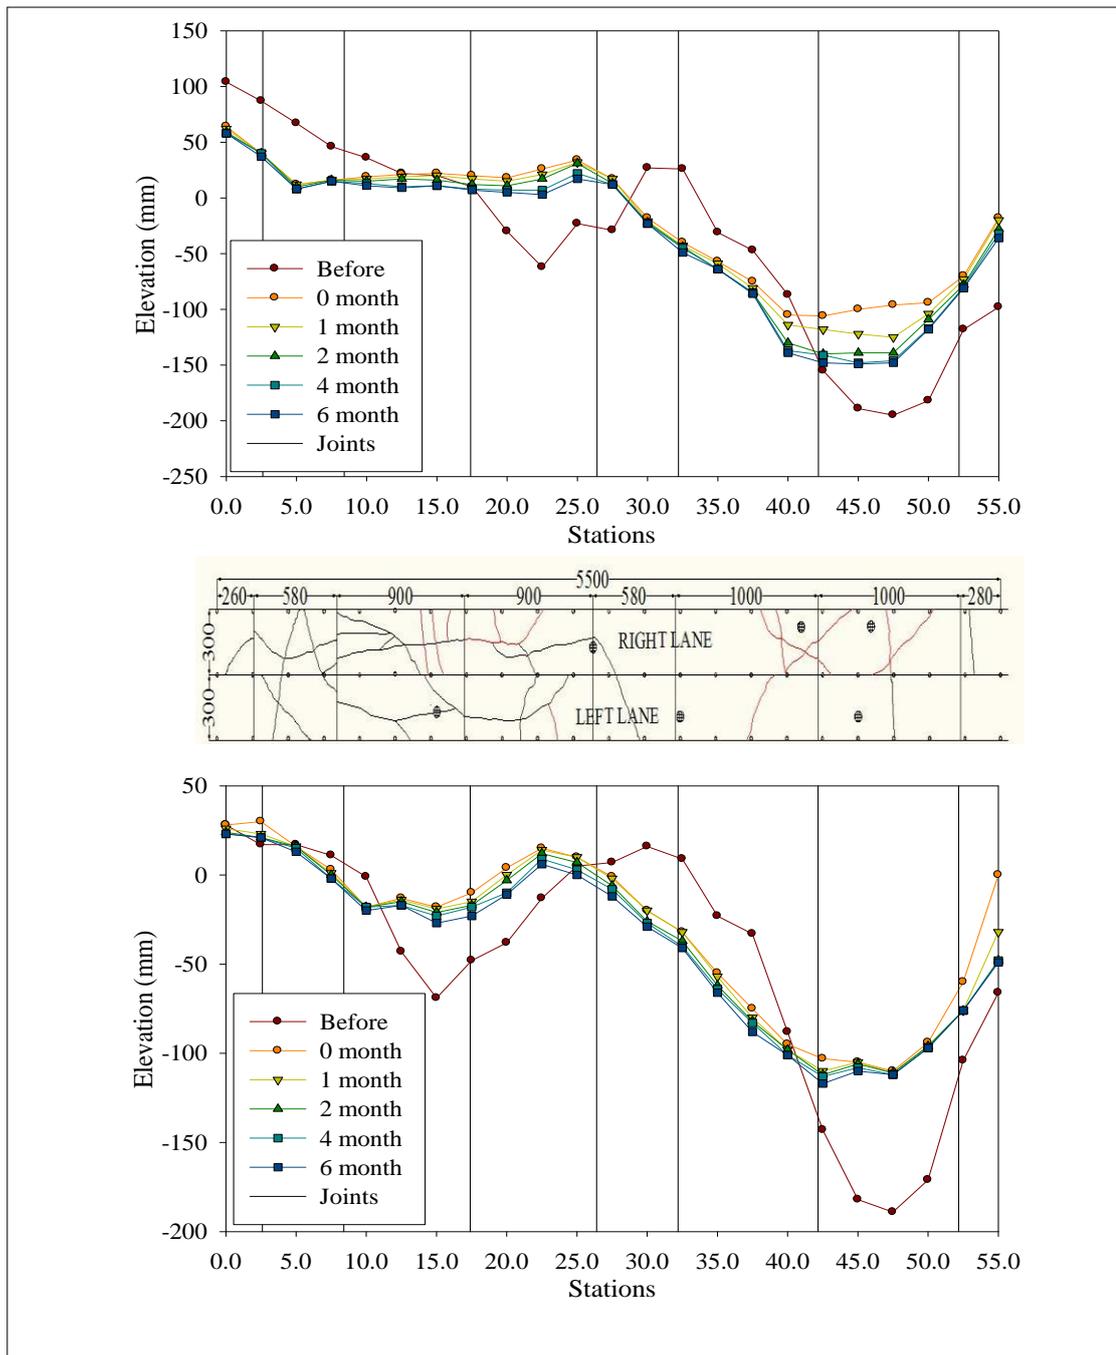
The settlements seen by profile surveying and the cracks observed during the distress survey were merged together to check the correlation and it was observed that cracking were more at area with more settlements. Further it was also seen that settlements mainly occurred near cracks; new cracks were marked in red and others in black. It was clear from Figure 4.16, that settlements and crack show a close relation.

**Figure 4.16** Correlating settlement and cracking on the pavement on the right lane (top) and left (bottom) of Withayawithee 2 Road.

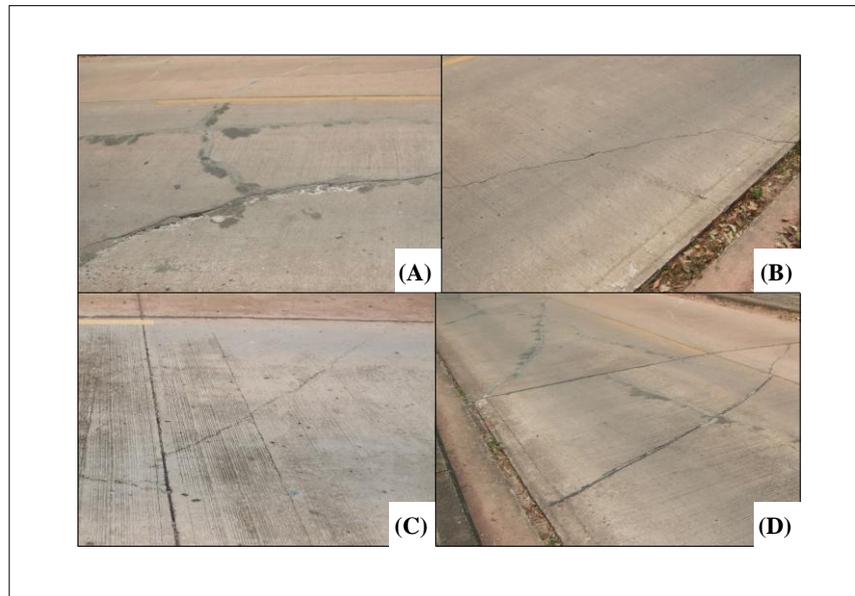
**Figure 4.17** (A) Old cracks to creating divided slab with spalling. (B) New cracked developed at the pavement. (C) Corner break. (D) Old repaired cracks leading to linear cracking and divided slab distresses.

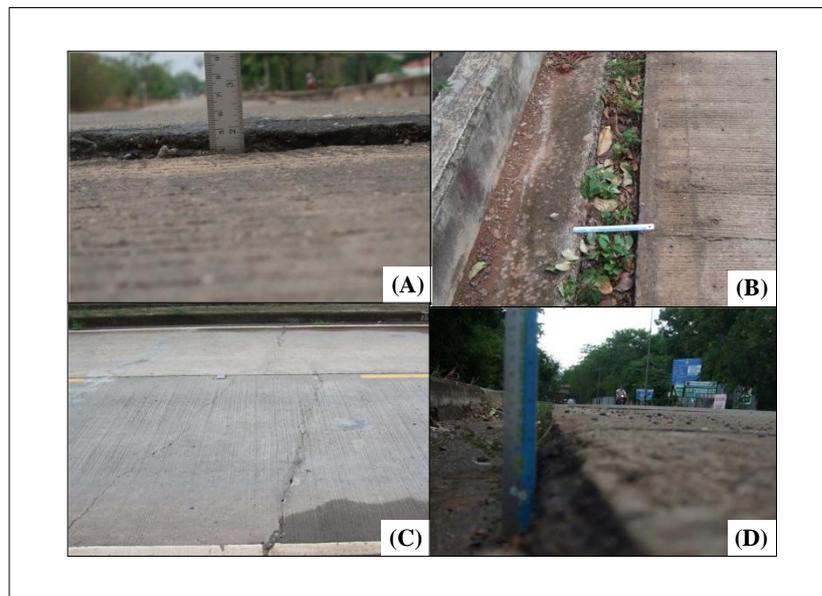
**Figure 4.18** (A) Faulting at the traverse joint. (B) Space formed due to lane/shoulder drop-offs. (C) Linear cracks.  
(D) Lane/shoulder drop-offs with faulting.

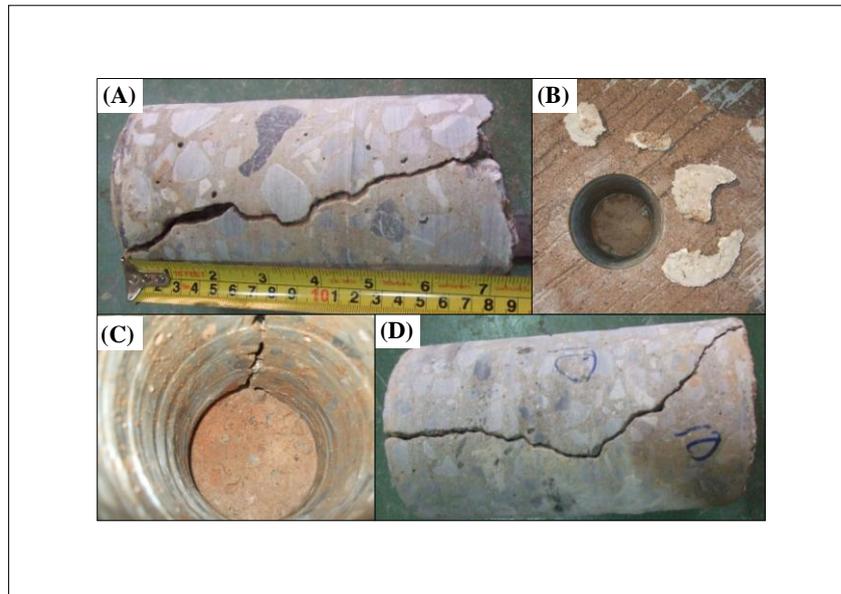
**Figure 4.23** (A) and (D) Core#6 and Core#10, respectively showing crack through its depth. (B) Core#7 indicating the void on one side due to inability of polyurethane to penetrate through the fault. (C) Core#8 showing the presence of polyurethane foam.

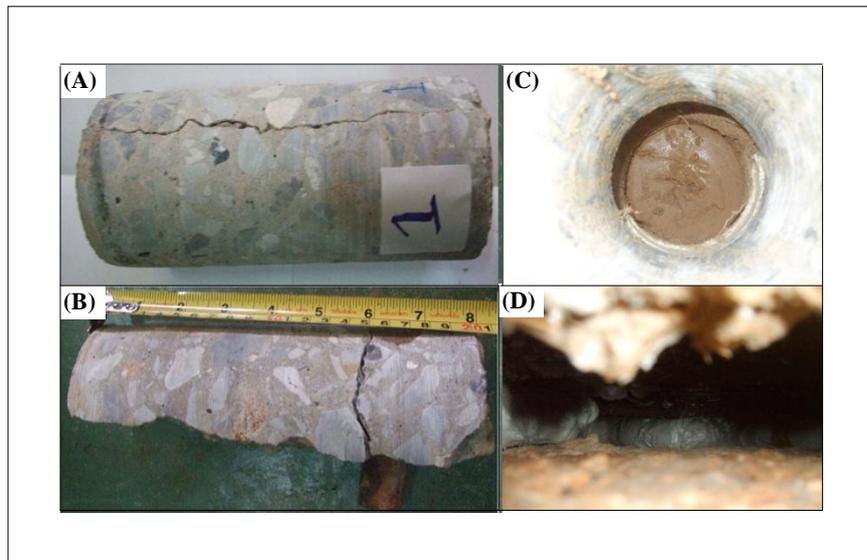
**Figure 4.24** (A) Core#1 showing crack through it since it was taken out from a cracked area. (B) Dowel bar at Core#2 which was in good condition. (C) and (D) Presences of void beneath the slab which was due to its surrounding being lifted by PFI at Core #4.

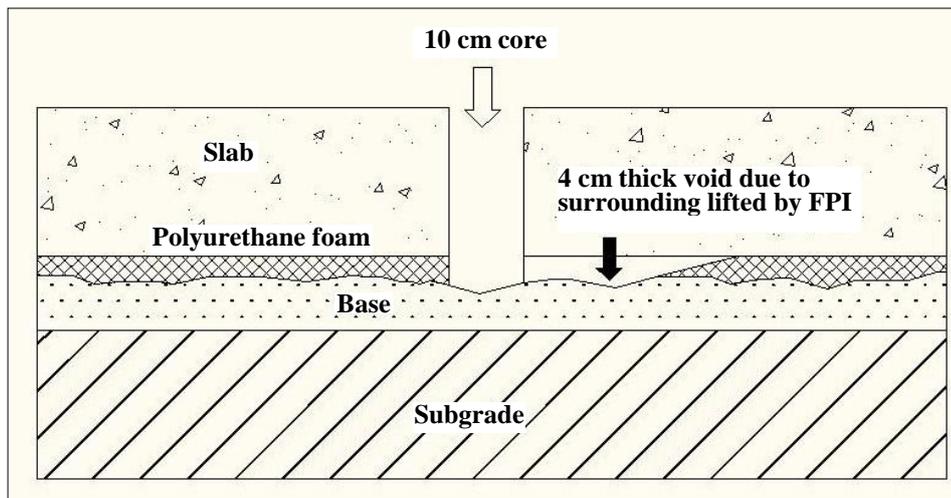
**Figure 4.25** Core#4 showing the void beneath the slab which was due to surrounding being lifted by PFI.

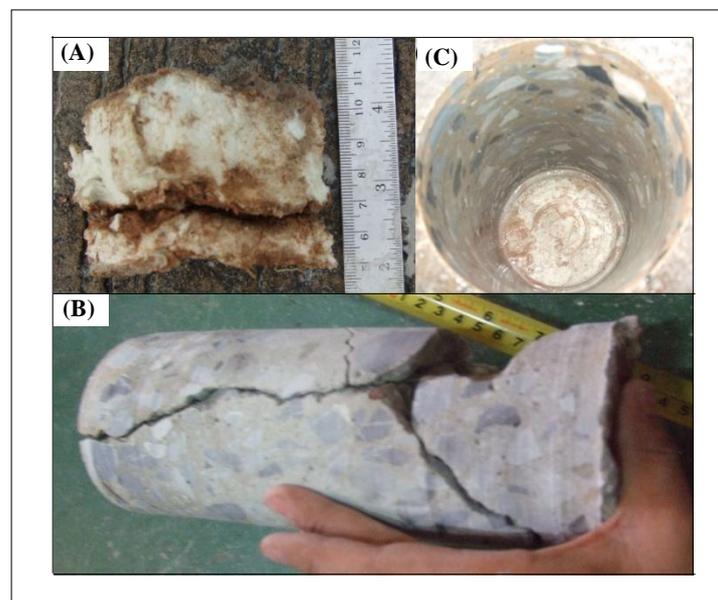
**Figure 4.26** (A) Polyurethane layer thickness shown at Core#12. (B) Core#13 which was broken while extraction. (C) Core#16 showing the presence of polyurethane foam.

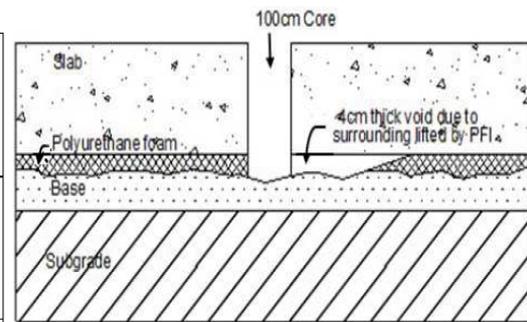
**Figure 5:** A 4 cm thick void formed due to surrounding being lifted by PFI beneath core #4

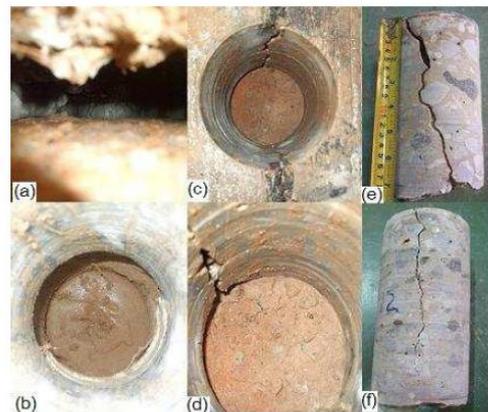
**Figure 6:** (a), (b) void formed by surrounding being lifted by PFI at core #4; (c), (d) PFI was not able to pass through the fault forming void at one side at core #7; (e) core #10 cracked throughout the core thickness; (f) core #12 crack half way through the thickness.

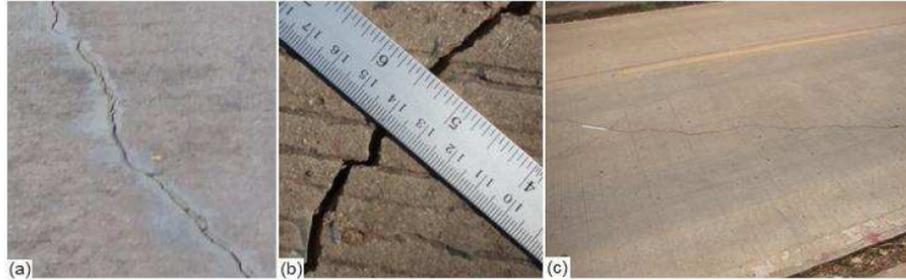
**Figure 13: (a) old cracked opened, (b) New cracks found and (c) Traverse Cracking Observed**
