Slope failure along Lomsak-Chumpae Highway, Thailand

K Fuenkajorn, Suranaree University of Technology, Thailand
P Thongthiangdee*, Suranaree University of Technology, Thailand

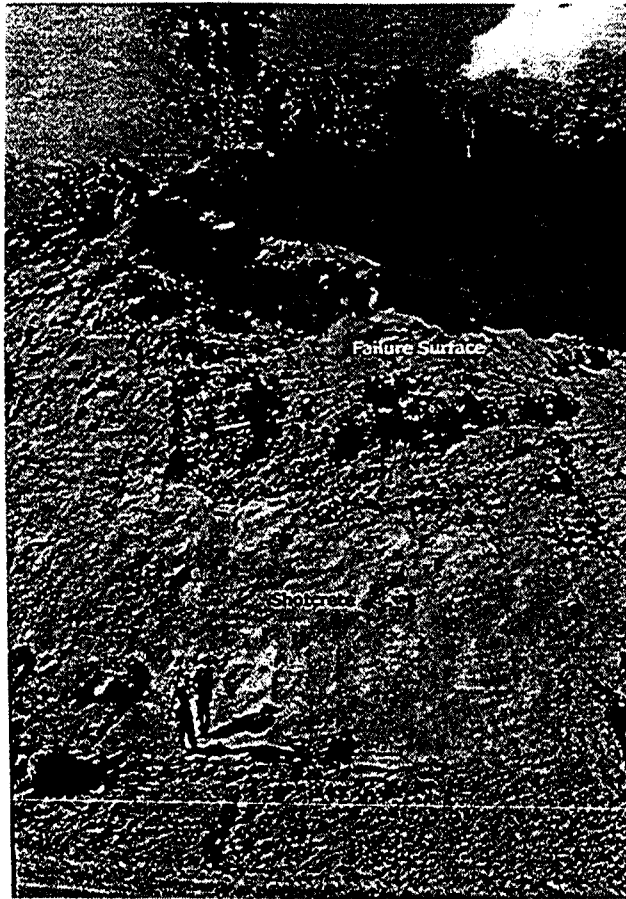
Since the year 2000, massive failure had repeatedly occurred on some slopes where the shotcrete has been installed. Four of these slopes failed within weeks apart. The failures brought down both the earthen and the supported materials. The remaining rock mass on the slopes also appears to be very unstable. Until then, through the service life of the highway, such massive failure had never occurred. Figures 1 and 2 show examples of the remaining slope faces after the massive failure occurred.

Figure 1 Massive failure occurred after the installation of shotcrete. Failure surface cuts from the upper slope through the mid-height of the slope face. Part of shotcrete remains at the lower slope face.

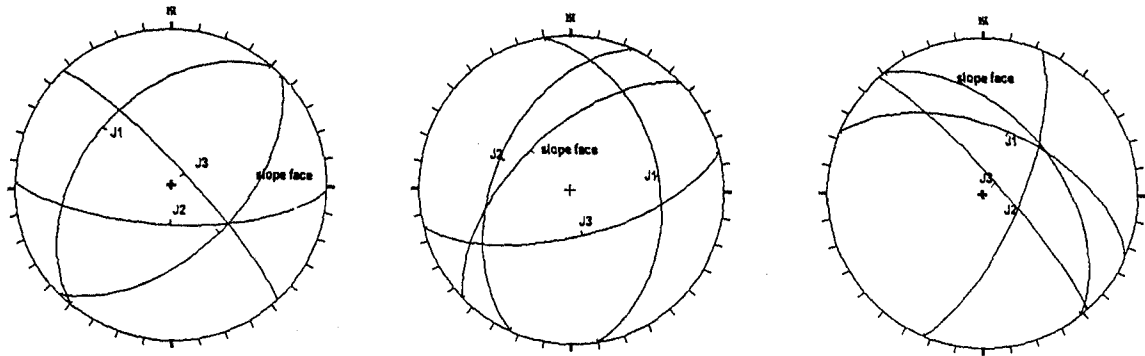
The orientations of the representative plane of the discontinuities (Figure 3) indicate that these slopes are not stable. Prior to the installation of any rock support, plane and wedge slides likely occur for all slopes. For Slope D, block toppling is also possible. This interpretation is supported by the results from the field observations that piles of rock fragments with an average size of 8x10x10 cm have been found at the slope toes. This minor failure is likely initiated by the surface runoff and groundwater pressure. This is evidenced by the fact that during the dry seasons all slopes remain stable; no rock fall has been observed. The weathering and erosion have significantly reduced the intact rock strength and the joint shear strength. The rock joints with very small spacing and low shear strength also increase the possibility of circular failure for all slopes, particularly during and after heavy rainfall. Since the rock mass has relatively high permeability (heavily fractured), the groundwater can freely seep out from the slope face. Subsequently, the water pressure within the slopes had never reached a critical point that a massive circular failure could occur.

Figure 4 Stereographic projections of slope face and discontinuities (J1, J2, J3) for slope A (left), slope B (Middle) and slopes C & D (right).

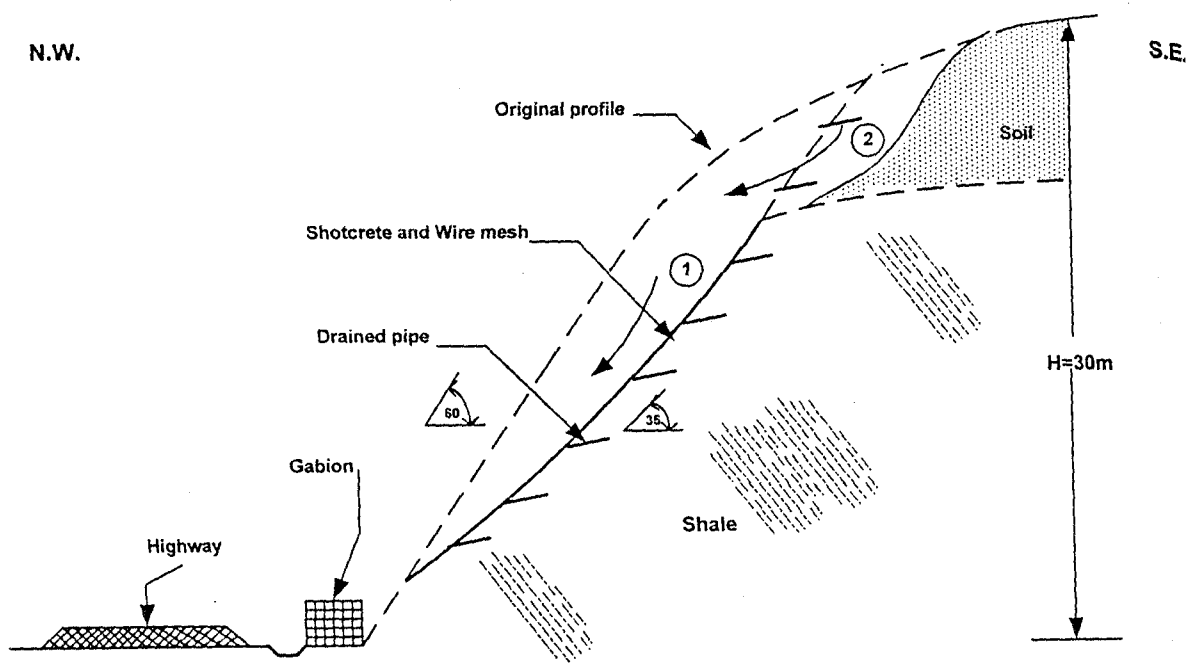
Slope A locates at km 20.5. The orientation of the slope face is (strike/dip angle) 225/60. The height is 30 m and length is 80 m. The slope is formed by heavily fractured shale. There are three joint sets with the following orientations (strike/dip angle); 075/65, 203/48 and 350/42. The average joint spacing is 15 cm. Persistence of the rock discontinuities is 100%. The joint roughness coefficient (JRC) is 1 (smooth planar). The width of the apertures is 0.1-1 cm (moderately wide to wide). They are filled with soft clay. The uniaxial compressive strength of the intact (field estimation) is 25-50 MPa.

Figures 5 through 8 show the cross-sections of the massive failure for Slopes A, B, C & D, respectively. The common cause and the sequence of the failure for these slopes are that the full-face shotcrete with inappropriate drained pipes prevented the infiltrated water from seeping out of the slope. The shotcrete was not effective in preventing the rock fragments from dislodging from the slope face. It is observed that slabs of shotcrete in many areas were detached from the surface of the weathered rocks. The drained pipes were poorly designed. They were too short and were not effective in reducing the pore pressure. No water flowed from any of those pipes during the rainfall. No water stain was observed below the pipes during the dry seasons. The permeability increase allowed groundwater to infiltrate even deeper into the rock mass behind the slope face, and eventually increased the pore pressure. Prior to the massive failure, the groundwater table nearly reached the upper slope face as indicated by the water stain near the cracks in the shotcrete. The failures were sudden. The failure surface on these slopes was a combination of plane and wedge sliding and circular failure. The sliding occurred on the top and the middle, and the circular occurs at the bottom of the failed surface. It is interesting to note that the failures of these four locations had occurred within weeks apart.

Figure 5 Cross-section of the failing rock slope at location A.

A computerized expert system, ROSES program [7] is used to design the stabilization methods for the present four rock slopes. The slope geometry, rock mass characteristics, existing rock supports, previous failure, and groundwater conditions (described above) are used as data input. The program also considers the level of safety required by the structures. The recommendations can be summarized as follows. A square pattern of fully grouted rock bolts with 2 meters spacing is required on the slope face. They should be installed in horizontal and normal to the slope face. The minimum bolt length is 4 meters. Resin should be used as grouting material in the holes. The bolts should be used with 5 cm opening wire mesh or chain link. The mesh should be galvanized. A series of drained pipes should be installed horizontally with 2 meters spacing. The drained pipes should have a minimum length of 15 meters, and are fully perforated. Shotcrete should be avoided. The overlying soil should be removed to at least 10 meters from the slope face.

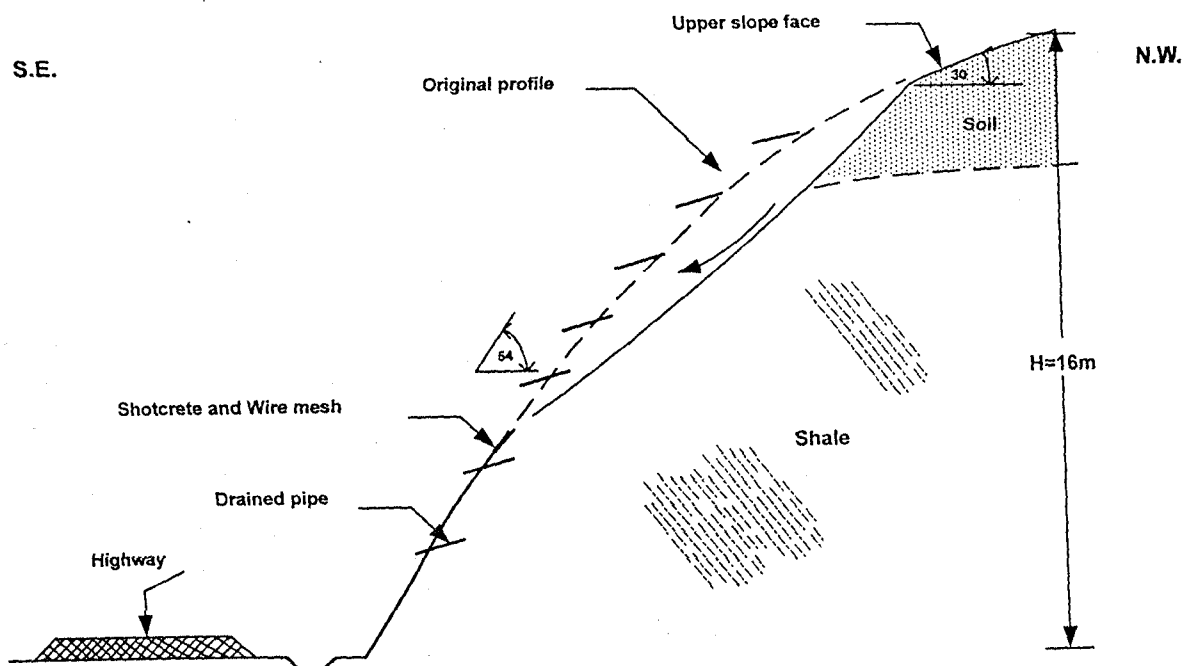
Slope B locates at km 21. The orientation of the slope face is 55/54. The height is 16 m and length is 40 m. The rock mass is weathering shale. There are three joint sets with the following orientations; 220/43, 092/69 and 318/81. The average joint spacing is 8 cm. Persistence of the rock discontinuities is 80-100% with JRC = 1. The joint apertures are 0.1-1.5 cm (moderately wide to extremely wide) and are filled with clay. The uniaxial compressive strength of the shale is approximately 25 MPa.

Figure 6 Cross-section of the failing rock slope at location B.

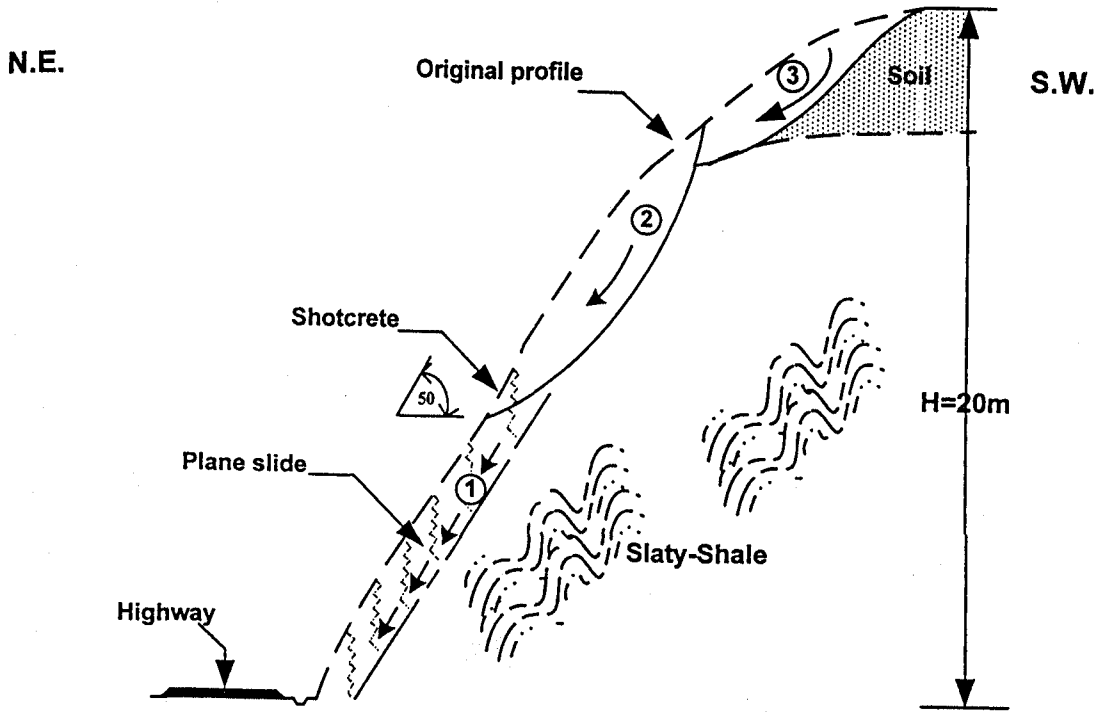
Slope C locates at km 36. The rock is highly weathered shale. The slope profile is very irregular with the average orientation of 321/50. It is 20 meters high, and 50 meters in length. There are three joint sets: 293/55, 023/70 and 318/80. The average joint spacing is 15 cm. Most joints are tight with JRC = 1-3. Persistence of rock discontinuities is 100%. The estimate compressive strength is 25 MPa. Slope D locates at km 37. It is 15 meters high and 25 meters long. The slope orientation is 303/55. The rock mass characteristics are virtually identical to those of the slope C.

Figure 7 Cross-section of the failing rock slope at location C.

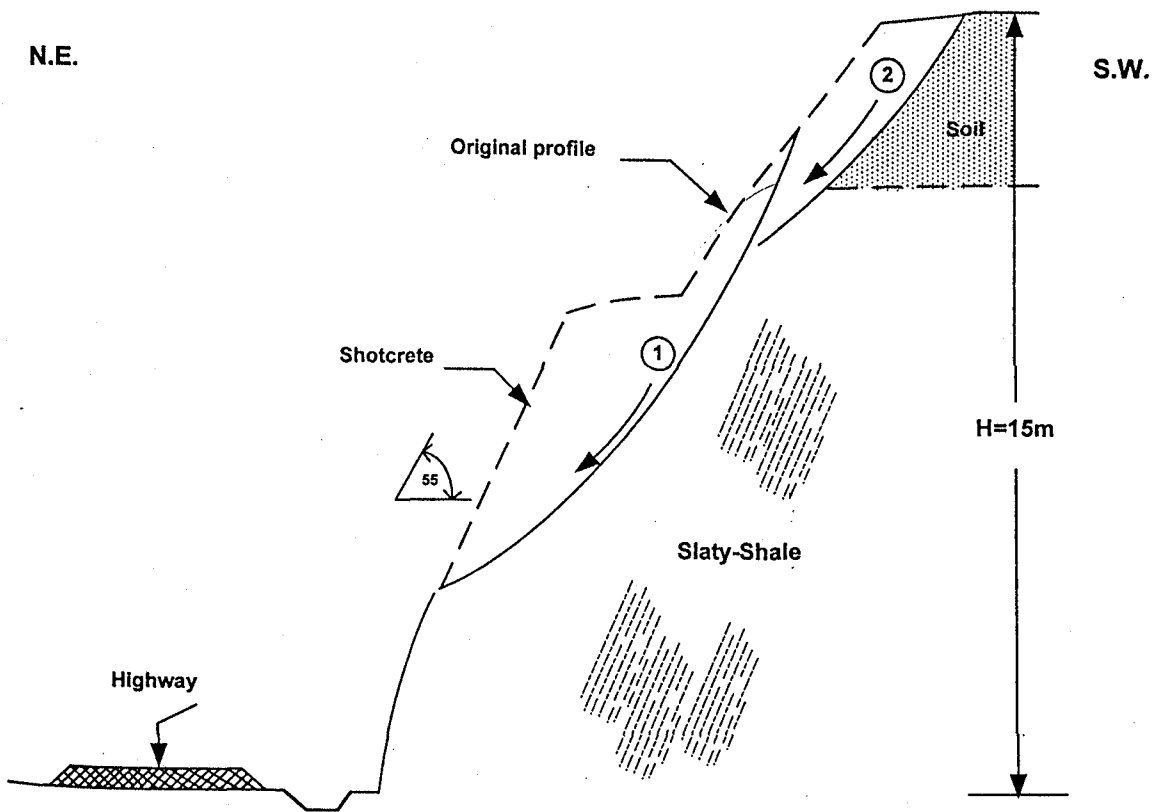
Figure 8 Cross-section of the failing rock slope at location D.
