# **ROCK SLOPE DESIGN USING EXPERT SYSTEM**

**A Thesis Submitted in Partial Fulfillment of the Requirements for the**

**Degree of Master of Engineering in Geotechnology**

**Suranaree University of Technology**

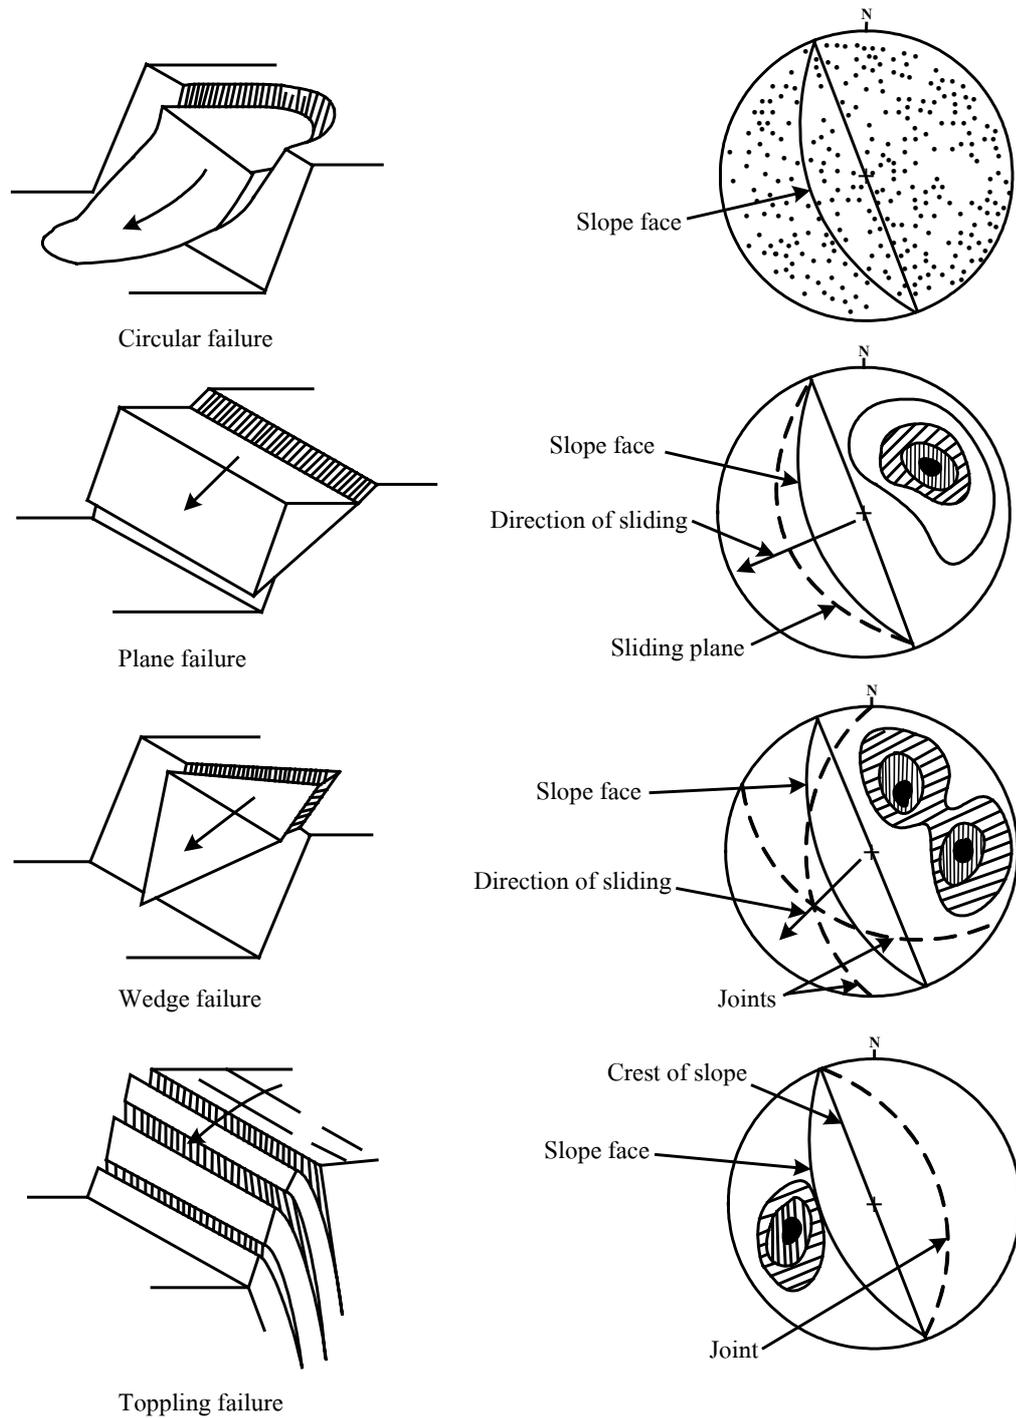
**Figure 2.1** Modes of rock slope failure and comparison with dip direction and dip angle in form of stereoplots (after Hoek and Bray, 1981).

The problem of evaluating the stability of slopes in jointed and weathered rock masses remains as a major challenge in the practice of rock engineering. The stability of a structure depends on the strength and deformability of the rock masses. The rock masses are typically heterogeneous and anisotropic (unpredictable) because of the different rock types and properties. The most universally occurring anisotropic characteristic of all rock masses is the presence of distinct breaks, or discontinuities, in the physical continuity of the rock. These include bedding surfaces, joints, and faults, etc. The water can reduce rock strength from pervasive chemical weathering. The presence of discontinuities in rock mass is the primary controlling factor of rock mass strength and deformability. Discontinuities also have a dominant role in defining rock mass properties. The slope geometries have become important on stability evaluation. Hoek and Bray (1981) and Goodman (1989) have classified the modes of slope failure into four types; plane and wedge sliding, toppling and circular failure (Figure 2.1).

A plane slide forms under gravity alone when a rock block rests on an inclined weakness plane that “daylights” into free space. The inclination of the plane of slip must be greater than the friction angle of that plane. The conditions for failure reside dormant in the slope until excavation or rock movement removes the barrier to block translation. Movement of a block like that shown in Figure 2.1 supposes that the restraint to sliding has been overcome not only along the surface of sliding but along the lateral margins of the slide as well. In soft rocks, like shale, the side restraint can be released by rupture of the rock itself if the base of sliding is inclined considerably steeper than the friction angle. In hard rocks, plane sliding can occur only if there are other discontinuities or valleys transverse to the crest of the slope releasing the sides of the block.

Toppling failure involves overturning of rock layers like a series of cantilever beams in slates, schists, and thin-bedded sediments inclined steeply into the hillside. Each layer tending to bend downhill under its own weight transfers force downslope. If the toe of the slope is allowed to slide or overturn, flexural cracks will form in the layers above, liberating a large mass of rock. If there are frequent cross-joints, the layers can overturn as rigid columns rather than having to fail in flexure. In either event, destructive slope movements must be prefaced by interlayer slip of a normal fault type.

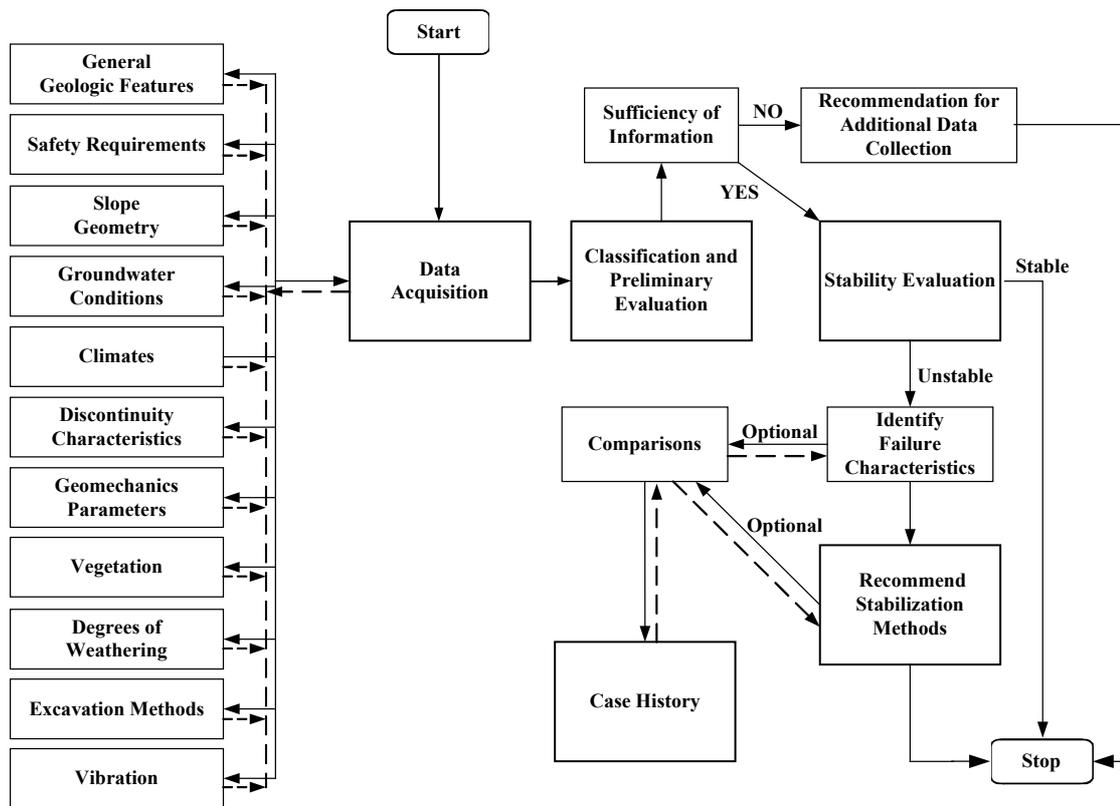
**Figure 4.1** Main network of ROSES.

The preliminary goal of ROSES is to know, as soon as possible, the general features of the rock slope that the user is dealing with. Such features include general geology, slope geometry, and engineering requirements. ROSES will quickly

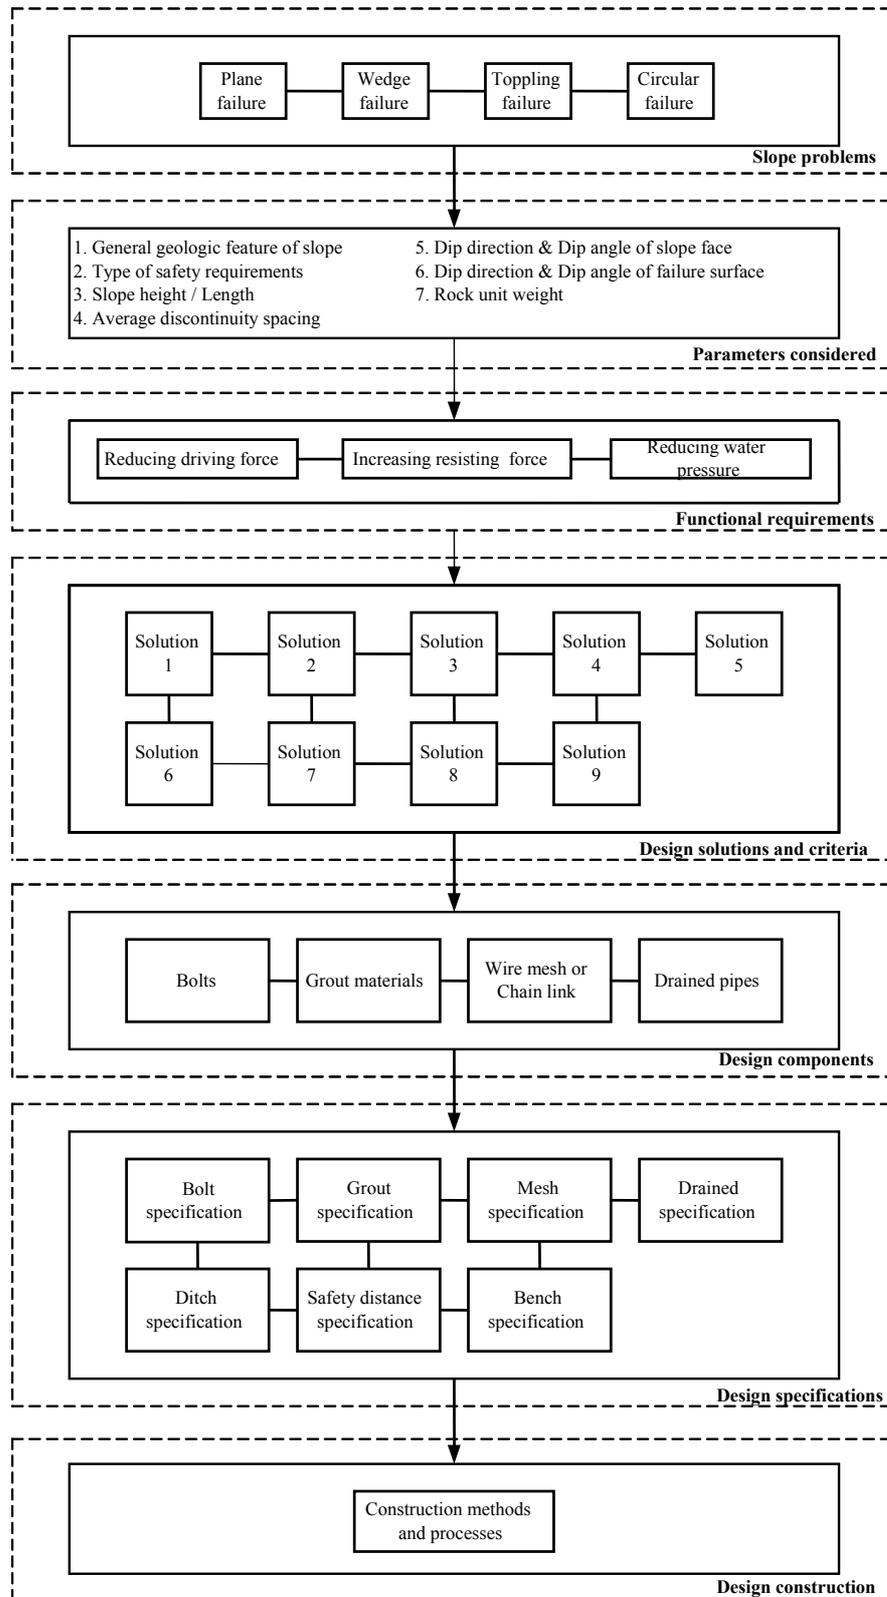
**Figure 4.2** Stabilization methods of ROSES diagram.

Based on the slope characteristics, the system selects the most suitable design solution for the reinforcements. A total of 9 design solutions are available. They comprise different combinations of the design components (Figure 4.2). The

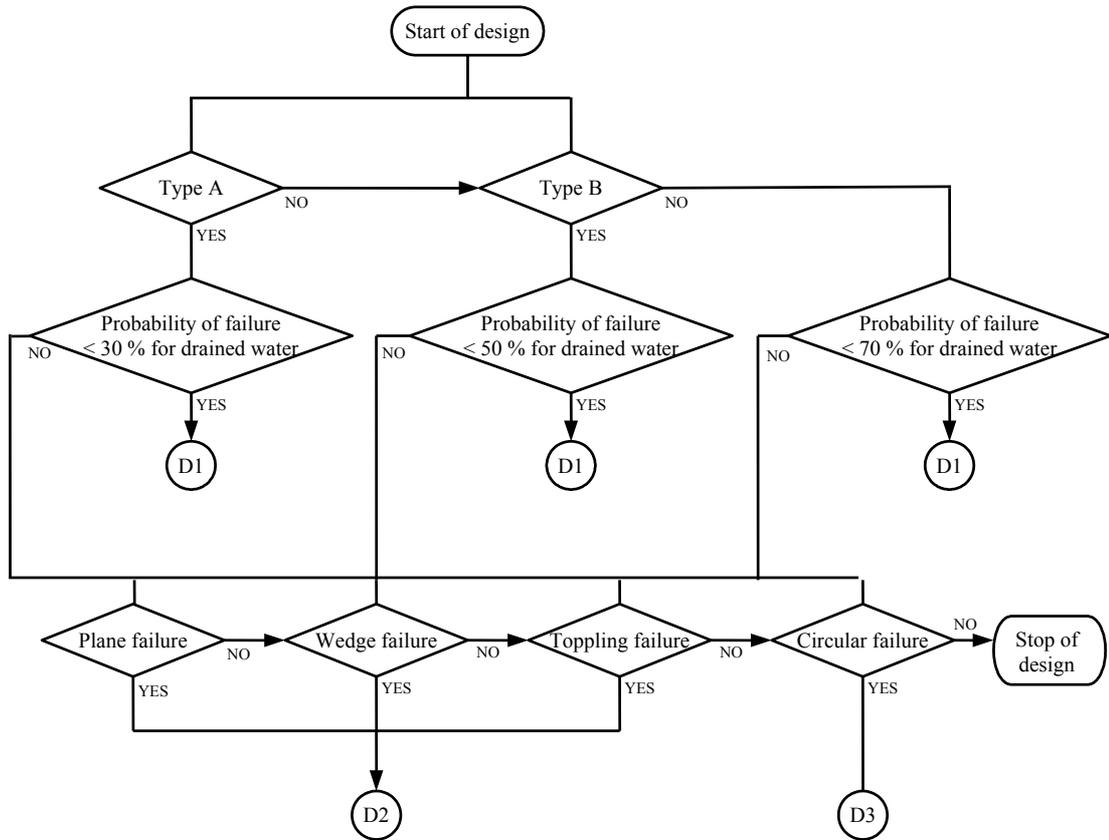
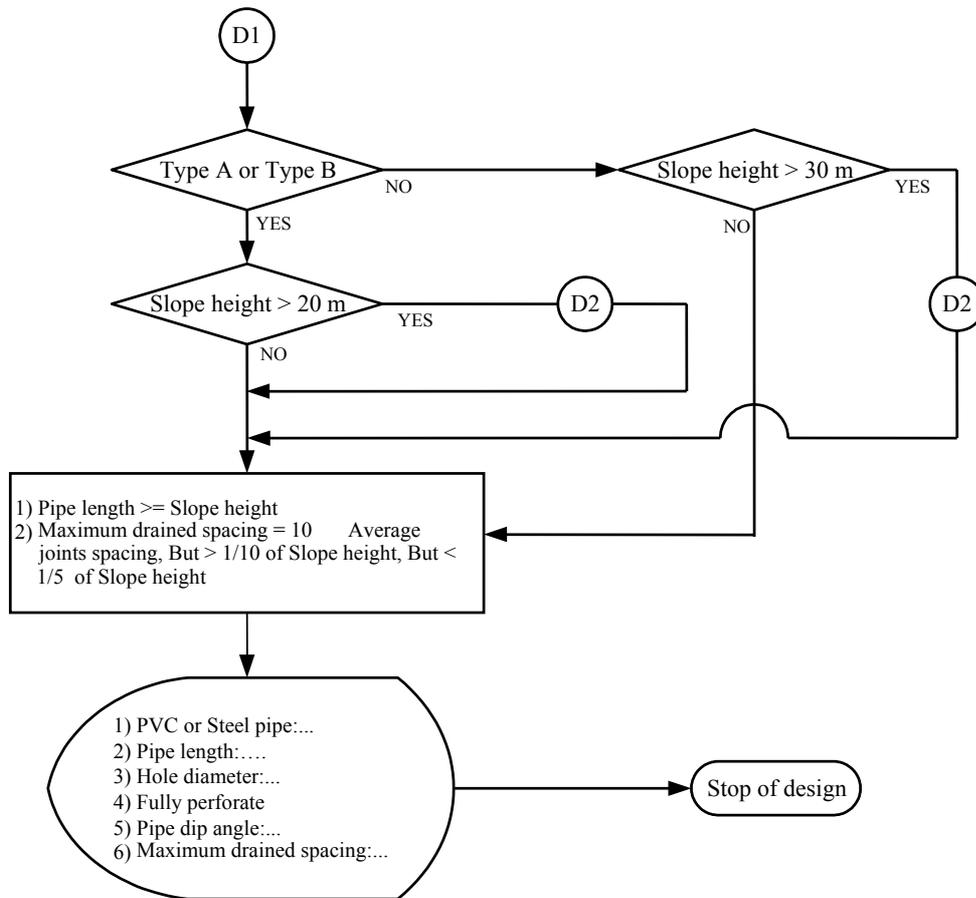
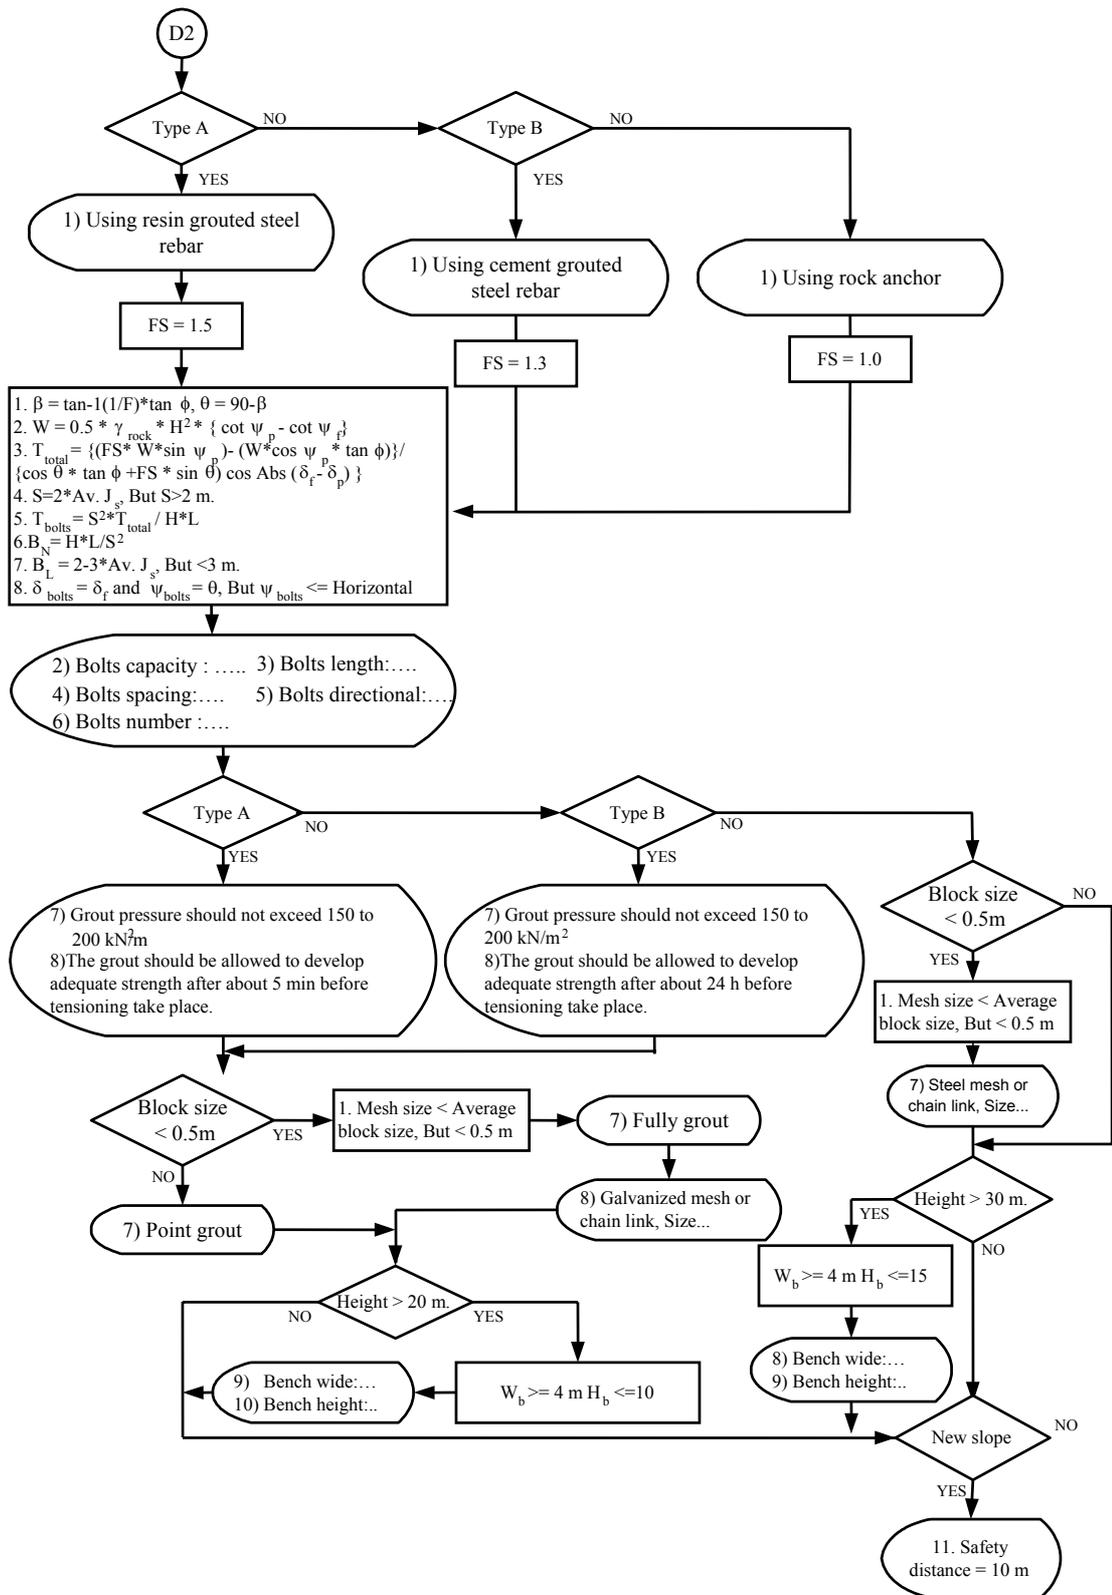
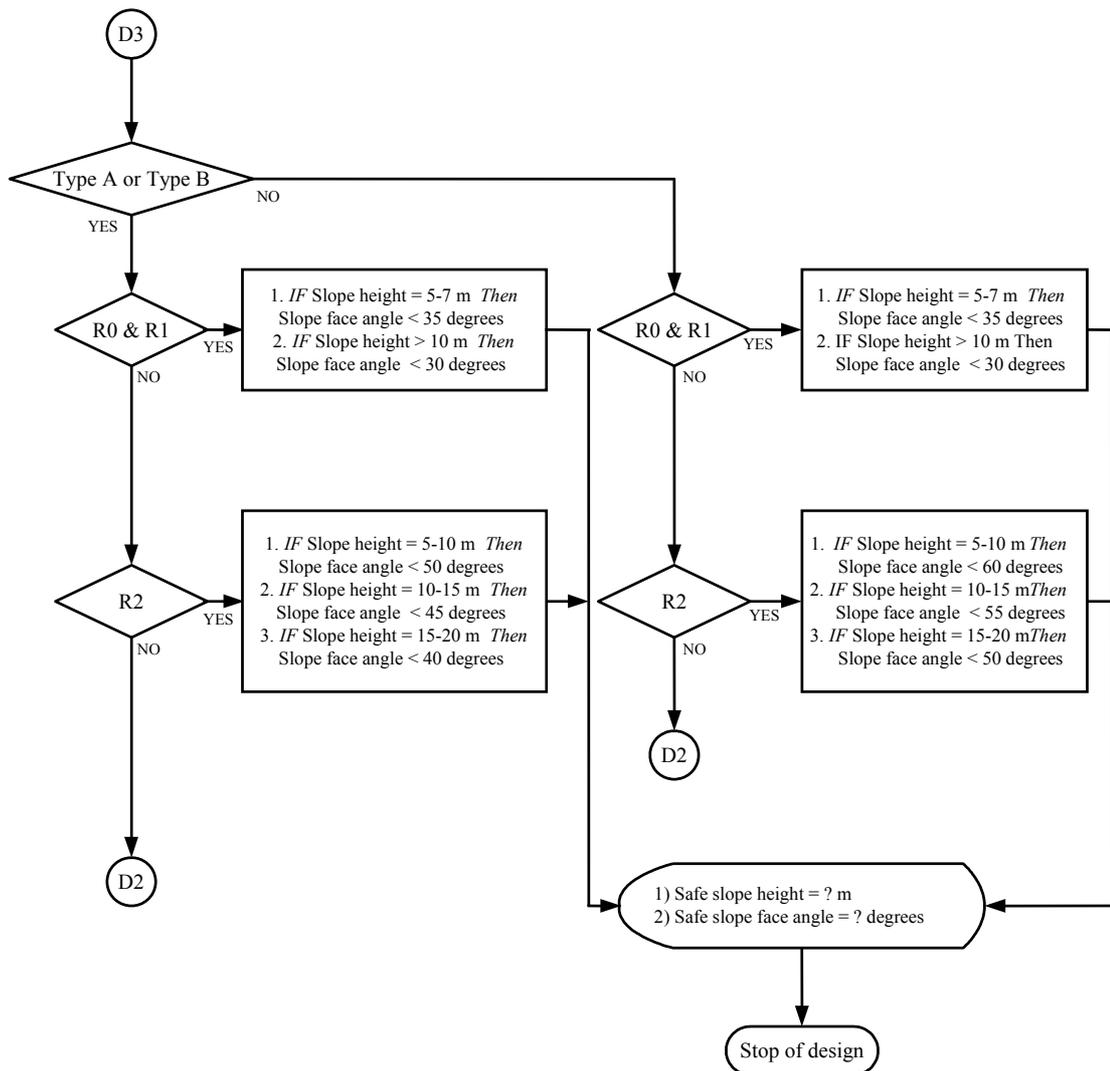
**Figure 5.14** Design supports and recommendations flowchart

**Figure 5.15** Design supports and recommendations flowchart (cont.)

Figure 5.16 Design supports and recommendations flowchart (cont.)

**Figure 5.17** Design supports and recommendations flowchart (End)

shows the possibility of failure, the program will offer the design for stabilization schemes. Figures 5.14 through 5.17 show how the program recommends the appropriate methods to stabilize the slope.

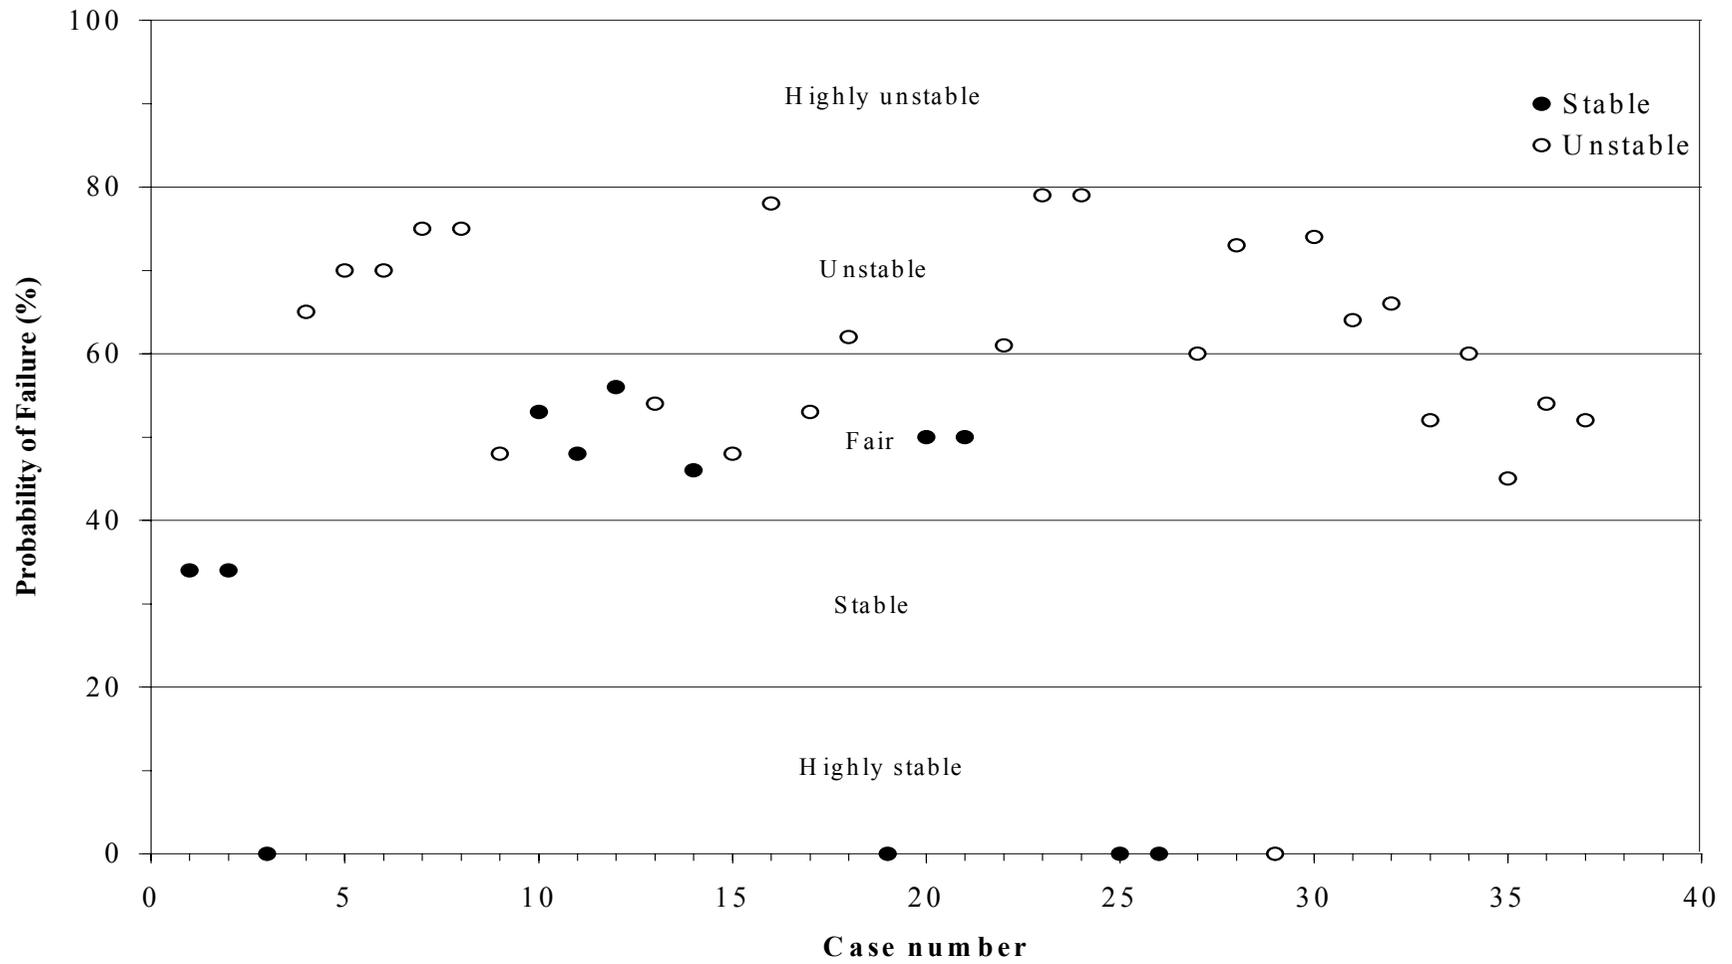
**Figure 7.1** Comparisons between expert system predictions and actual condition.

H = Slope Height $\psi_f$ = Dip Angle of Slope Face $\delta_f$ = Dip Direction of Slope Face $\sigma_c$ = Uniaxial Compressive Strength c = Cohesion $\phi$ = Friction angle		$P_f$ = Probability of Failure J1, J2, J3 and J4 = Joint Set Number (dip direction / dip angle) S1, S2, S3 and S4 = Joint Spacing for set 1, 2, 3 and 4 Slope number designation as indicated in Appendix

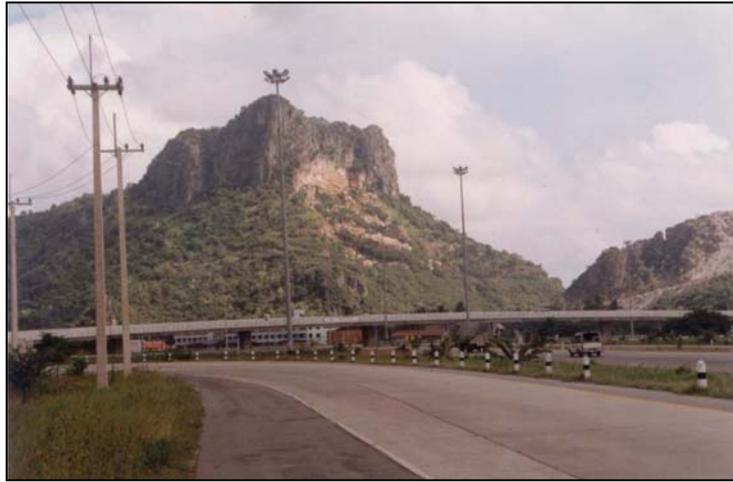
**Figure A.2** The secondary toppling of Khao Chow Lai Yai, Cha-Am district, Phetchaburi province (slope no.1).

The mode of failure is secondary toppling on the vertical joint of limestone. The failure occurred due to the excessive excavation of soft shale formation at the toe.

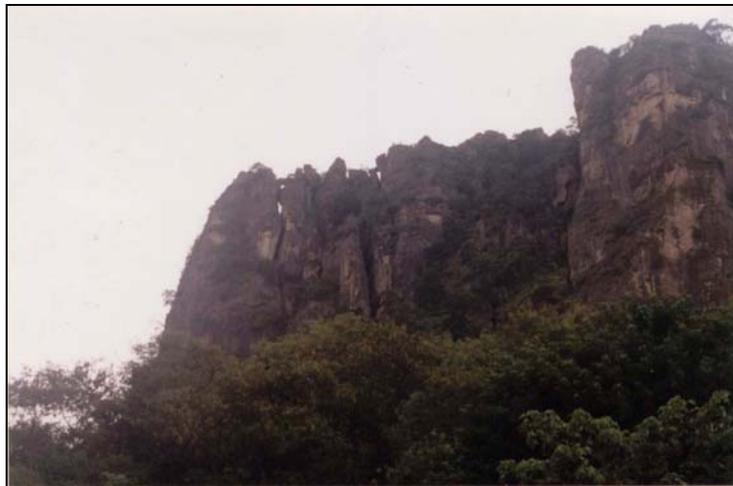
**Figure A.3** The vertical joint of limestone is located in Khod Nang Panturat of Khao Chow Lai Yai (slope no.1).

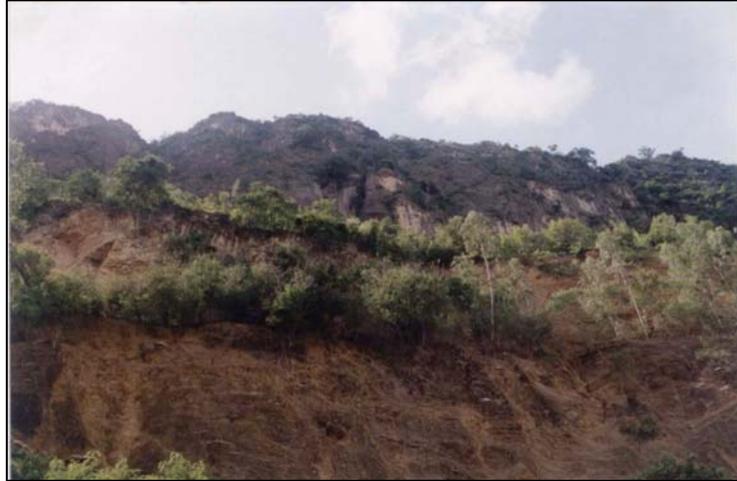
**Figure A.8** The excessive excavation of the soft shale formation at the toe of Khao Chow Lai Yai (slope no.2).

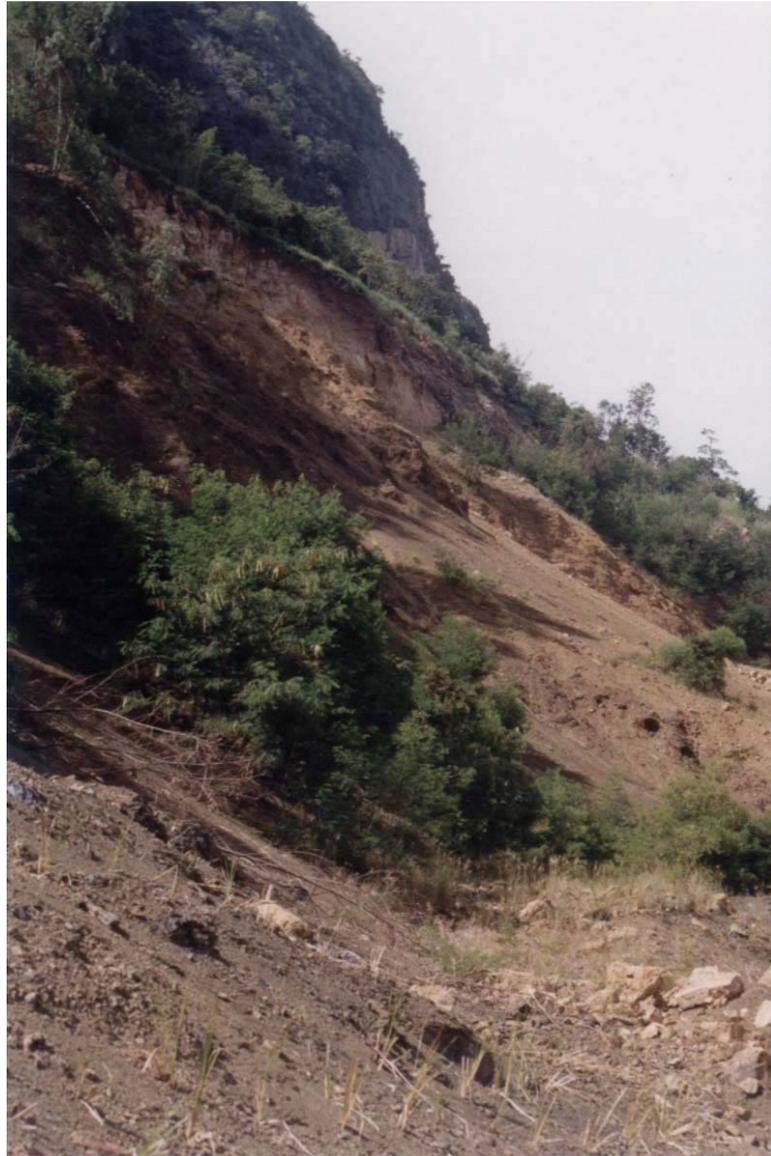
**Figure A.9** The excessive excavation of the soft shale formation at the toe of Khao Chow Lai Yai (slope no.2).

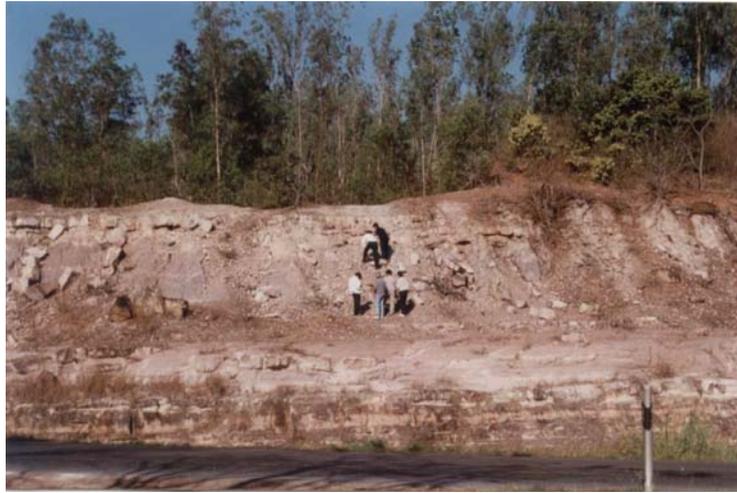
**Figure A.13** The secondary toppling of hard-soft interbedded rock is located at km 70 of highway No. 304 (slope no.3).

The mode of failure is secondary toppling of the vertical joint in massive sandstone (size is  $0.7 \times 0.8 \times 0.5 \text{ m}^3$ ). The failure is caused by the erosion of the soft shale bed which results in the collapse of the hard sandstone bed above.

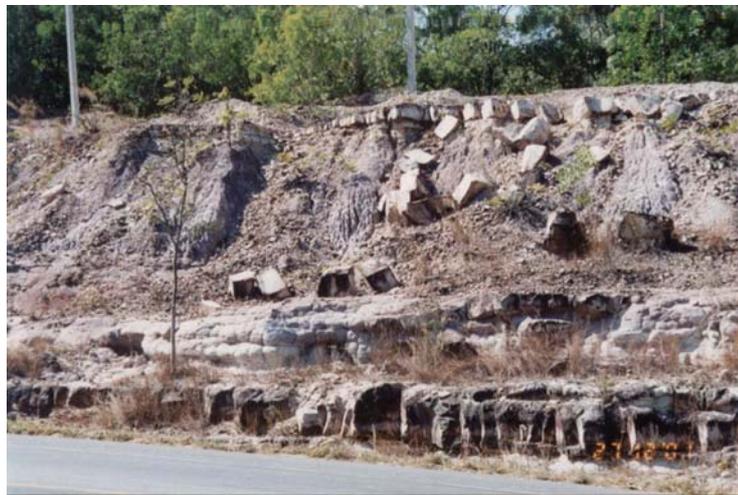
**Figure A.14** The block sizes of sandstone are  $0.7 \times 0.8 \times 0.5 \text{ m}^3$  at the toe of slope (slope no.3).

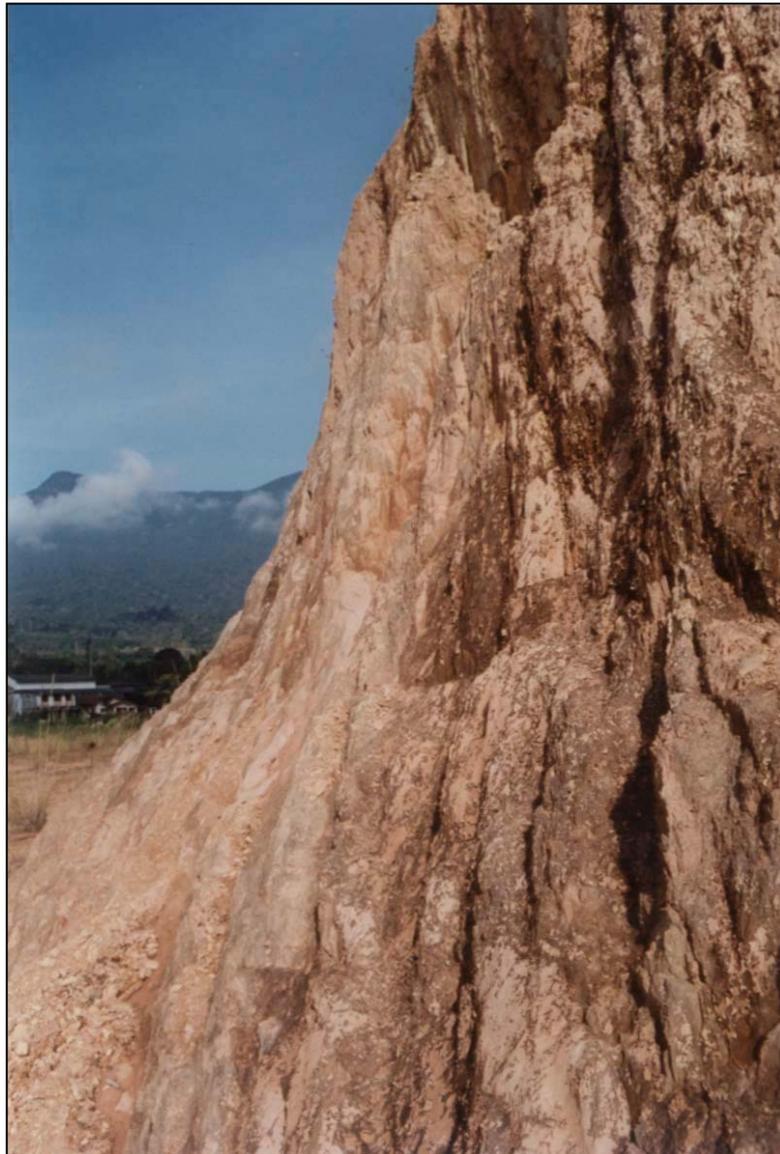
**Figure A.17** Heavily jointed rock of shale quarry is located in Pong Nam Ron district, Chathaburi province (slope no.6).

The slope no.6 is located in Pong Nam Ron district, Chanthaburi province. The slope location is 48 P 0203877 and UTM 1427846 of GPS system (Figures A.16 and A.17). The slope is classified as heavily jointed rock. The slope height is 8-10

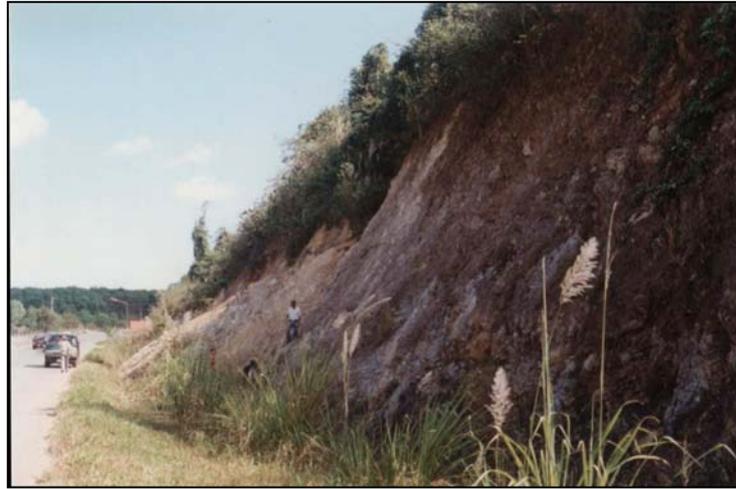
**Figure A.18** Heavily jointed rock slope is located at km 92-93 of highway no.344 (slope no.7).

The slope no.7 at km 92-93 of highway no.344 is located in Chanthaburi province. The slope location is 47 P 0784101 and UTM 1421792 of GPS system (Figures A.18 and A.19). The slope is classified as heavily jointed rock. The slope height is 13 meters. The strike of the slope face is 300 degrees. The dip angle is 60 degrees. The UCS of the intact rock is 5-25 MPa. The rock has two joint sets, as follows.

The failure modes are the combination of plane sliding, toppling and circular failure. The failure is caused by the combination of water saturation, ground vibration (by heavy traffic) and the high angle slope face.

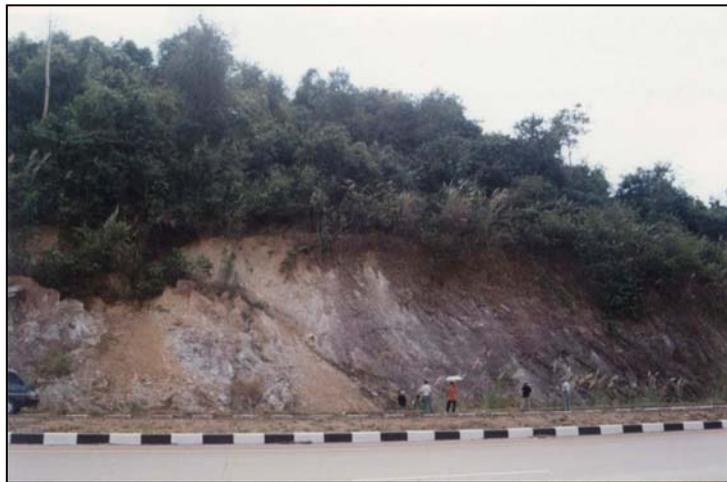
**Figure A.19** The circular failure of heavily jointed rock slope on highway no. 344, Chon Buri province (slope no.7).

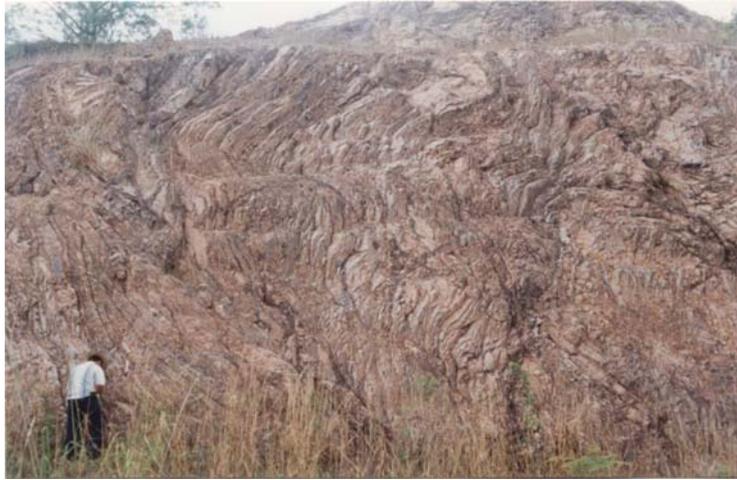
**Figure A.23** Folding of shale is located in slaty-shale quarry, Chon Buri province (slope no.10).

The failure modes are toppling and surface circular failure. The failure is caused by the combination of water saturation, ground vibration and the high angle slope face.

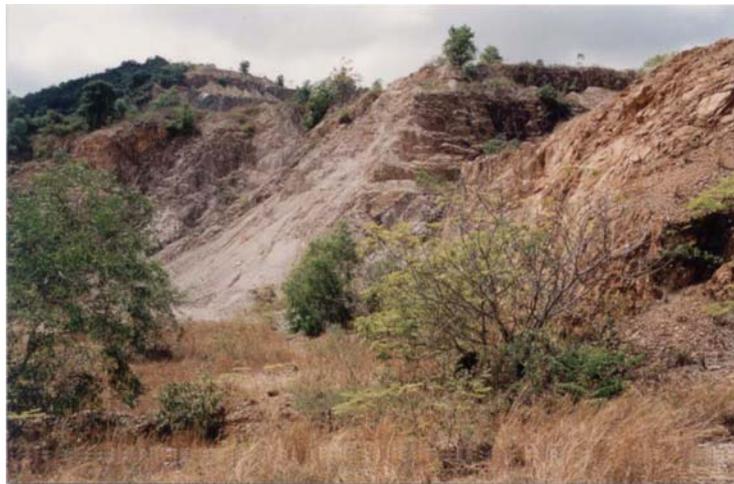
**Figure A.24** Circular failure of blocky rock slope of slaty-shale quarry, Chon Buri province (slope no.10).

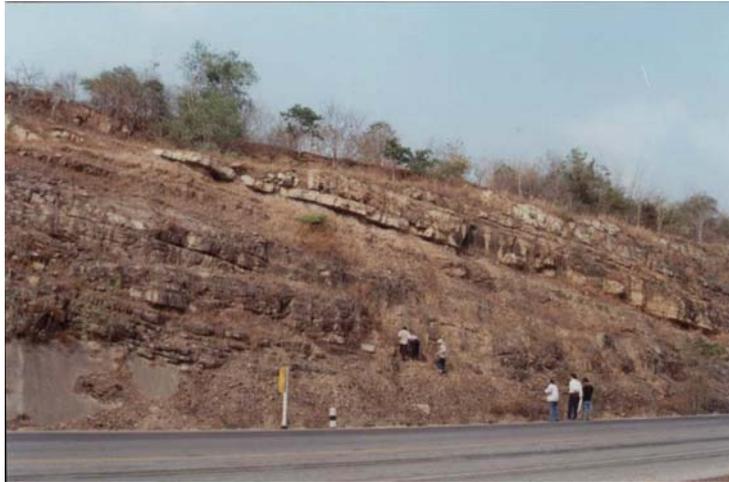
**Figure A.30** The rock slope on highway no.2256, Chai Badan district, Lop Buri province (slope no.12).

The slope no.12 is located on highway no.2256. The slope location is 47 P 0759028 and UTM 1670703 of GPS system (Figures A.30 and A.31). The slope is classified as hard-soft interbedded rock mass. The hard formation is sandstone. It has 0.6 to 1.0 meter in thickness. The soft formation is shale. It has 0.2 to 1.0 meter thickness. The slope height is 50 meters. The strike of the slope face is 080 degrees. The dip angle is 60 degrees. The UCS of the intact rock is about 5-25 MPa for shale and about 50-100 MPa for sandstone. The rock has three joint sets, as follows.

The failure is secondary toppling of the vertical joint in massive sandstone (size is  $0.5 \times 0.5 \times 0.7 \text{ m}^3$ ). The failure is caused by the erosion of the soft shale bed which results in the collapse of the hard sandstone bed. The existing supports include shotcrete, drained holes and ditch.

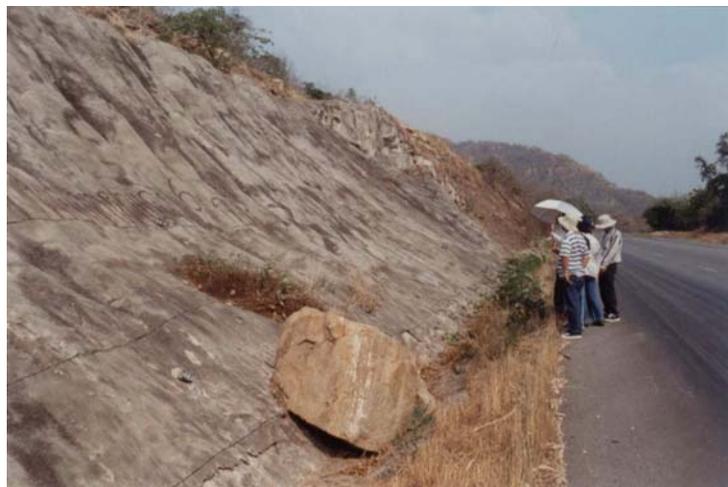
**Figure A.31** The sandstone block size is  $0.8 \times 0.7 \times 0.7 \text{ m}^3$  on the toe of slope (slope no.12).

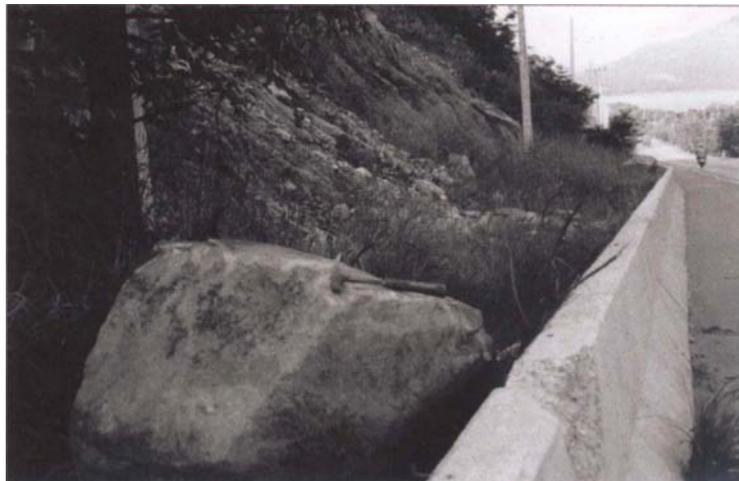
**Figure A.34** Sandstone block size is  $2 \times 1 \times 1 \text{ m}^3$  on the toe of slope (slope no.13).

The failure is secondary toppling of the vertical joint in massive sandstone (size is  $0.5 \times 0.5 \times 0.7$  to  $2.0 \times 1.0 \times 1.0$  m<sup>3</sup>). The failure is caused by the erosion of the soft shale bed which results in the collapse of the hard sandstone bed.

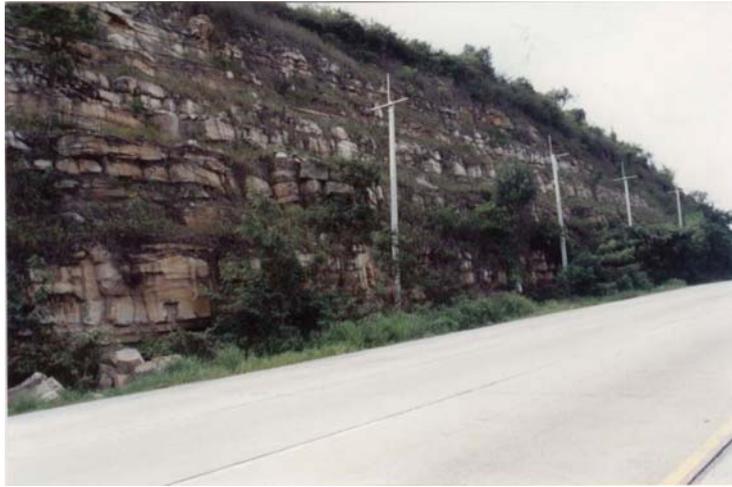
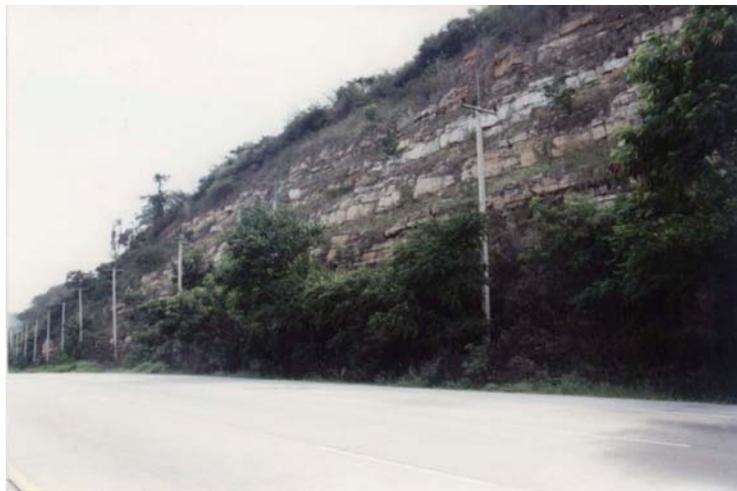
**Figure A.35** The slope location at km 193-194 of Friendship highway, Lam Takong dam, Nakhon Ratchasima province (slope no.14).

**Figure A.36** The slope location at km 193-194 of Friendship highway, Lam Takong dam, Nakhon Ratchasima province (slope no.14).

The slope no.14 at km 194-195 is located on Friendship highway. The slope location is 47 P 0775301 and UTM 1641908 of GPS system (Figures A.35 to A.37). The slope is classified as hard-soft interbedded rock. The hard formation is sandstone. It has 0.6 to 1.0 meter in thickness. The soft formation is shale. It has 0.5 to 1.5 meter thickness. The slope height is 40 meters. The strike of the slope face is 206 degrees. The dip angle is 55 degrees. The UCS of the intact rock is about 5-25 MPa for shale and about 50-100 MPa for sandstone. The rock has three joint sets (Figures A.38 and A.39). Give more joint detail as follows.

The failure is secondary toppling of the vertical joint in massive sandstone (size is  $0.2 \times 0.3 \times 0.5$  to  $0.6 \times 0.8 \times 1.0$  m<sup>3</sup>). The failure is caused by the erosion of the soft shale bed which results in the collapse of the hard sandstone bed.

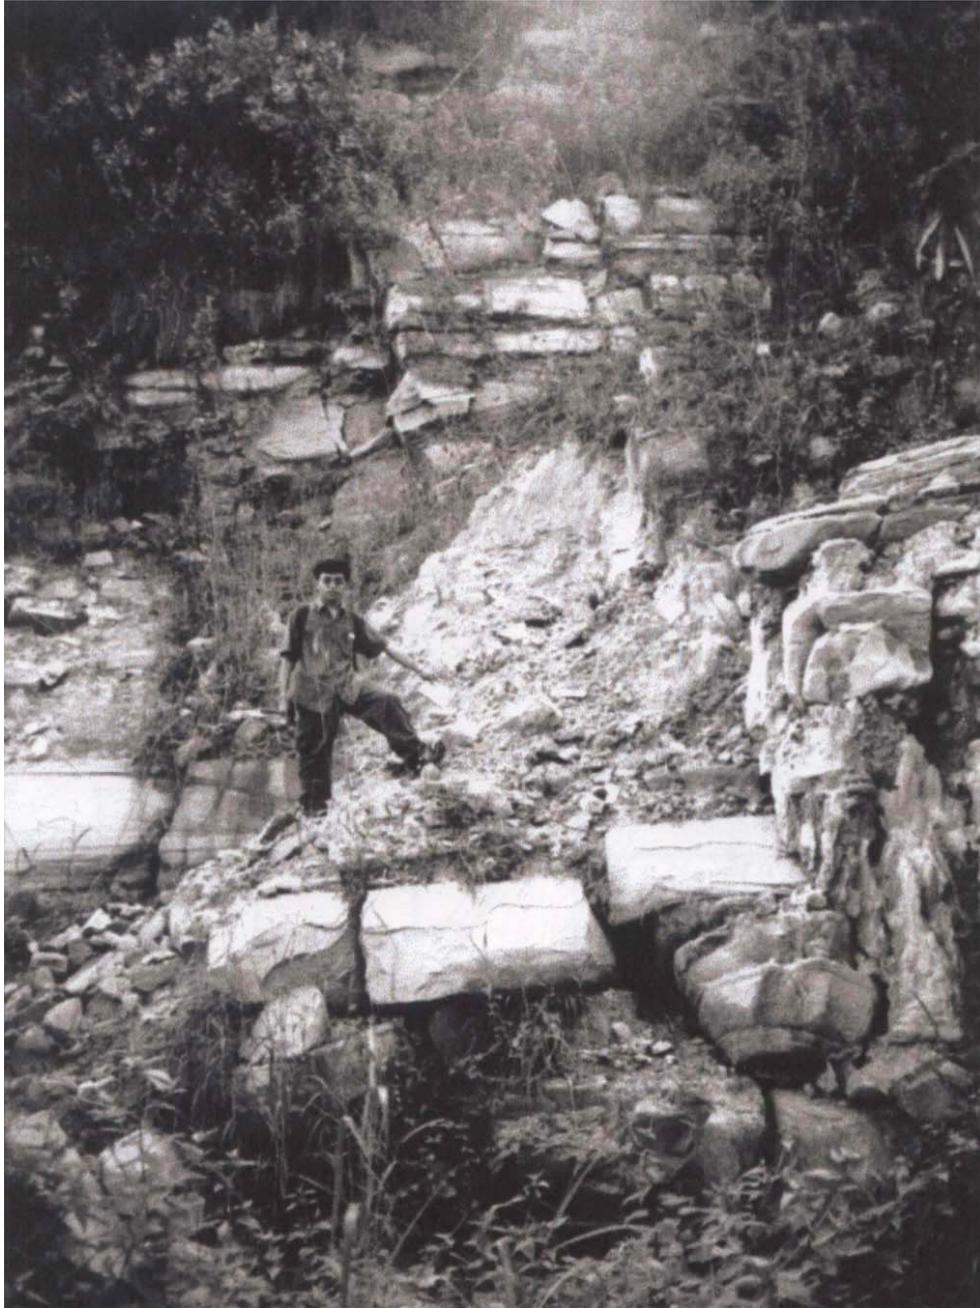
**Figure A.37** The failure is caused by the erosion of the soft shale bed which results in the collapse of the hard sandstone bed (slope no.14).

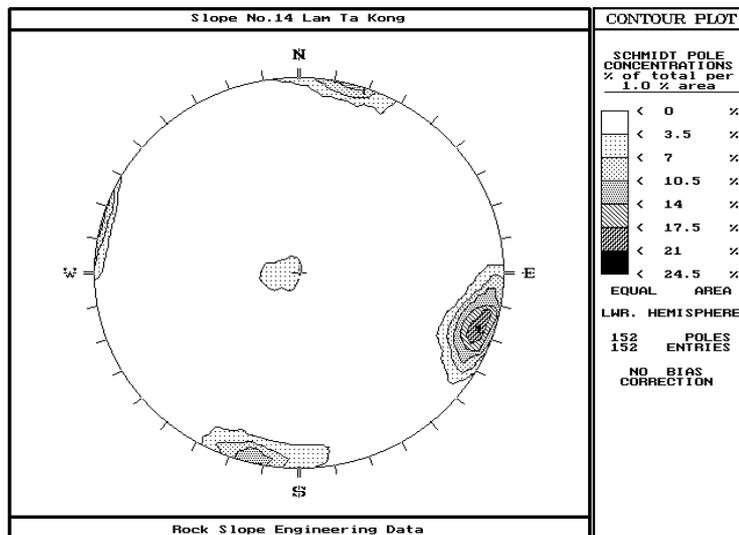
**Figure A.38** The contour plot of sandstone discontinuity set of slope is located at km 193 -194 of Friendship highway (slope no.14).

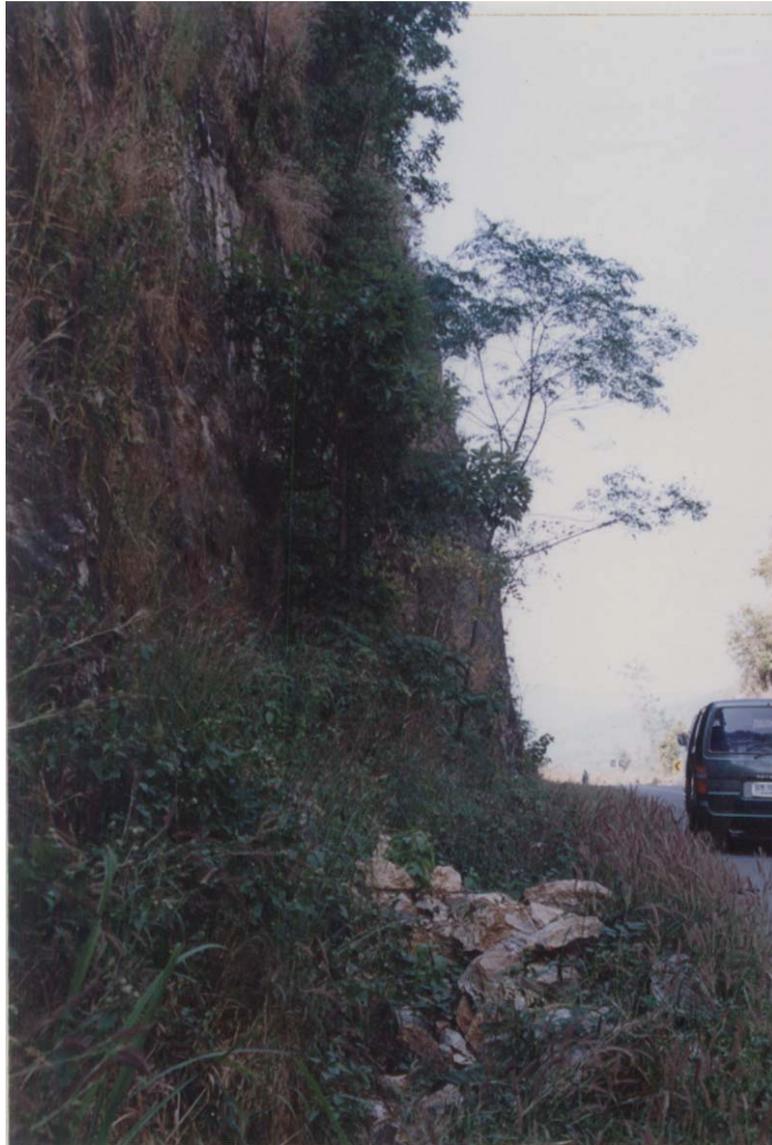
**Figure A.68** The falling rock of limestone at the toe of slope (slope nos. 24 and 25).

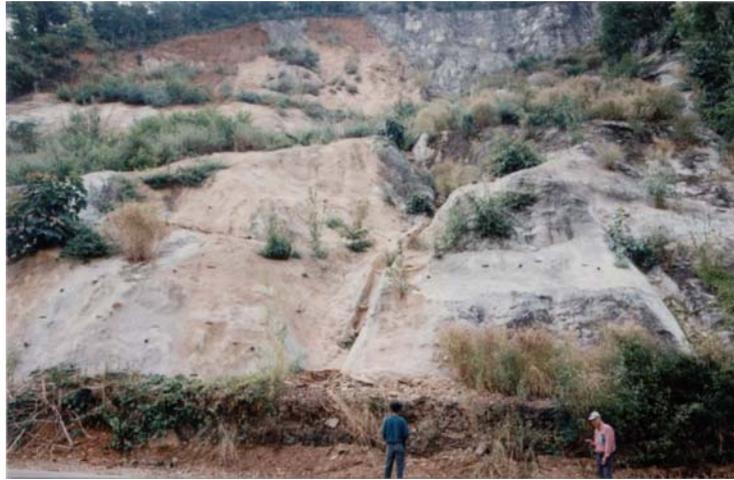
**Figure A.75** The heavily jointed slope is located on 20 to 21-km of highway no.12, Lom Sak district, Petchabun province (slope no.27).

The slope No.27 at km 20-21 is located on Lomsak-Chumpae highway. The slope location is 47 Q 0754024 and UTM 1851415 of GPS system (Figures A.75 and A.76). The slope is classified as heavily jointed rock. The slope height is 30 m and length is 25 m. The strike of the slope face is 225 degrees. The dip angle is 55 degrees. The rock type is weathered shale. The UCS of the intact rock is about 5-25 MPa. The slope is unstable. The failure mode is circular. The existing supports include shotcrete, drained holes, ditch and gabion. The rock has three joint sets (Figures A.77 and A.78), as follows.
