# **ROCK SLOPE DESIGN USING EXPERT SYSTEM**

**A Thesis Submitted in Partial Fulfillment of the Requirements for the**

**Degree of Master of Engineering in Geotechnology**

**Suranaree University of Technology**

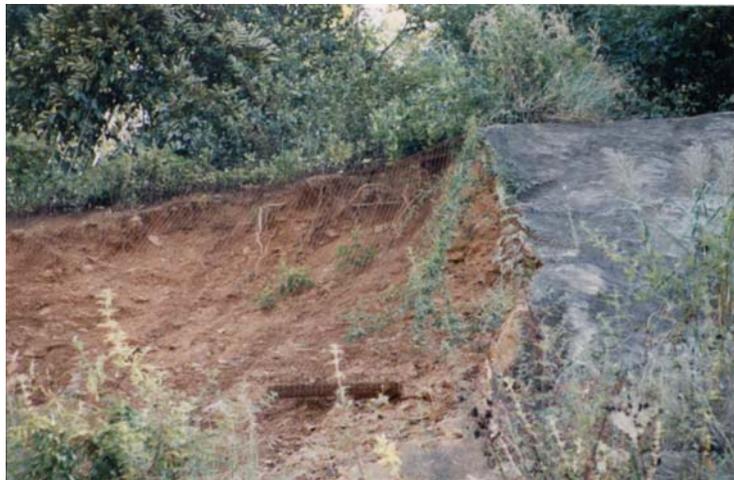
**Figure A.76** The mode of failure is circular on the top of heavily jointed slope (slope no.27).

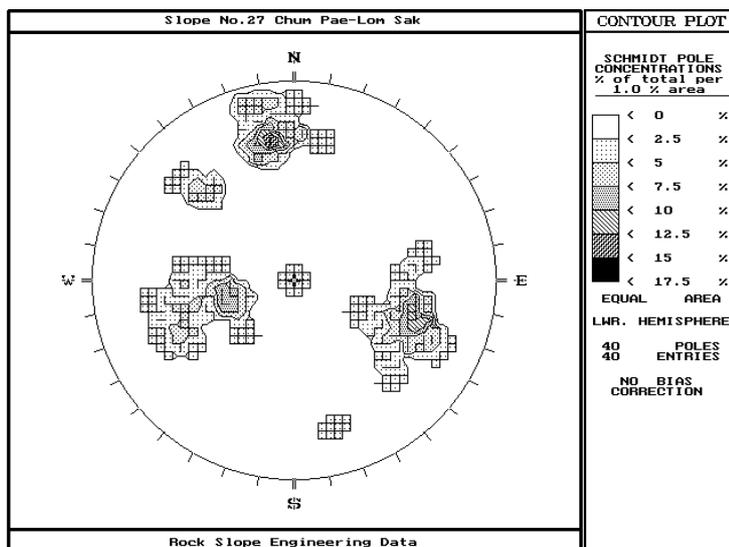
**Figure A.77** The contour plots of slaty-shale discontinuity for heavily jointed slope on highway no.12 (slope no.27).

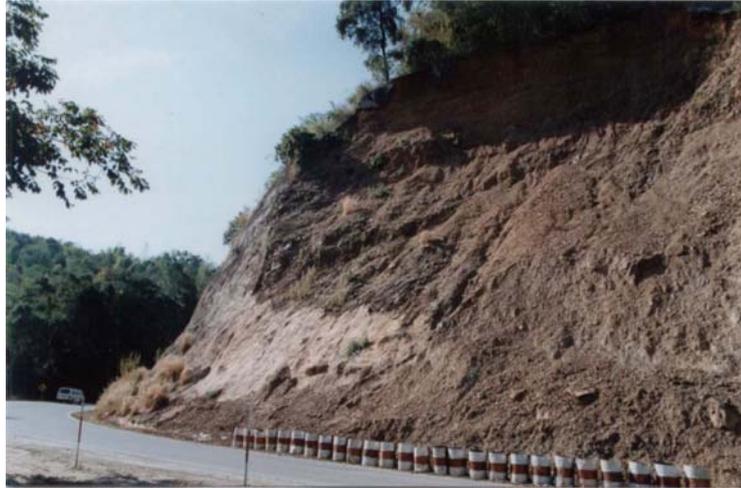
**Figure A.79** The heavily jointed slope is located on 22 to 23-km of highway no.12, Lom Sak district, Petchabun province (slope no.28).

The slope no.28 at km 22-23 is located on Lomsak-Chumpae highway. The slope location is 47 Q 0754604 and UTM 1851201 of GPS system (Figures A.79 and A.80). The slope is classified as heavily jointed rock. The slope height is 18 m and length is 40 m. The strike of the slope face one is 110 degrees. The dip angle is 48 degrees and face two is 055 degrees of strike and 54 degrees of dip angle. The rock type is weathered shale. The UCS of the intact rock is between 5-25 MPa. The slope is unstable. The failure mode is surface circular. The existing supports include shotcrete, drained holes, ditch and gabion. The rock has three joint sets (Figures A.81 and A.82) as follows.

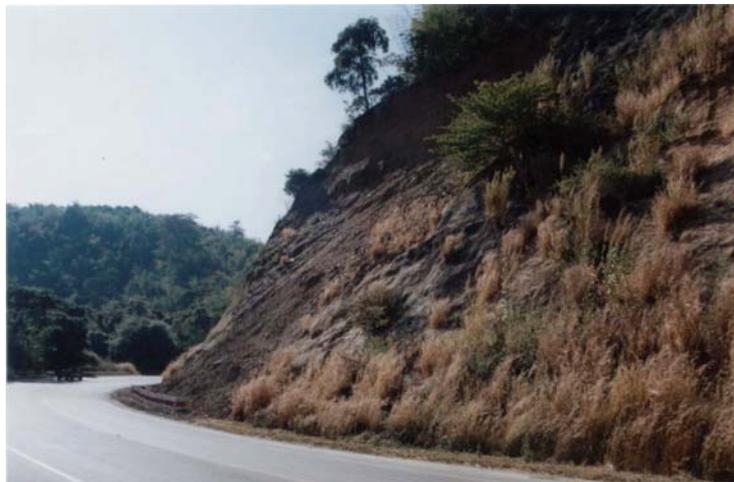
**Figure A.80** The mode of failure is circular on the top of heavily jointed slope (slope no.28).

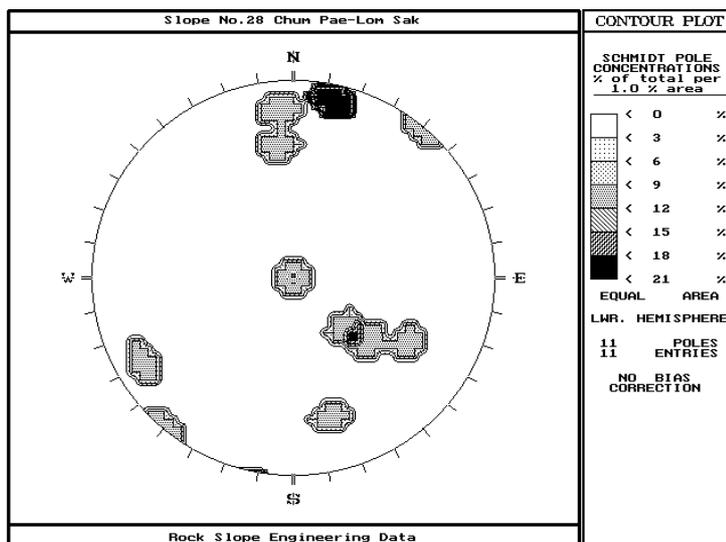
**Figure A.81** The contour plots of slaty-shale discontinuity for heavily jointed slope on highway no.12 (slope no. 28).

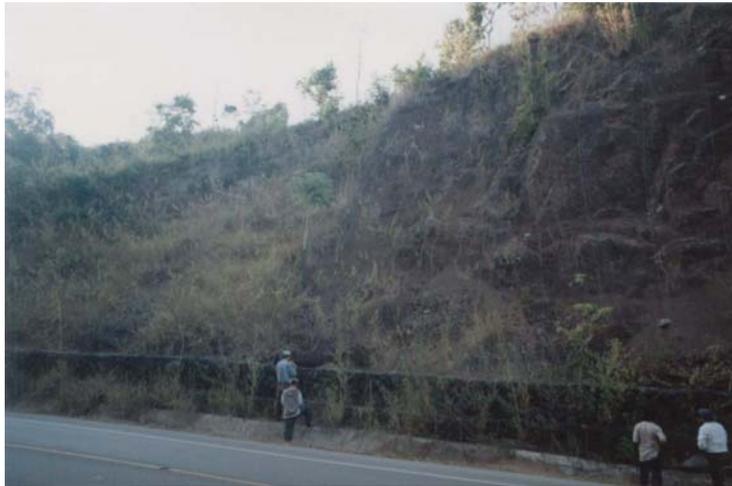
**Figure A.83** The heavily jointed slope is located on 23 to 24-km of highway no.12, Lom Sak district, Petchabun province (slope no.29).

The slope no.29 at km 23-24 is located on Lomsak-Chumpae highway (Figures A.83 and A.84). The slope is classified as heavily jointed rock. The slope height is 12 m and length is 20 m. The strike of the slope face one is 040 degrees. The

dip angle is 65 degrees. The rock type is silty-sandstone. The UCS of the intact rock is between 25-50 MPa. The slope is unstable. The failure modes are plane, wedge and toppling. The existing supports include wire mesh, ditch and gabion wall. The rock has three joint sets (Figures A.85 and A.86), as follows.

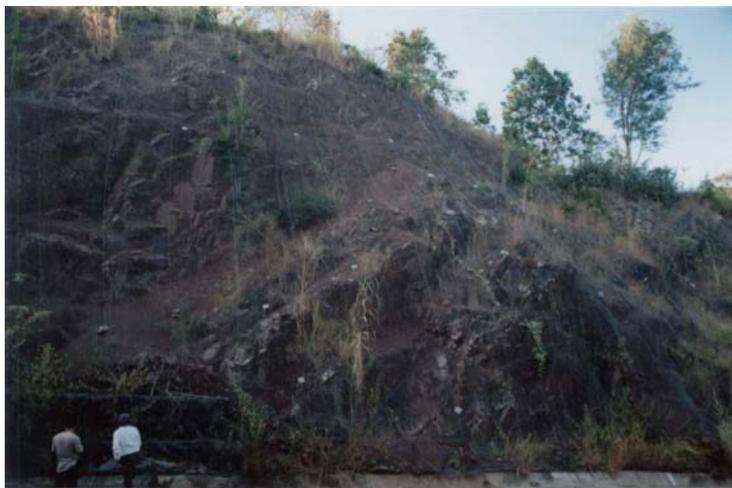
**Figure A.84** The modes of failure are combination of plane and wedge sliding on the siltstone slope (slope no.29).

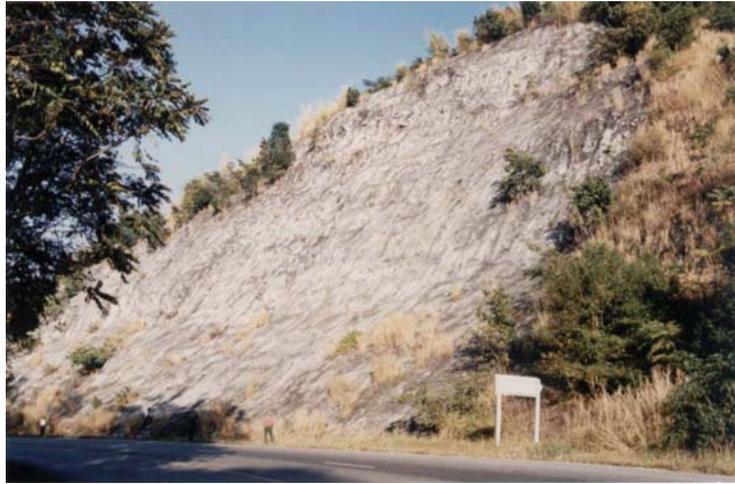
**Figure A.87** The stable slope is located at km 16 -17 of highway no.12, Lom Sak district, Petchabun province (slope no.30).

The slope no.30 at km 16-17 is located on Lomsak-Chumpae highway. The slope location is 47 Q 0750708 and UTM 1850850 of GPS system (Figures A.87 and A.88). The slope height is 50 m and length is 40 m. The strike of the slope face one is 070 degrees. The dip angle is 65 degrees. The rock type is shale. The UCS of the intact rock is between 5-25 MPa. The slope is unstable. The failure mode is small surface circular. The existing supports include shotcrete, drained holes, ditch and gabion.

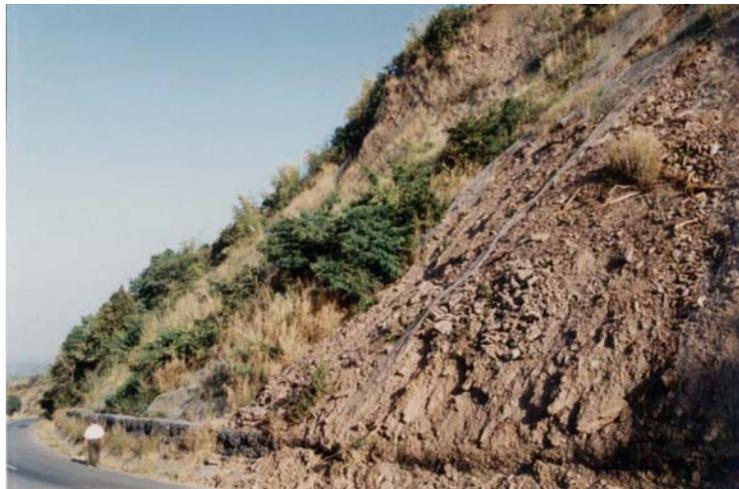
**Figure A.88** The surface failure of heavily jointed rock, Lom Sak district, Petchabun province (slope no.30).

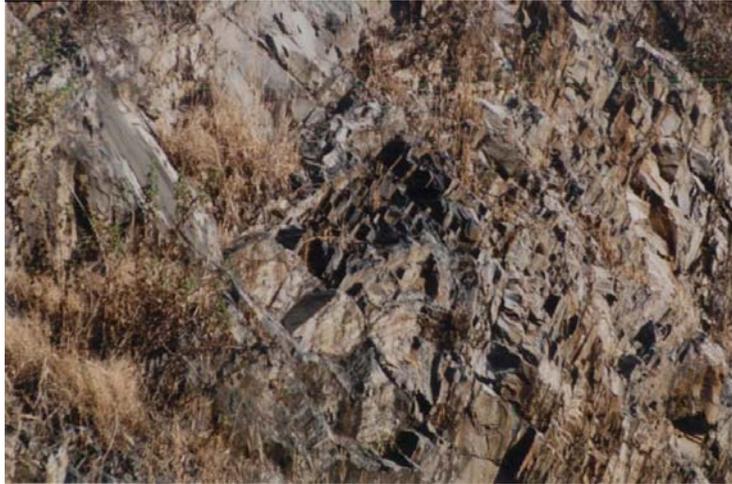
**Figure A.90** Heavily jointed of slaty-shale on slope is located at 17-18 of highway no.12, Lom Sak district, Petchabun province (slope no.31).

The slope height is 35 m and length is 40 m. The strike of the slope face one is 070 degrees. The dip angle is 72 degrees. The rock type is slaty-shale. The UCS of the intact rock is between 25-50 MPa. The slope is stable.

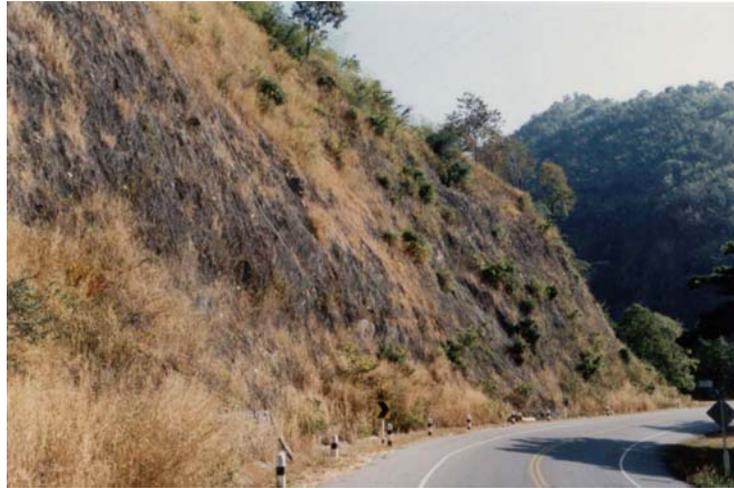
**Figure A.91** The shale slope is located at km 18-19 of highway no.12, Lom Sak district, Petchabun province (slope no.32).

The slope No.32 at km 18-19 is located on Lomsak-Chumpae highway. The slope location is 47 Q 0752212 and UTM 1850850 of GPS system (Figures A.91 and A.92). The slope height is 20 m and length is 30 m. The strike of the slope face one is 320 degrees. The dip angle is 55 degrees. The rock type is shale. The UCS of the intact rock is between 25-50 MPa. The rock slope is unstable. The failure mode is small surface circular. The existing supports include wire mesh, drained holes, ditch and gabion.

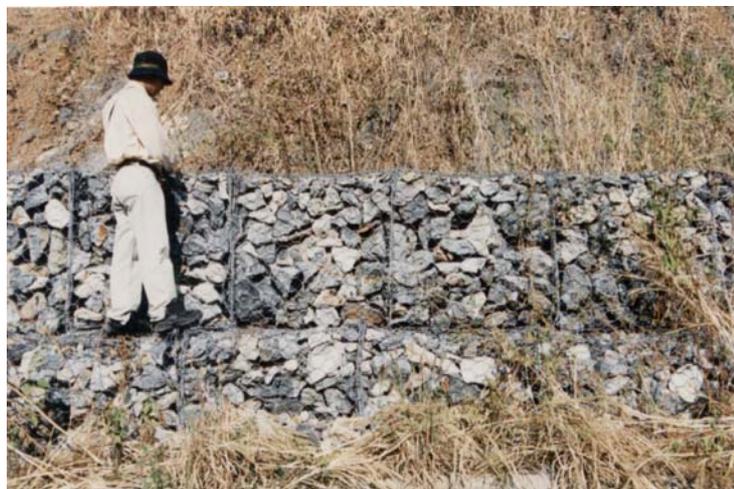
**Figure A.92** Gabion wall at the toe of slope, Lom Sak district, Petchabun province (slope no.32).

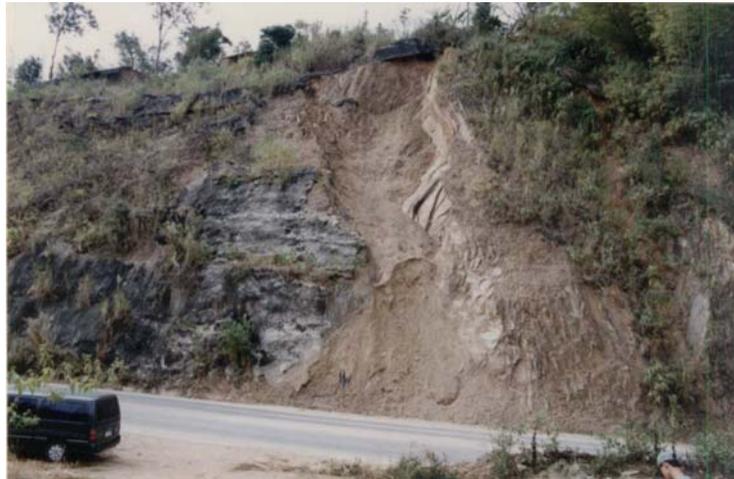
**Figure A.93** The failure of slaty-shale slope is located at km 36-37 of highway no. 12, Chum Pare district, Khon Kaen province (slope no.33).

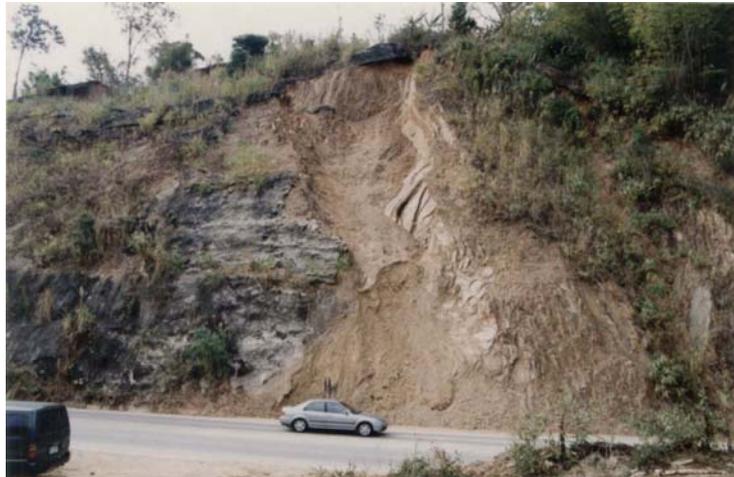
**Figure A.94** The failure of slaty-shale slope is located at km 36 to 37 of highway no.12, Chum Pare district, Khon Kaen province (slope no.33).

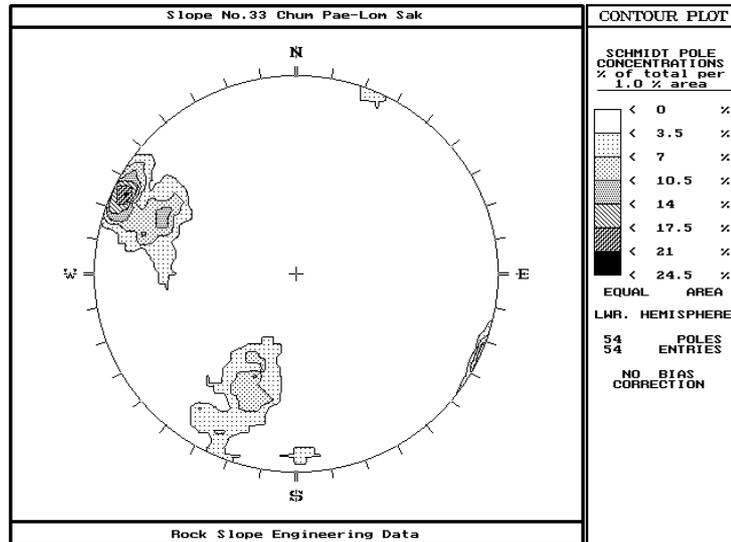
**Figure A.95** The contour plots of slaty-shale discontinuity for slope at km 36-37 of highway no.12, Chum Phae district, Khon Kaen (slope no.33).

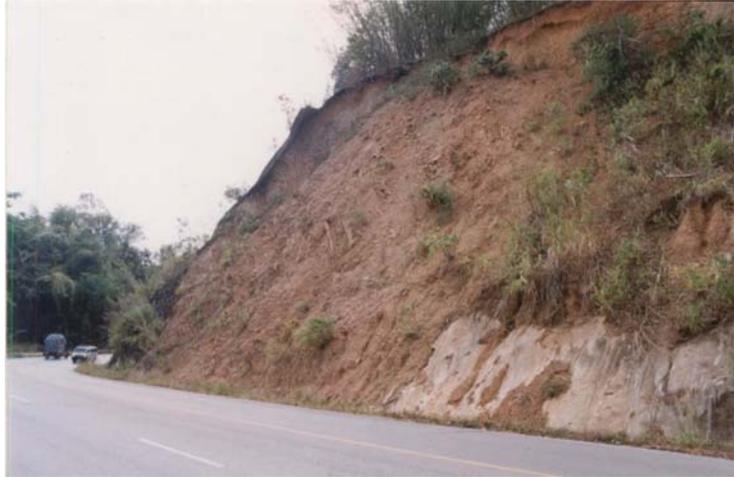
**Figure A.97** The failure of slaty-shale slope is located at km 36+600 of highway no.12, Chum Phae district, Khon Kaen province (slope no.34).

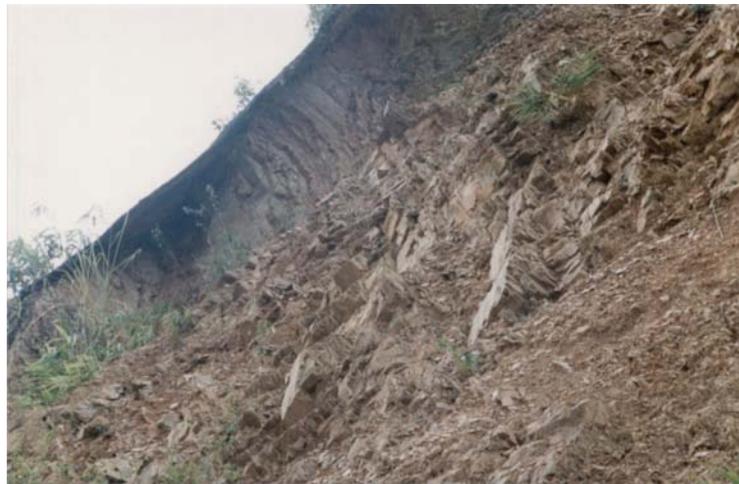
**Figure A.98** Rock slope at km 36+600. Failure surface exposed after massive slope failure. The failure brought down both earthen and installed materials. The remaining shotcrete appears on the left side of the slope face (slope no.34).

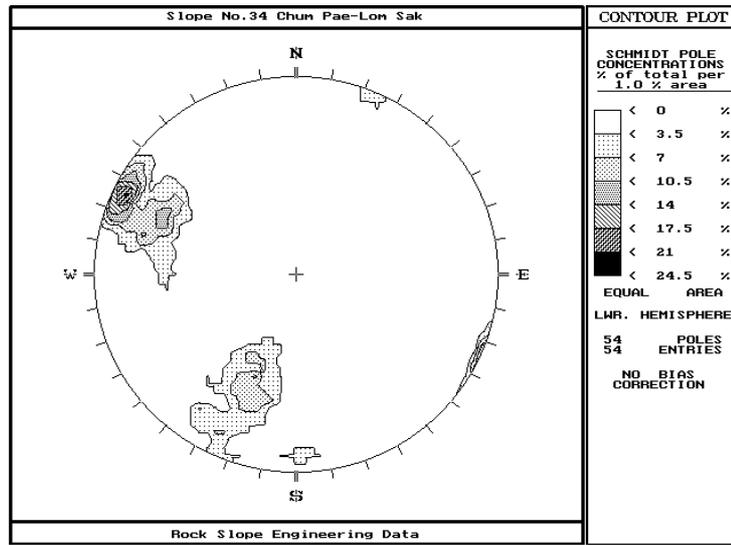
**Figure A.99** The contour plots of slaty-shale discontinuity at km 37 of highway no.12, Lom Sak district, Petchabun province (slope no.34).

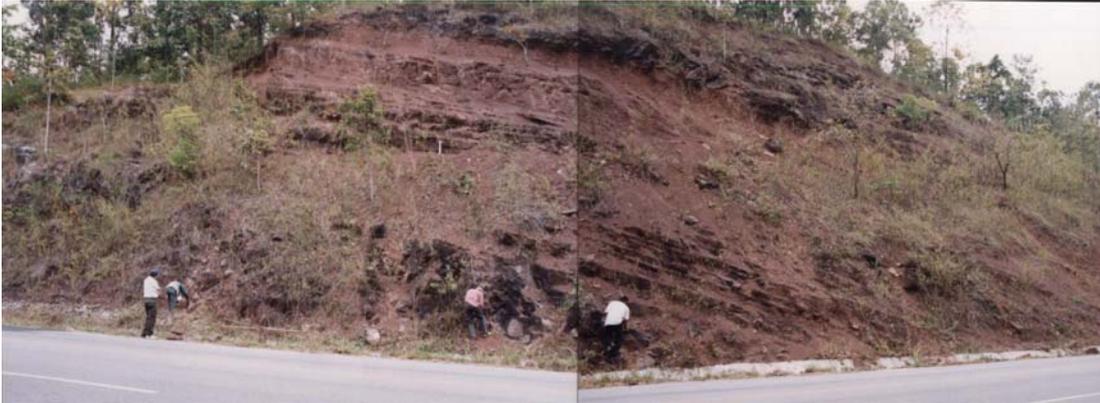
**Figure A.101** The siltstone slope at km 76-77 of highway no. 12 is located in Chum Pae district, Khon Kaen province (slope no.35).

The slope no.35 at km 76-77 located on Lomsak-Chumpae highway (Figures A.101 and A.102). The slope location is 47 Q 0784421 and UTM 1847721 of GPS system. The slope is classified as hard-soft interbedded rock. The hard formation is sandstone. It has 0.6 to 1.0 meter in thickness. The soft formation is mudstone. It has 0.2 to 0.8 meter thickness. The slope height is 15 m and length is 30 m. The strike of the slope face one is 156 degrees. The dip angle is 55 degrees. The UCS of the intact rock is between 5- 25 MPa for mudstone and about 25-50 MPa for sandstone. The slope is unstable. The failure modes are plane and wedge. The existing support is ditch. The rock has three joint sets (Figures A.103 and A.104), as follows.

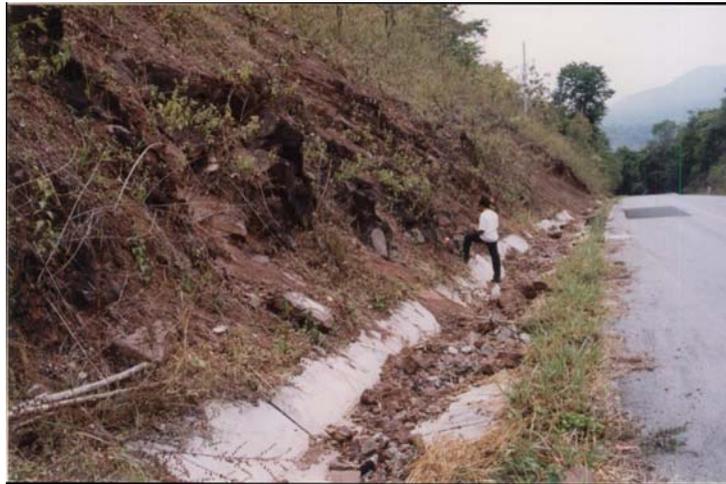
**Figure A102** The size are  $0.15 \times 0.2 \times 0.2$  to  $0.6 \times 0.5 \times 0.3$  m<sup>3</sup> of falling rock at the toe of slope (slope no.35).

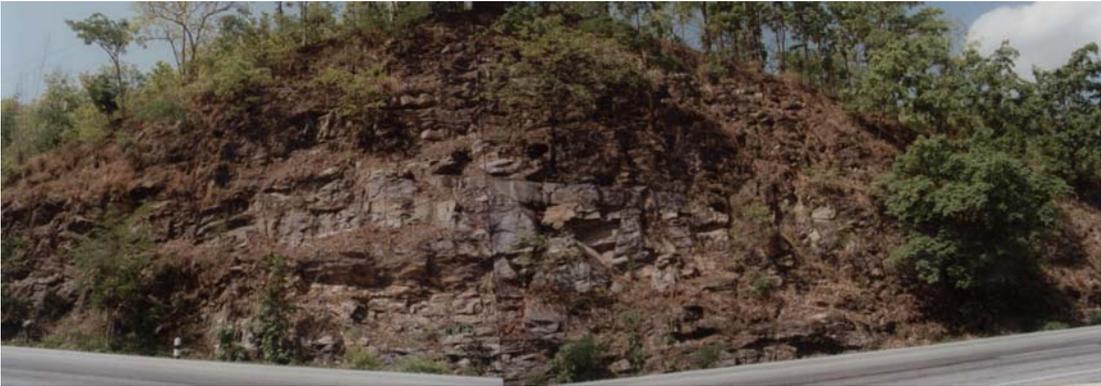
**Figure A.107** The blocky rock at km 17-18 of highway no.105, Tak province  
(slope no.36).

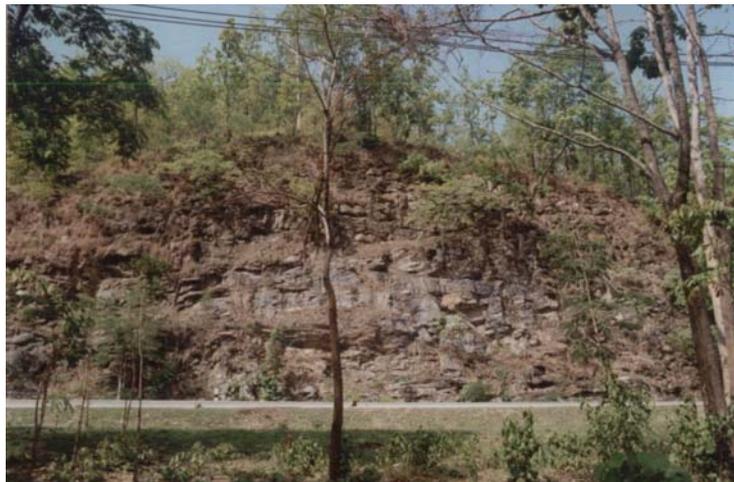
**Figure A.108** The blocky rock at km 17-18 of highway no.105, Tak province  
(slope no.36).

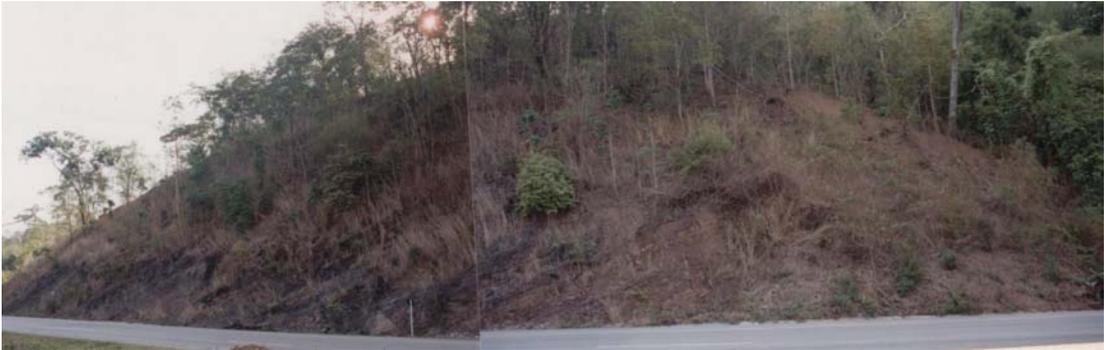
**Figure A.111** The shale slope at km 68-69 of highway no.105 is located in Mae Sot district, Tak province (slope no.37).

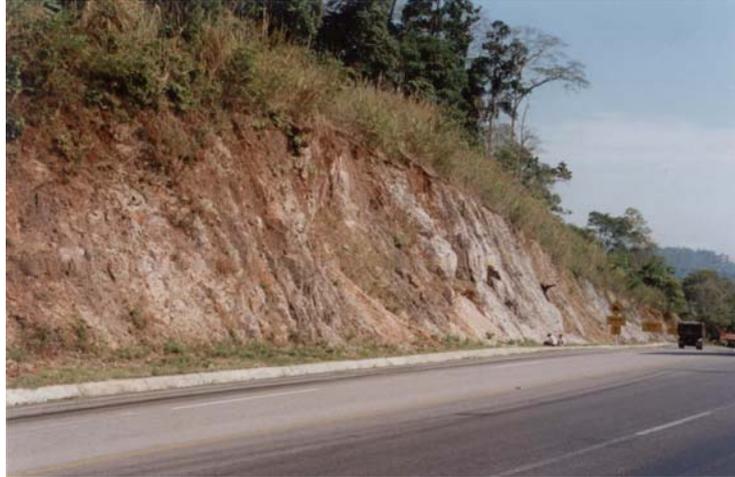
**Figure A.114** The heavily jointed rock at km 62-63 of highway no.105, Mae Sot district, Tak province (slope no.38).

The slope no.38 at km 61-62 located on highway no.105 (Figures A.114 and A.115). The slope location is 47 Q 0466571 and UTM 1854099 of GPS system. The slope is classified as soft rock. The slope height is 12 m and length is 50 m. The strike of the slope face one is 350 degrees. The dip angle is 80 degrees. The rock type is argillaceous limestone. The UCS of the intact rock is between 5-25 MPa. The rock has highly weathered. The slope is unstable. The failure mode is circular failure. The failure is caused by the combination of water saturation, ground vibration (by heavy traffic) and the high angle slope face. The existing support is ditch.

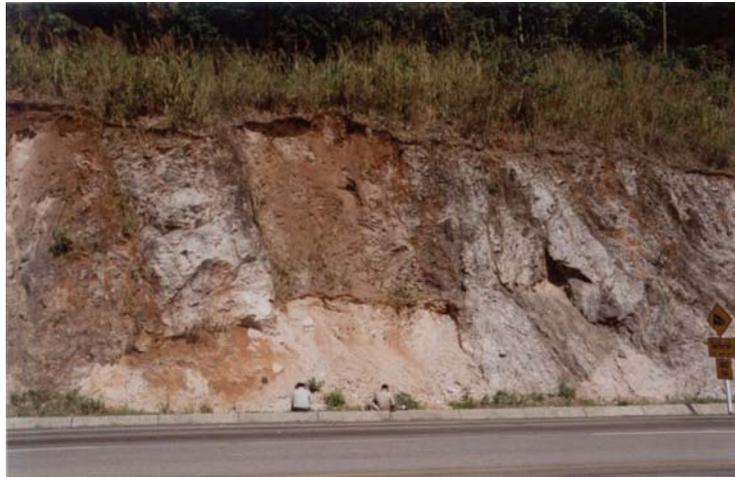
**Figure A.115** The surface circular failure of calcareous shale at km 62-63 of highway no.105 (slope no.38).

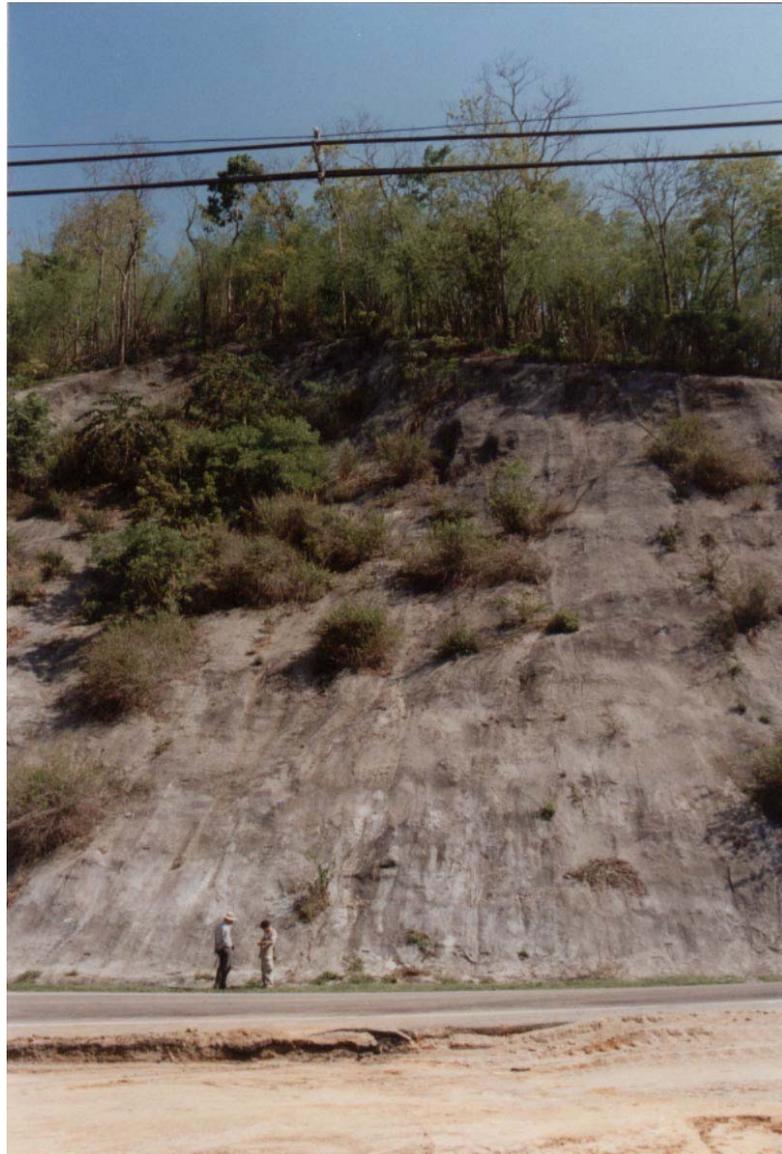
**Figure A.116** The stable slope at km 53+250 of highway no.105, Mae Sot district, Tak province (slope no.39).

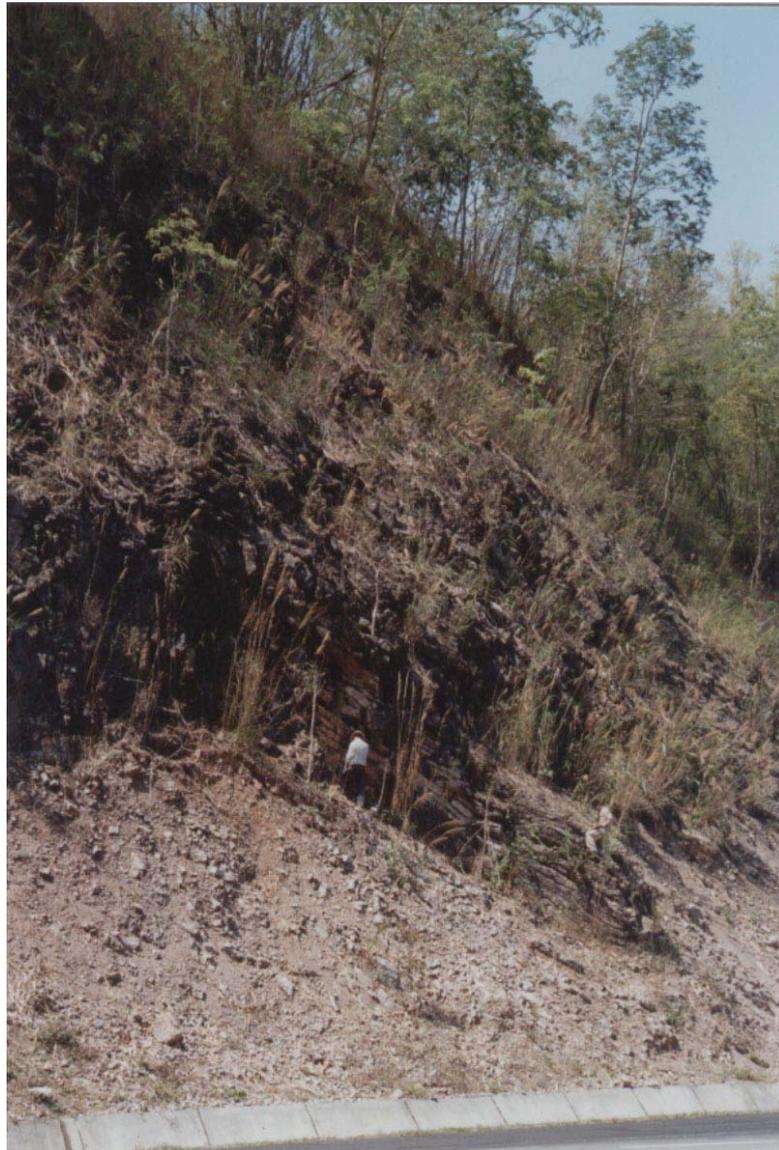
**Figure A.117** The heavily jointed rock at km 49-50 of highway no.105,  
Tak province.

The slope no.40 at km 49-50 located on highway no.105 (Figure A.117). The slope location is 47 Q 0476575 and UTM 1853523 of GPS system. The slope is classified as blocky rock. The slope height is 20 m and length is 40 m. The strike of the slope face is 230 degrees. The dip angle is 61 degrees. The rock type is calcareous shale. The UCS of the intact rock is between 25-50 MPa. The slope is stable. The

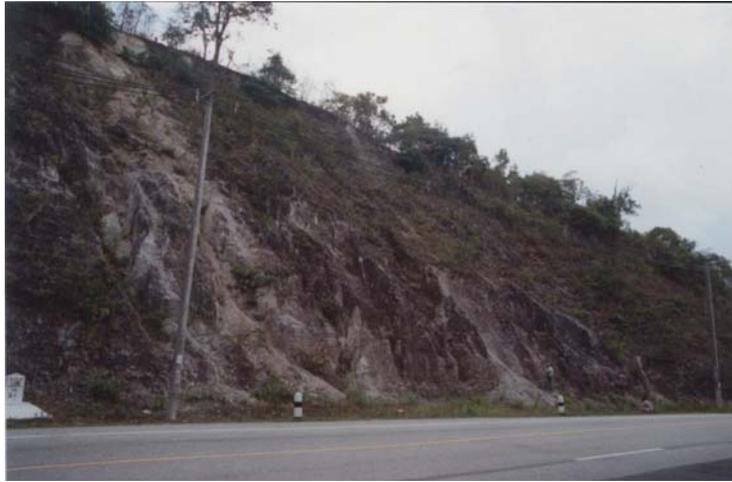
**Figure A.120** The soft shale slope at km 31-32 of highway no.105, Mae Sot district, Tak province (slope no.41).

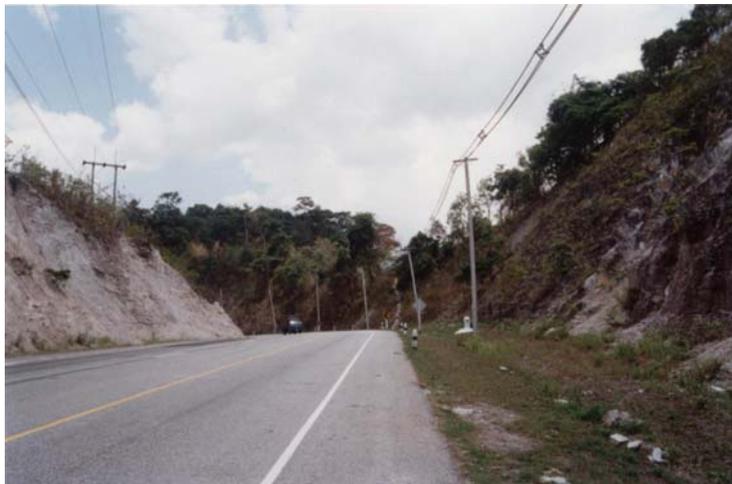
**Figure A.121** The soft shale slope at km 31-32 of highway no.105, Mae Sot district, Tak province (slope no.41).

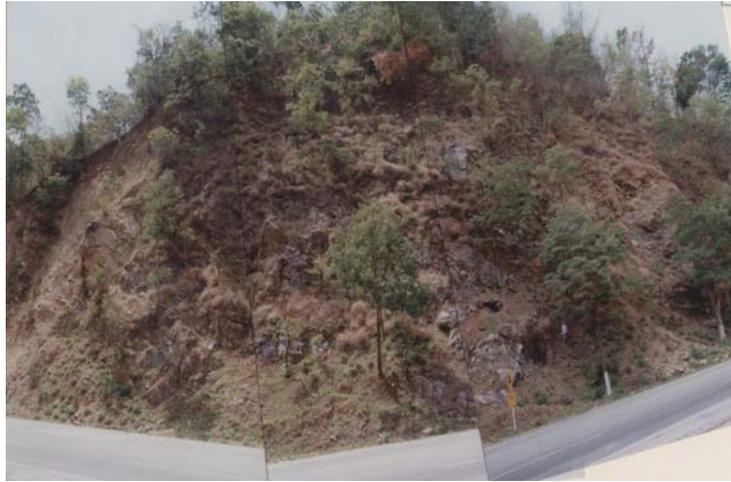
**Figure A.124** The schist slope at km 21-22 of highway no.105, Tak province (slope no.42).

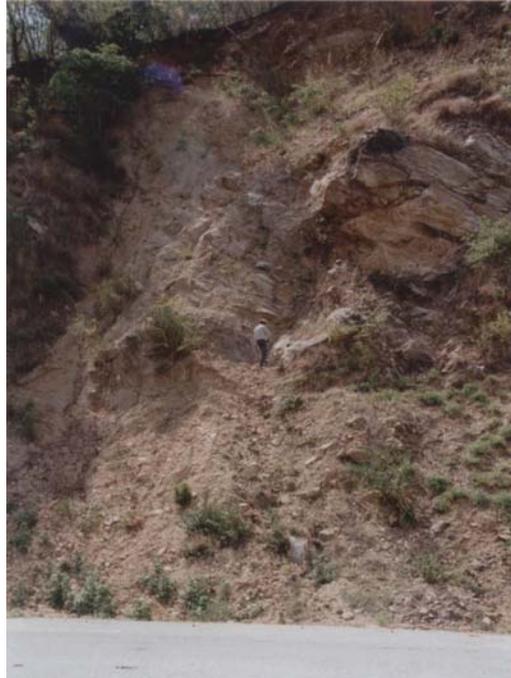
**Figure A.125** The toppling failure of schist slope 21-22 of highway no.105 Tak province (slope no.42).

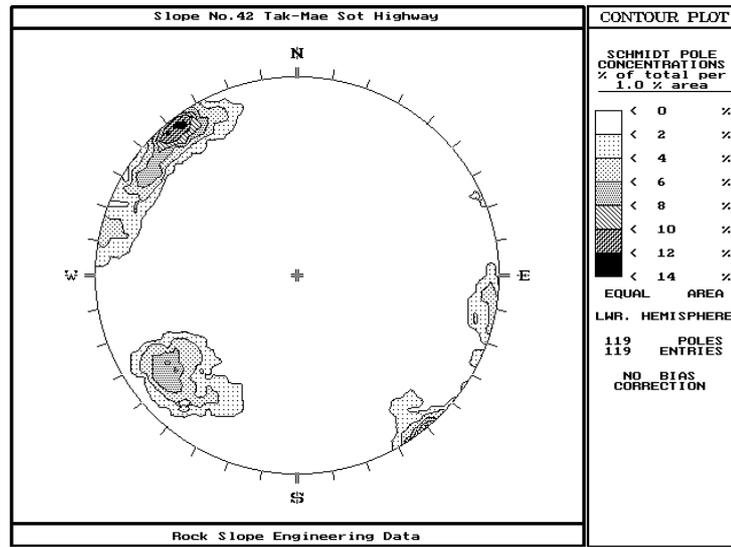
**Figure A.126** The contour plots of schist discontinuity at km 21-22 of highway no.105 (slope no. 42).

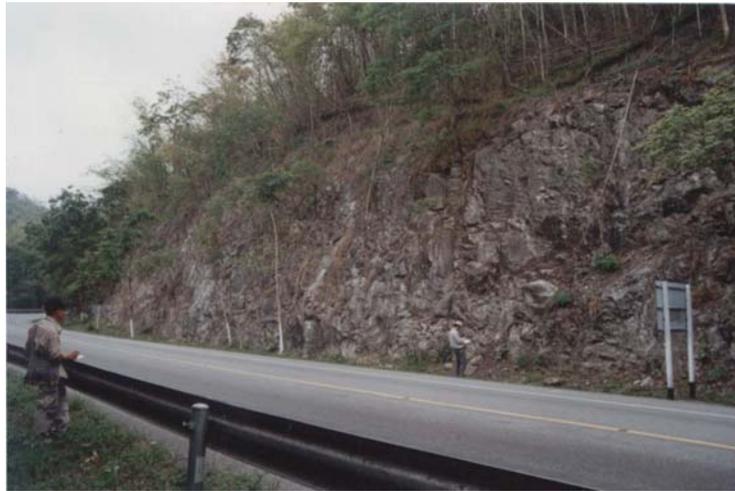
**Figure A.128** The Schist slope at km 21-22 of highway no.105, Tak province  
(slope no.43).

The slope No.43 at km 21-22 found on highway No.105 (Figures A.128 and A.129). The slope location is 47 Q 0495395 and UTM 1857734 of GPS system. The slope is classified as blocky rock. The slope height is 30 m and length is 200 m. The strike of the slope face is 060 degrees. The dip angle is 75 degrees. The rock type is schist. The UCS of the intact rock is between 25-50 MPa. The slope is stable. The rock has three joint sets (Figures A.130 and A.131), as follows.

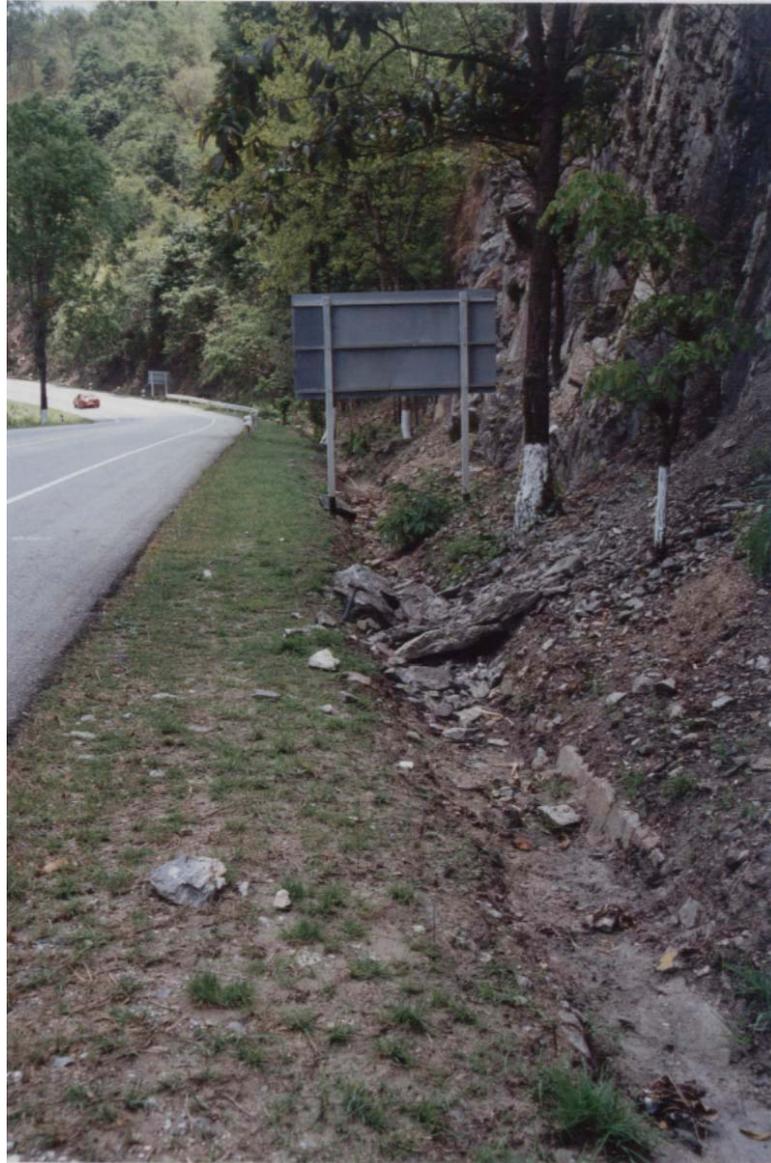
**Figure A.129** Schist slope failure at km 21-22 of highway no.105 (slope no.43).

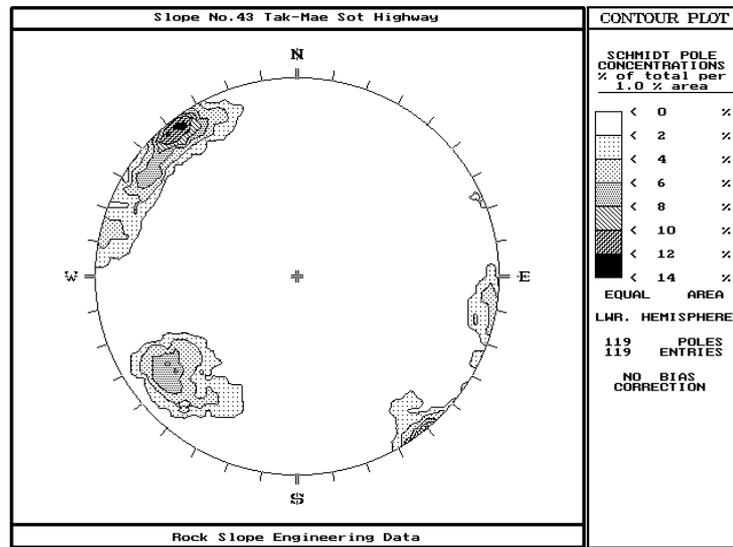
**Figure A.130** The contour plots of schist discontinuity at km 21-22 of highway no.105, Tak province (slope no.43).

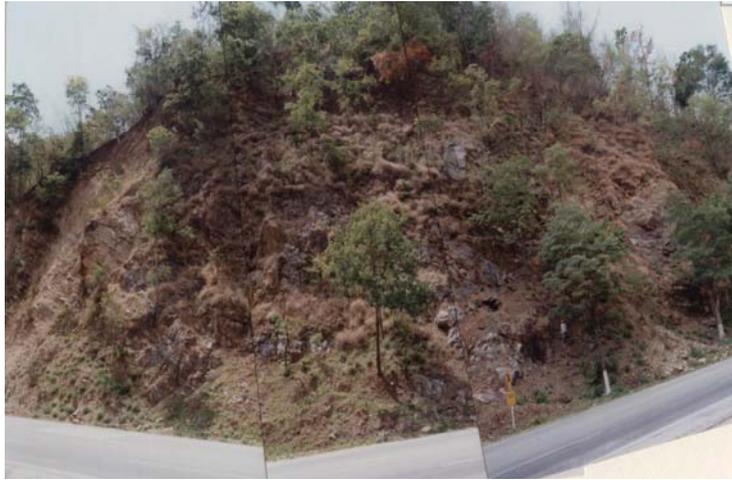
**Figure A.132** The schist slope at km 20-21 of highway no.105, Tak province  
(slope no.44).

The slope no.44 at km 20-21 located on highway no.105 (Figure A.132). The slope location is 47 Q 0495531 and UTM 1858081 of GPS system. The slope is classified as heavily jointed rock. The slope height is 50 m and length is 60 m. The strike of the slope face is 060 degrees. The dip angle is 68 degrees. The rock type is schist. The UCS of the intact rock is between 25-50 MPa. The slope is stable. The rock has four joint sets (Figures A.133 and A.134), as follows

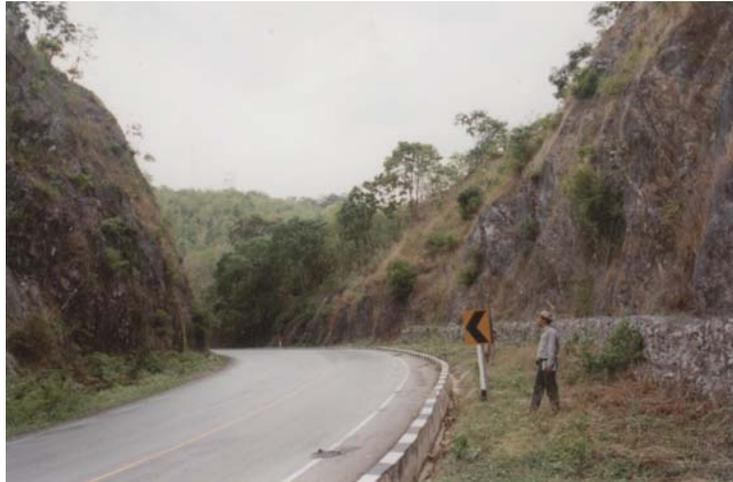
**Figure A.138** The shale slope at km 19-20 of highway no.105, Tak province (slope no.46).

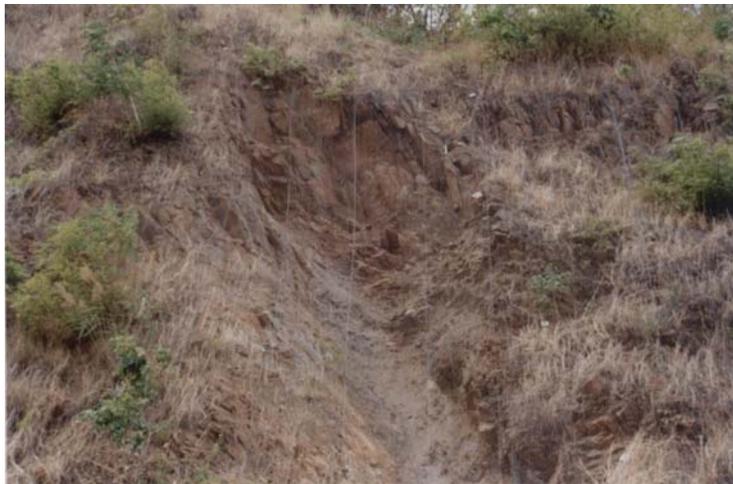
**Figure A.139** The surface failure of shale and wire mesh on slope at km 19-20 of highway no.105, Tak province (slope no.46).

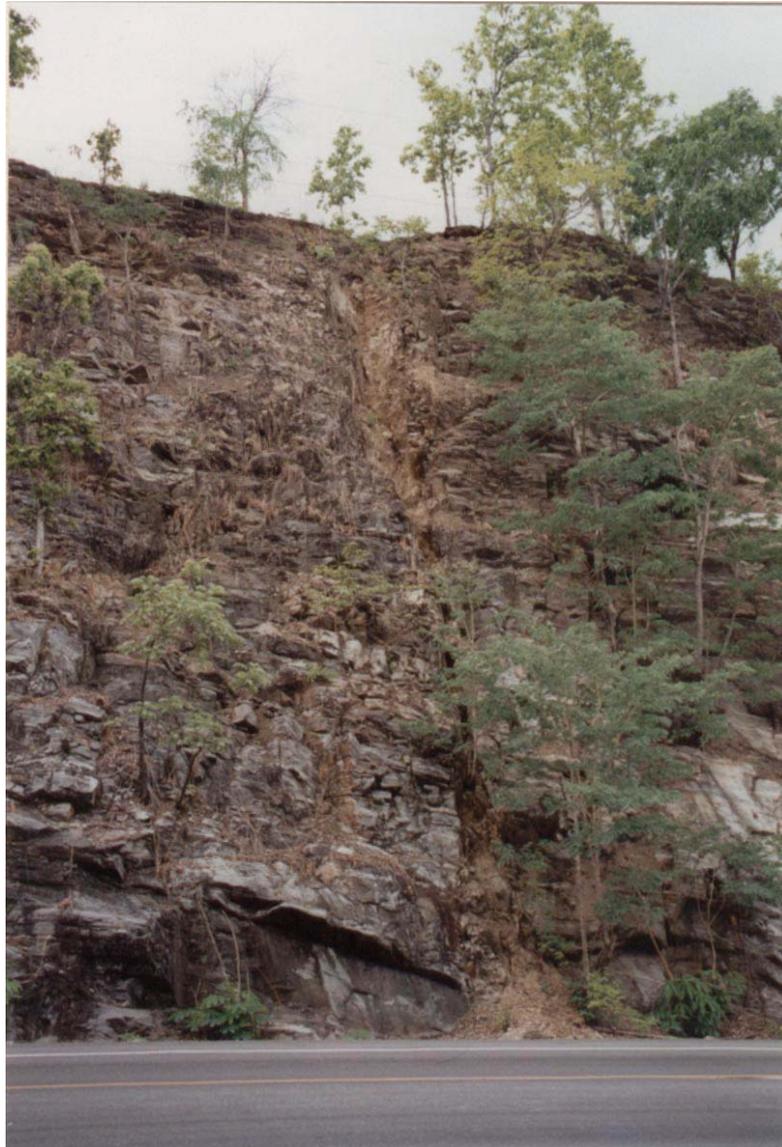
**Figure A.140** The Schist slope at km 17-18 of highway no.105, Tak province  
(slope no.47).

The slope no.47 at km 17-18 located on highway no.105 (Figure A.140). The slope location is 47 Q 0497475 and UTM 1858878 of GPS system. The slope is classified as heavily jointed rock. The slope height is 25 m and length is 50 m. The strike of the slope face is 012 degrees. The dip angle is 72 degrees. The rock type is schist. The UCS of the intact rock is between 25-50 MPa. The rock slope is fair stable. The rock has three joint sets (Figures A.141 and A.142), as follows.

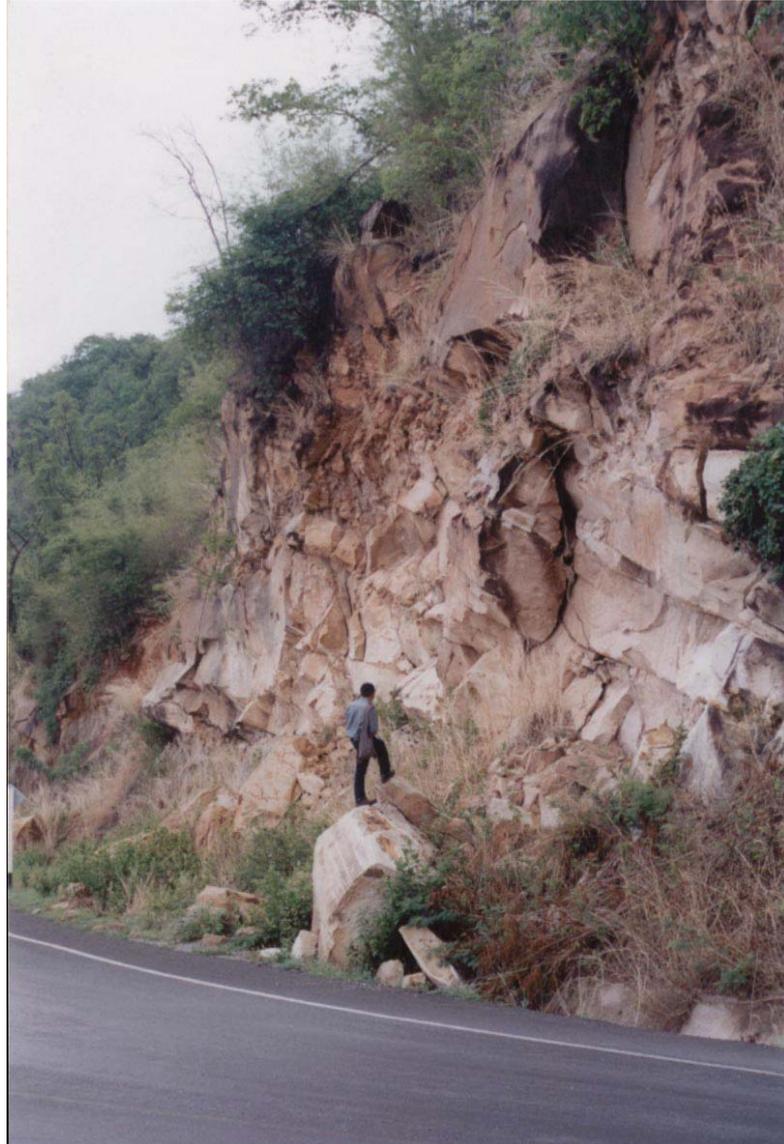
**Figure A.143** The sandstone slope is located near with Ubonrat dam, Khon Kaen province (slope no.48).

The slope no.48 is located on the crest of Ubonrat dam (Figures A.143 and A.144). The slope location is 47 Q 0245671 and UTM 1859043 of GPS system. The slope is classified as blocky rock. The slope height is 20 m and length is 30 m. The strike of the slope face is 170 degrees. The dip angle is 90 degrees. The rock type is sandstone. The UCS of the intact rock is between 50-100 MPa. The rock slope is unstable. The failure is toppling of the vertical joint in massive sandstone (sizes are  $0.2 \times 0.1 \times 0.3$  to  $1.6 \times 2.0 \times 1.2$  m<sup>3</sup>). The rock has three joint sets (Figures A.145 and A.146), as follows.

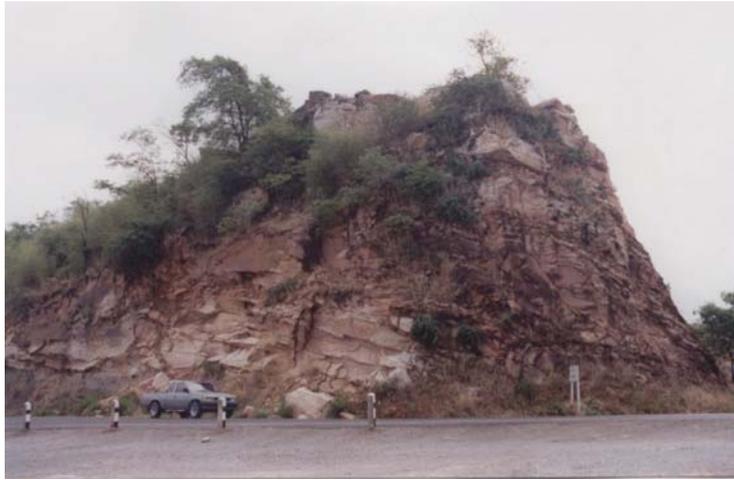
**Figure A.144** The sandstone slope is located near with Ubonrat dam, Khon Kaen province (slope no.48).

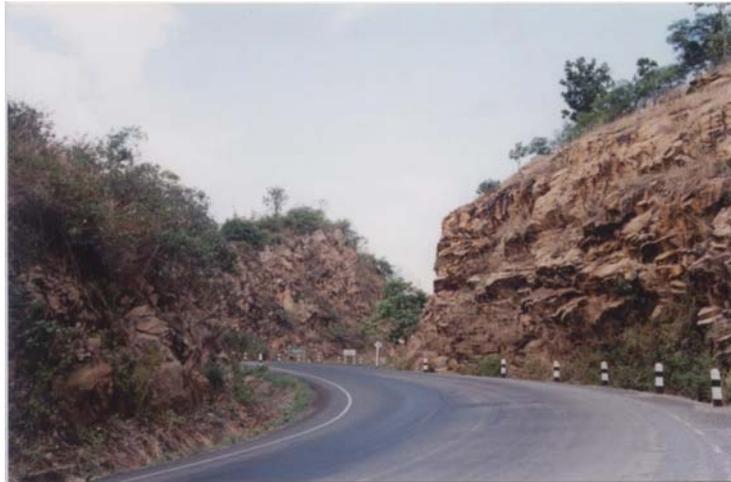
**Figure A.150** The sandstone slope, Ubonrat dam, Khon Kaen province  
(slope no.50).

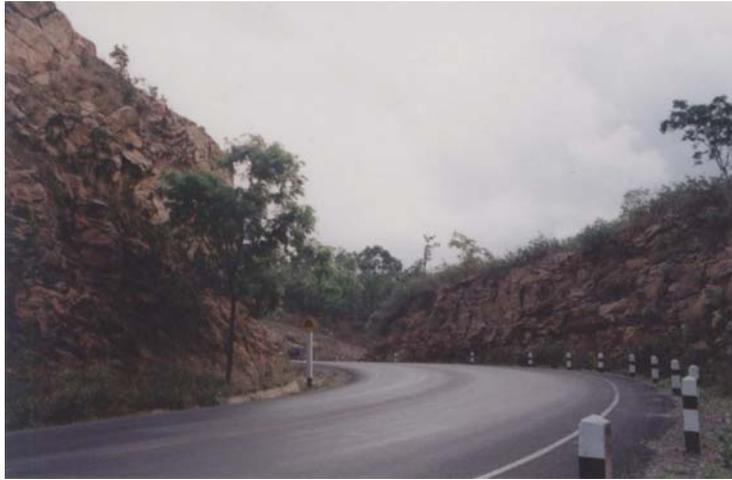
**Figure A.153** The sandstone slope, Ubonrat dam, Khon Kaen province  
(slope no.51).

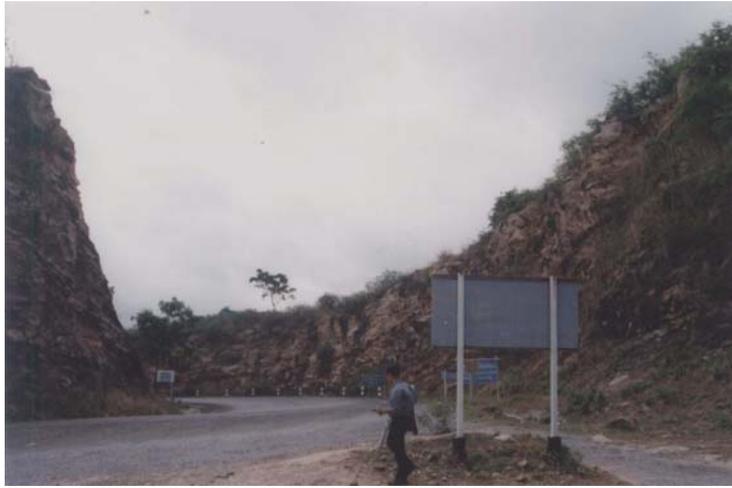
**Figure A.156** The sandstone slope, Ubonrat dam, Khon Kaen province  
(slope no.52).
