**EVALUATION OF ROCK S LOPE STABILITY ALONG
SOME HIGHWAYS USING GEOGRAPHIC
INFORMATION SYSTEM**

**A Thesis Submitted in Partial Fulfillment of the Requirements for the
Degree of Master of Engineering in Geotechnolgy
Suranaree University of Technology
Academic Year 2012**

KIATTISAK ARTKHONGHAN : EVALUATION OF ROCK SLOPE STABILITY
ALONG SOME HIGHWAYS USING GEOGRAPHIC INFORMATION SYSTEM.
THESIS ADVISOR : PRACHYA TEPNARONG, Ph.D., 125 PP.

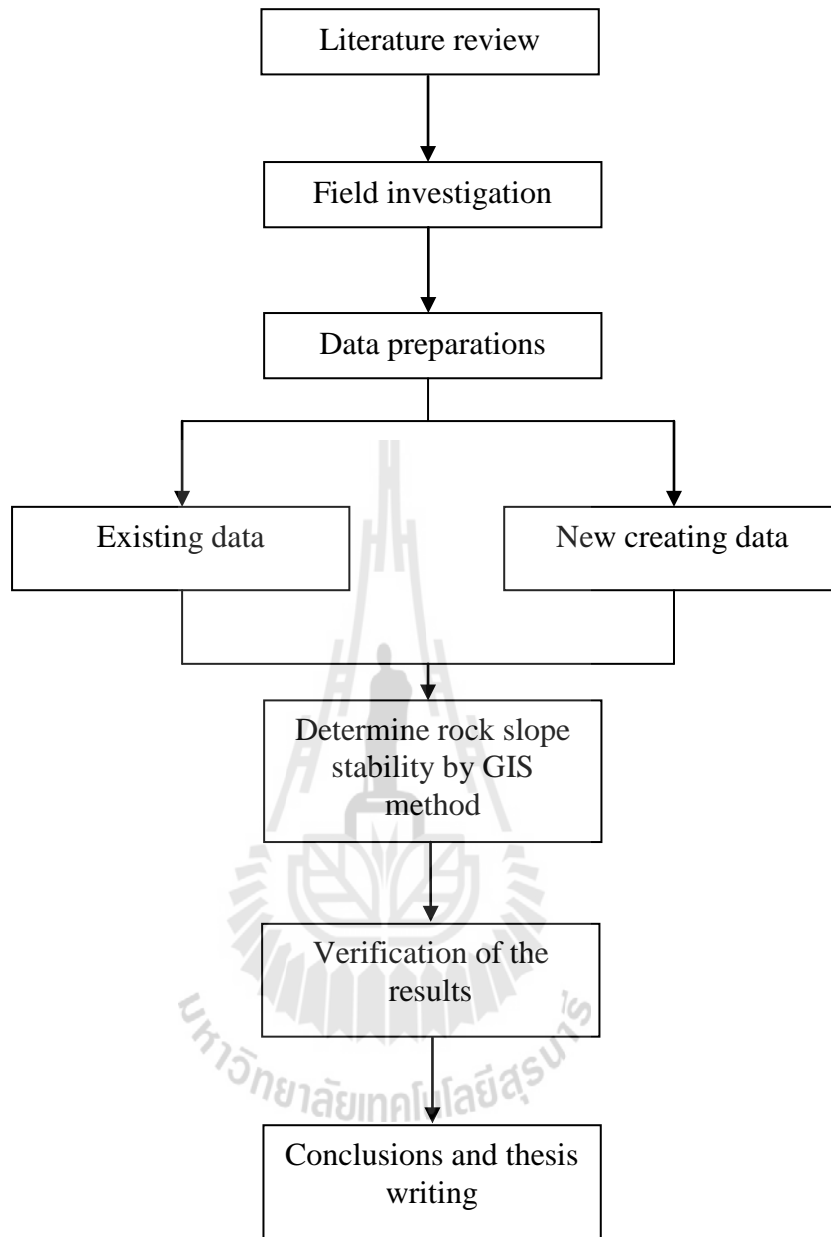
Figure 1 Research methodology.

1) Literature review: The objective of the literature review is to collect and examine the previous studies on the geological conditions of the sites, the evaluated rock slope stability based on expert system, and the case studies from the published papers (journals, proceedings, and conferences).

2) Field investigation: Field investigation will be conducted along highway. The purpose of field investigation is to obtain geological engineering data of the sites. The study criteria follow as much as practical the methods suggested by the International Society of Rock Mechanics (Brown, 1981). The data include slope geometry, joint conditions and orientation, intact rock strength, performance of the existing rock supports (if any), modes of failure, rock conditions, and groundwater conditions. The data obtained from fieldwork will be used for kinematics analysis and computer simulation.

3) Determination of rock slope stability using numerical method: The numerical computer simulation is to calculate the factor of safety (FS) for circular failure mode. Several values of properties are assumed in the computer simulation, which eventually gives safety factors close to the actual field condition. The FLAC SPLOE program will be used in the analysis.

4) Determination rock slope stability using GIS method: The system classifies each factor considered in the stability evaluation into small ranges or sub-divisions, mainly to convert the input slope characteristics into quantitative form. Data input included: Digital Elevation Model (DEM), geologic unit map, land-use map, and road map. The results of stability are shown in terms of probability of failure.

5) Auditing and verification: Comparison between GIS and result from numerical method. This section is to verify an appropriate factor for predicting further slope failures by GIS.

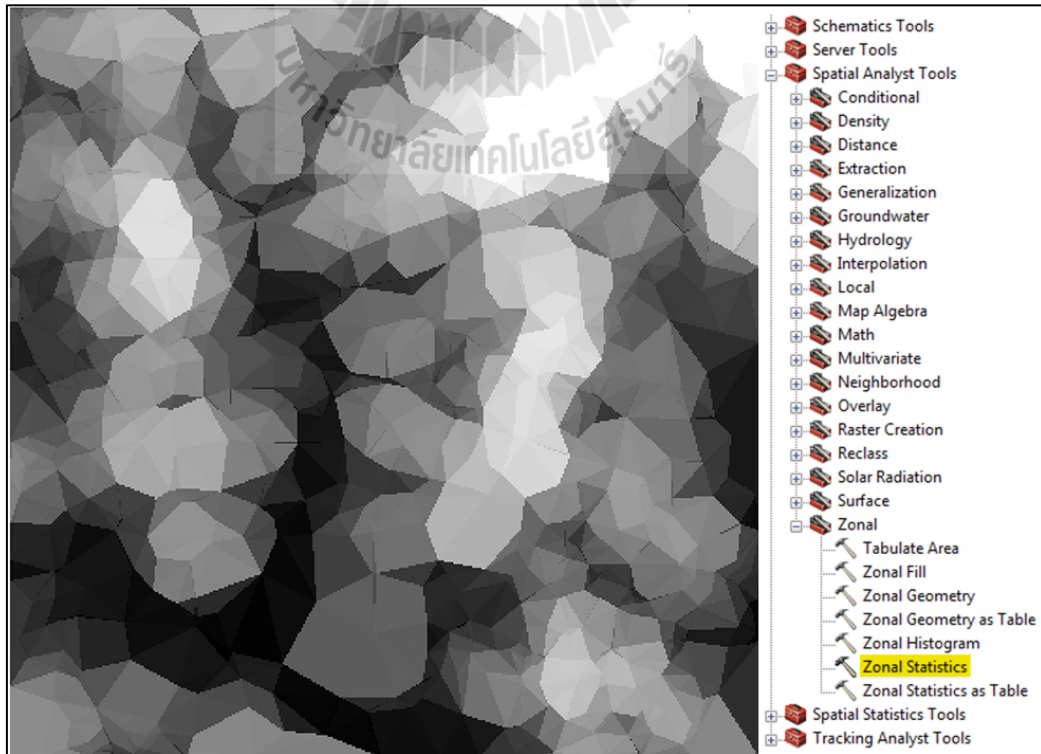
Figure 5.7 Maximum and minimum elevation created from TINs.

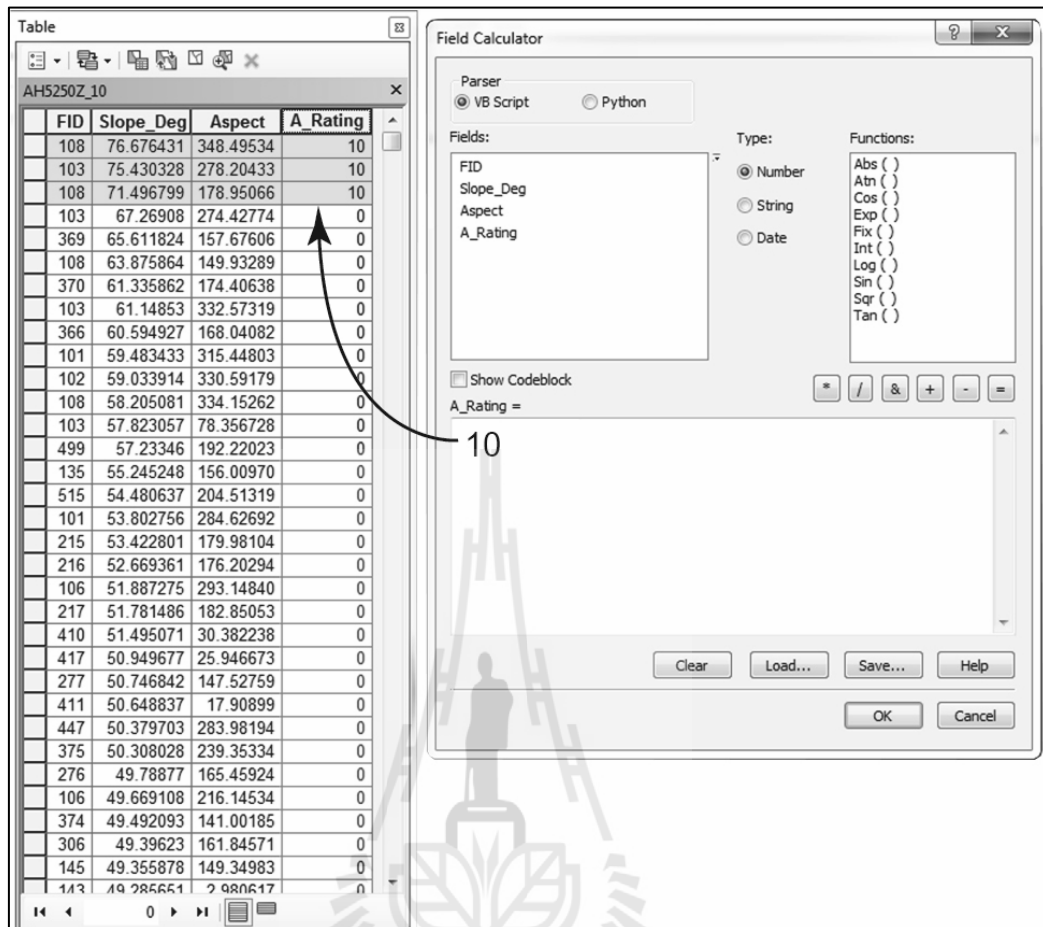
Figure 6.1 Rating insert in attribute table. The considered attribute (Slope_Deg) have been divided into sub-divisions and add rating to new field (A_Rating).

All considered parameters from chapter V have been edited, add new field to attribute table for get rating value. Setup the field type to integer for stored quantitative values. Selected similar attribute and respective add rating values to each range. The values insert to new created field that nominate “_Rating” must be short integer (Figure 6.1).

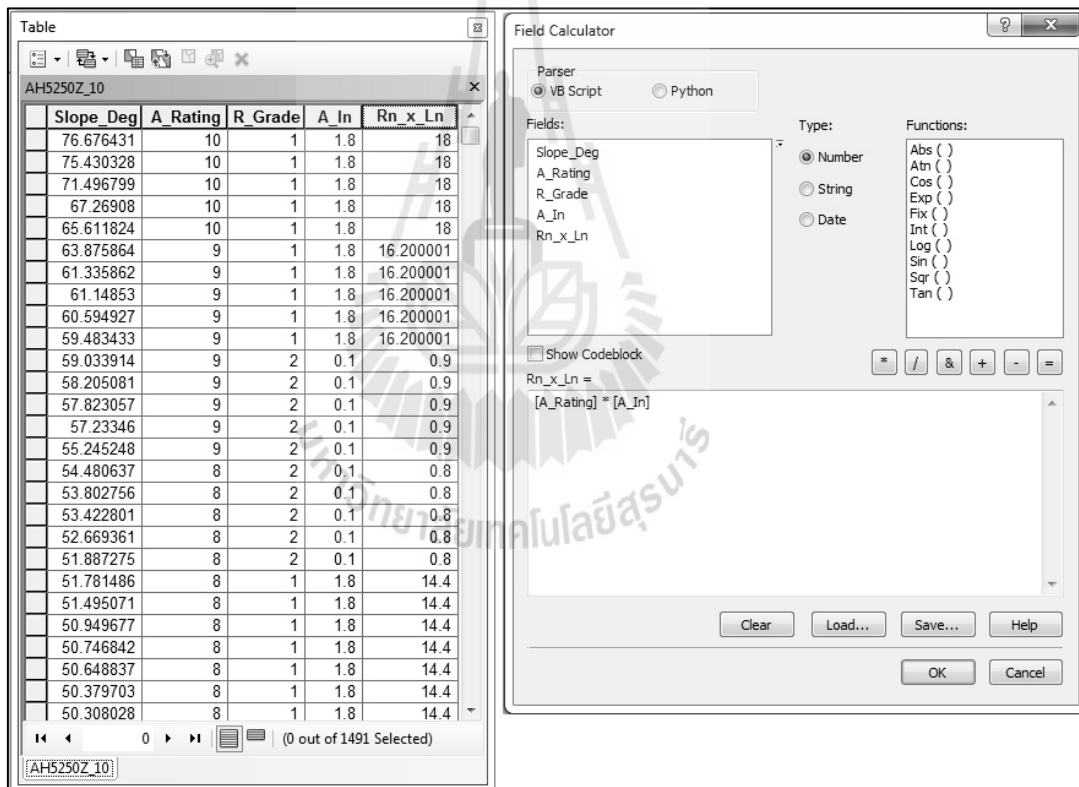
Figure 6.2 Adjustment of considered parameters defined as multiply with influencing factor.

The calculations of PF use 8 parameters. After convert them to quantitative value, each parameter has been adjusted. The union of all GIS vector layers which are considered parameters map and geologic map resulted in the layer. The layer containing polygons with identical combination attributes of considered parameters and geotechnical properties of materials. A set of influencing factor is also defined as multiplying for the corresponding parameter (Figure 6.2). The attributes of the layer were performed using equation (4.1) and result in additional attribute name “Sum_PF” (Figure 6.3).

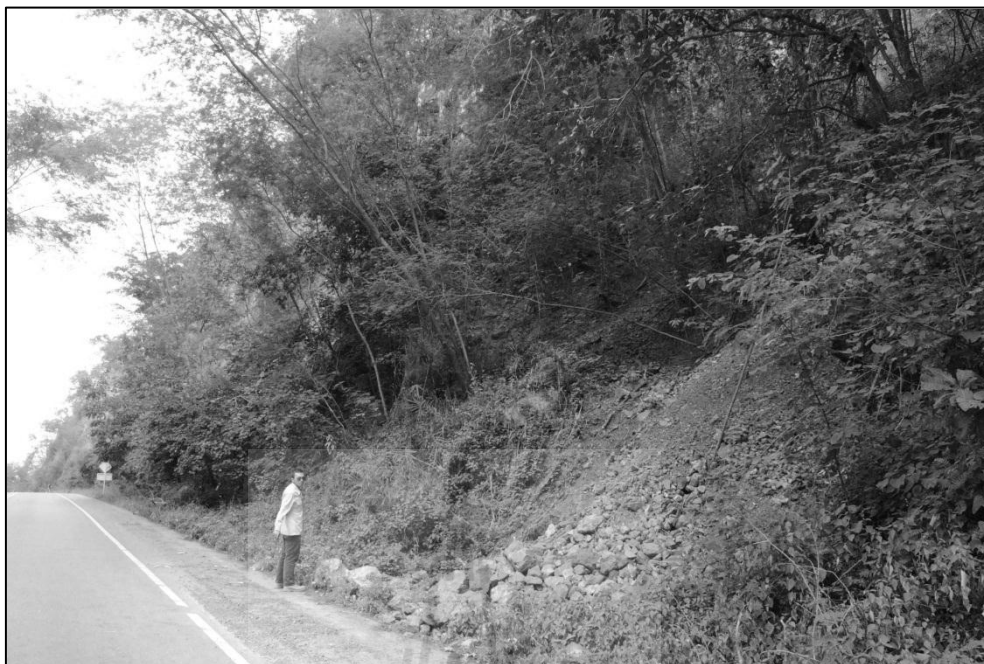
Figure A7 The circular failure mode on station 04. Plant and grass are generally covered on the slope face.

The station 04 at km 16+200 is located on Lomsak-Chumpae highway (Figure A7). The slope location is 47Q 0750300 and UTM 1850998 of GPS system. The slope is classified as moderately weathered rock. The slope height is 20 meters and length is 150 meters. The strike and dip angle of slope face is 83 and 51 degrees. The rock type is shale. The slope was fail in circular mode. The representative plane has shown on figure A8.

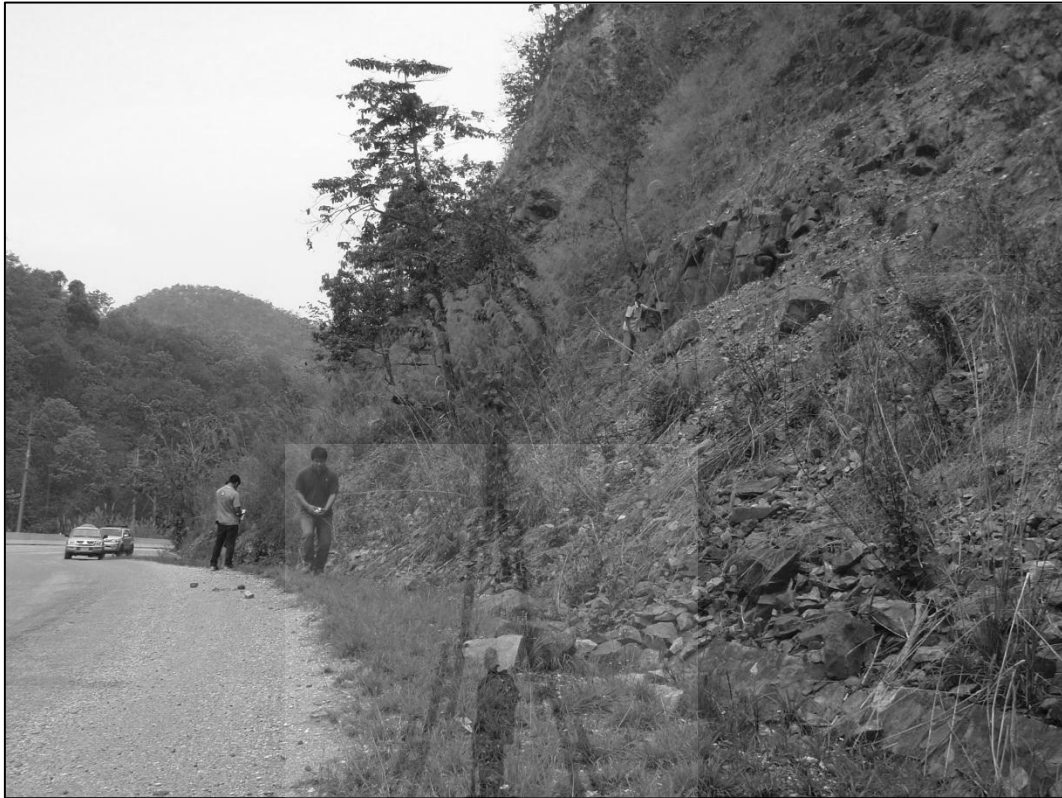
Figure A15 Slope of station 08 on highway no.12. the circular failure was occurred on the top of the slope.

Joint set 3 has a strike of 270 degrees, with 78 degrees dip angle. Joint spacing is 25 centimeters. Joint aperture is 0.5 millimeters. JRC is estimated as 5. The joints are filled with clay.

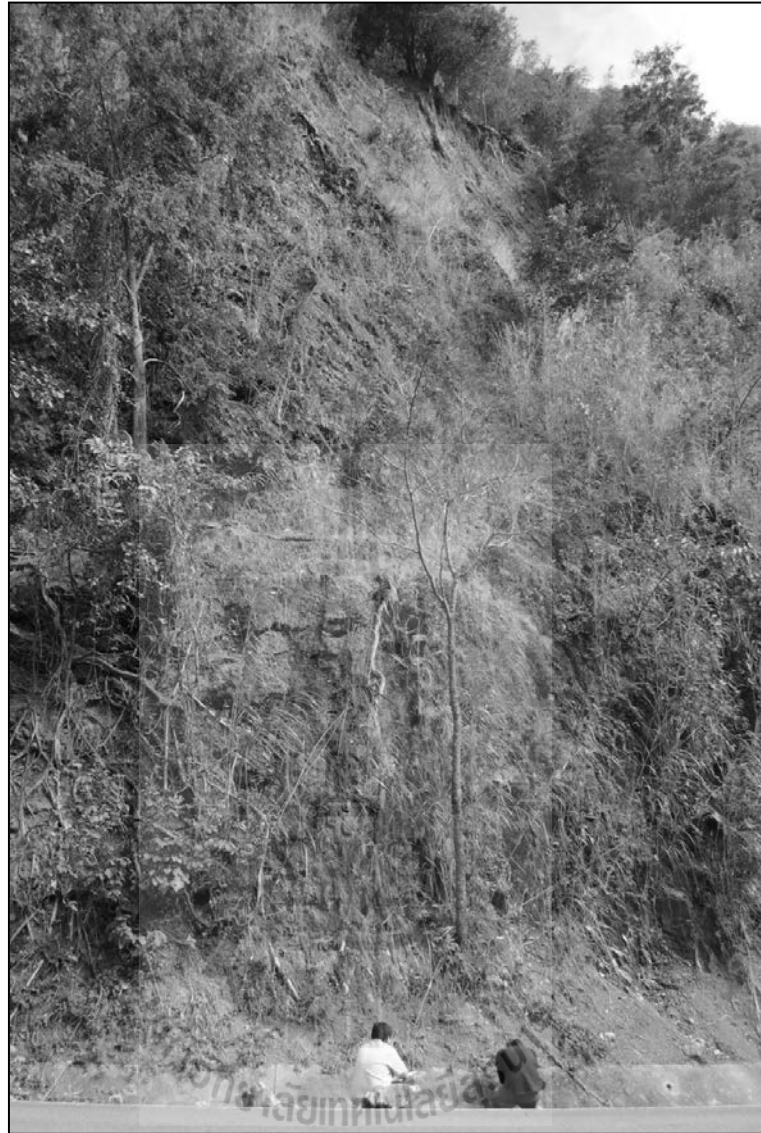
Figure A21 Slope location at km 28+200 of highway no.12. The circular failure was occurred on the top of the slope.

Joint set 2 has a strike of 255, with 79 degrees of dip angle. The joint spacing is 0.015 to 0.4 meters. The joint aperture is 0.1 to 0.5 centimeters. The JRC is estimated as 2. The joint are filled with clay.

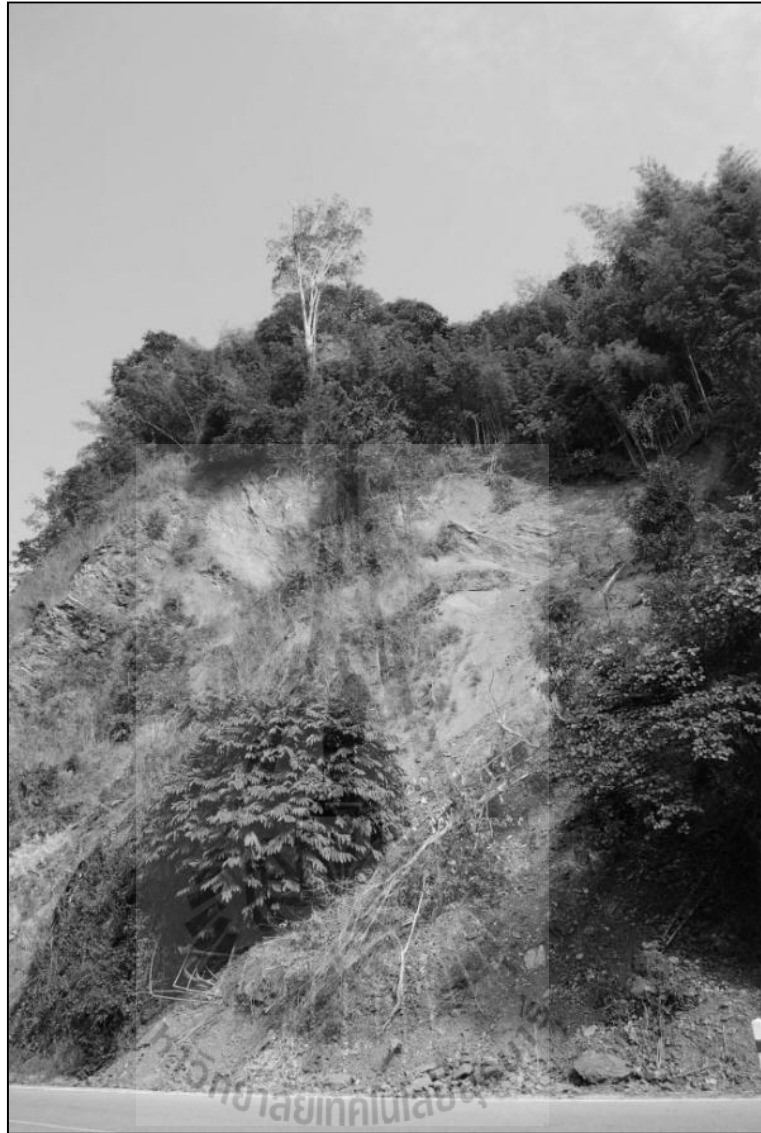
Figure A23 Slope location at km 32+500 of highway no.12. The circular failure was occurred on the top of the slope.

Joint set 2 has a strike of 255, with 79 degrees of dip angle. The joint spacing is 0.015 to 0.4 meters. The joint aperture is 0.1 to 0.5 centimeters. The JRC is estimated as 2. The joint are filled with clay.

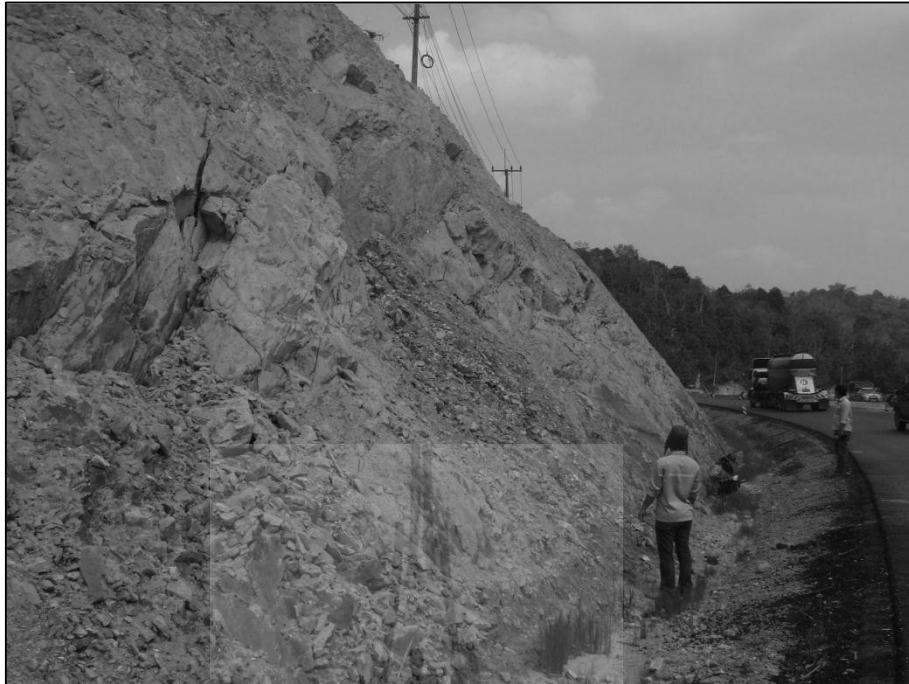
Figure A25 The circular failure occurred on slope no.13. The slope was failed during road construction.

The slope no. 13 at km 303+850 is located on Laplae – Den Chai highway (Figure A25). The slope location is 47Q 0619934 and UTM 1964782 of GPS system. The slope is classified as soft rock. The slope height is 50 meters and length is 150 meters. The strike and dip angle of slope face is 250 and 60 degrees. The rock type is shale. The slope is fail in circular mode. The failure caused by the combination of water saturation, ground vibration and the high angle slope face. The slope does not install support. Figure A26 is shown the orientation of the slope face.

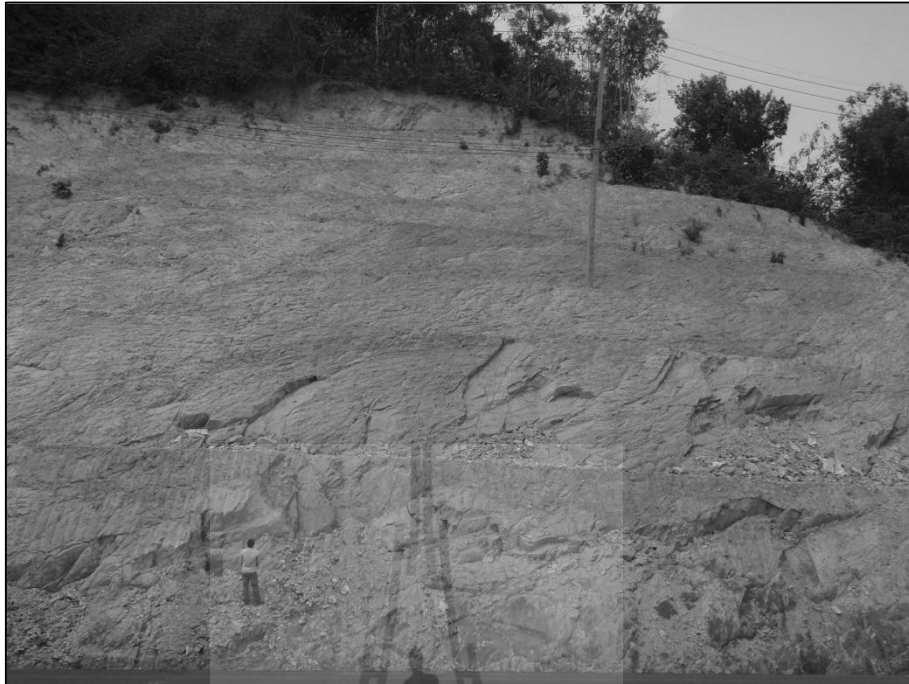
Figure A27 The circular failure occurred on slope no.14. The slope was failed during road construction.

The slope no. 13 at km 309+800 is located on Laplae – Den Chai highway (Figure A27). The slope location is 47Q 0616465 and UTM 1970400 of GPS system. The slope is classified as soft rock. The slope height is 40 meters and length is 120 meters. The strike and dip angle of slope face is 172 and 47 degrees. The rock type is shale. The slope divided as four benches. The slope is fail in circular mode. The failure caused by the combination of water saturation, ground vibration and the high angle slope face. The slope does not install support. Figure A28 is shown the orientation of the slope face.

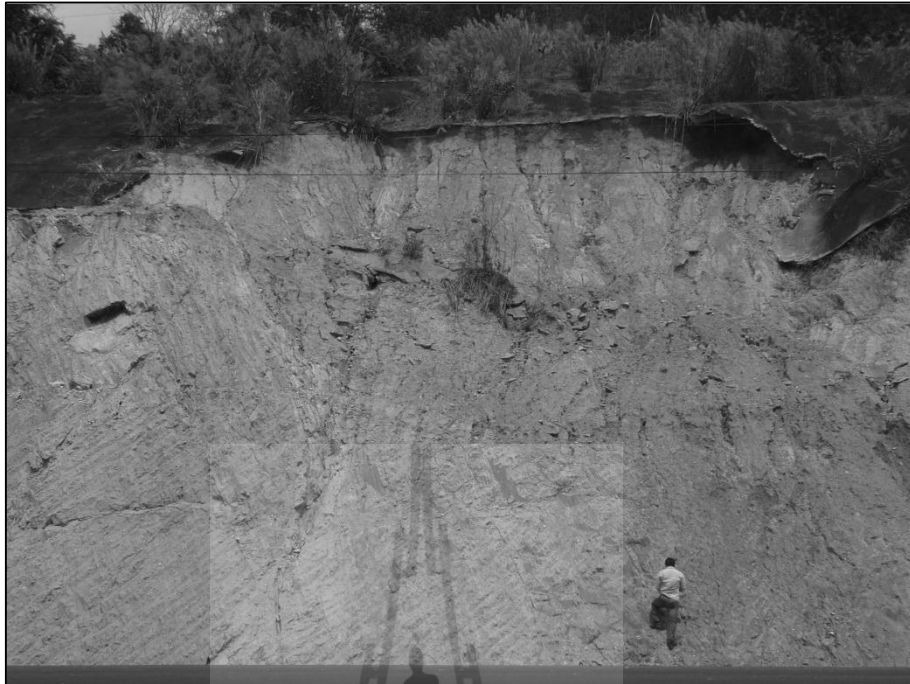
Figure A29 The circular failure occurred on slope no.15.

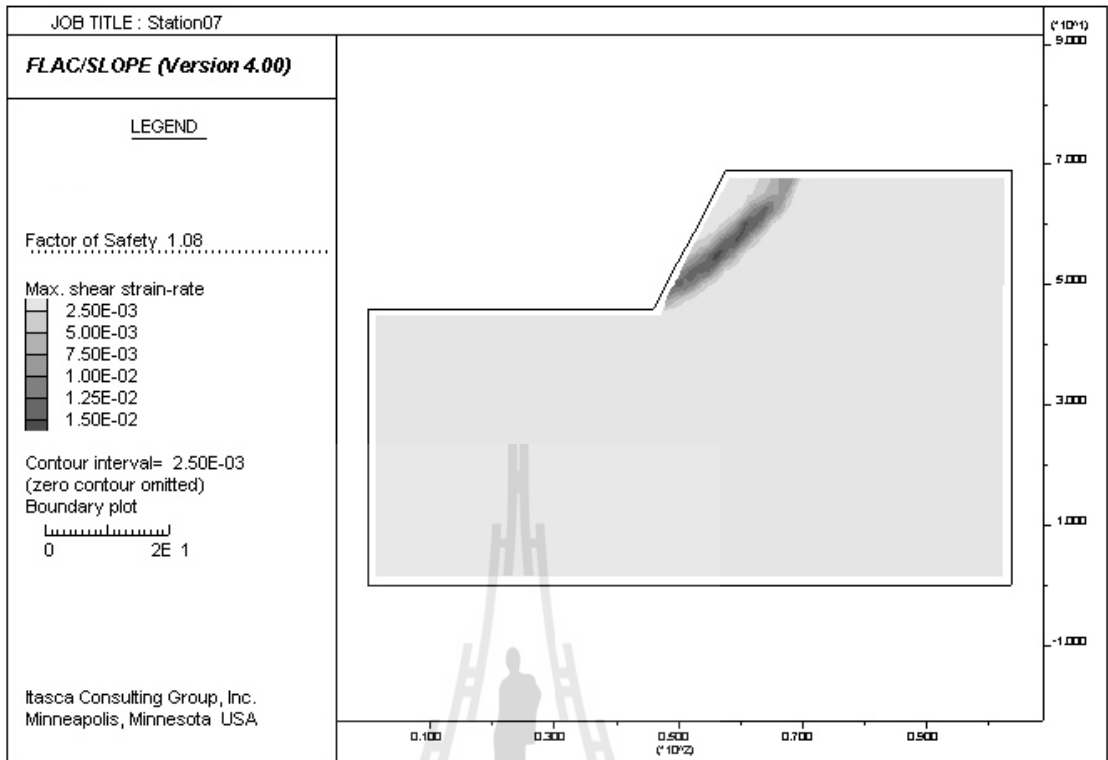
Figure B7 Stability evaluation of overall slope for station 07 using FLAC4.0 simulation
