**SLOPE FAILURE ALONG LOMSAK-CHUMPAE HIGHWAY  
PHETCHABUN PROVINCE, THAILAND**

**Master of Engineering in Geotechnology**

**Suranaree University of Technology**

The main objectives of this research are to investigate the slope failure and to propose remedial measures to prevent further failure along Lomsak-Chumpae highway, Thailand. The research involves field examination and computer modeling which has been performed to identify the failure characteristics of eleven rock slopes along the highway. The collected data are slope geometry, joint conditions and orientation, performance of the existing supports (if any), modes of failure, rock conditions, and groundwater conditions. The Hoek-Brown criterion and the Mohr-Coulomb criterion are used for estimating the shear strength properties of the rock mass. The results of field investigation indicate three stable slopes and eight unstable slopes. The results from computer modeling provide the shear strength estimates of Hoek and Brown criterion, which are in good agreement with the back-calculated strength under saturated condition. Calibrated shear strength parameters for calculating the safety factor of the rock slopes are performe

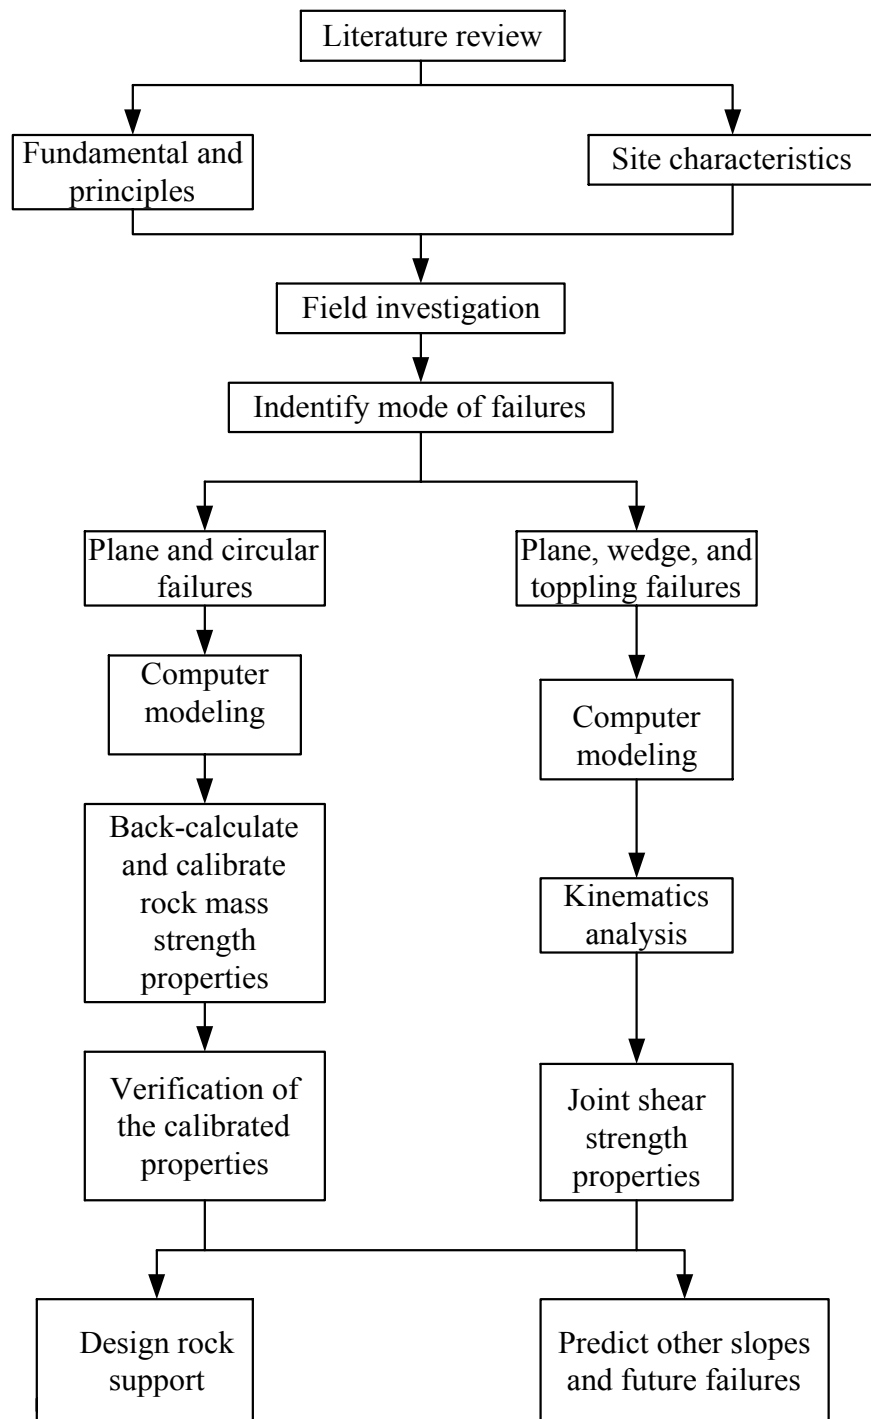
**Figure 1.1** Flow chart of the study on slope failures along Lomsak-Chumpae highway, Thailand.

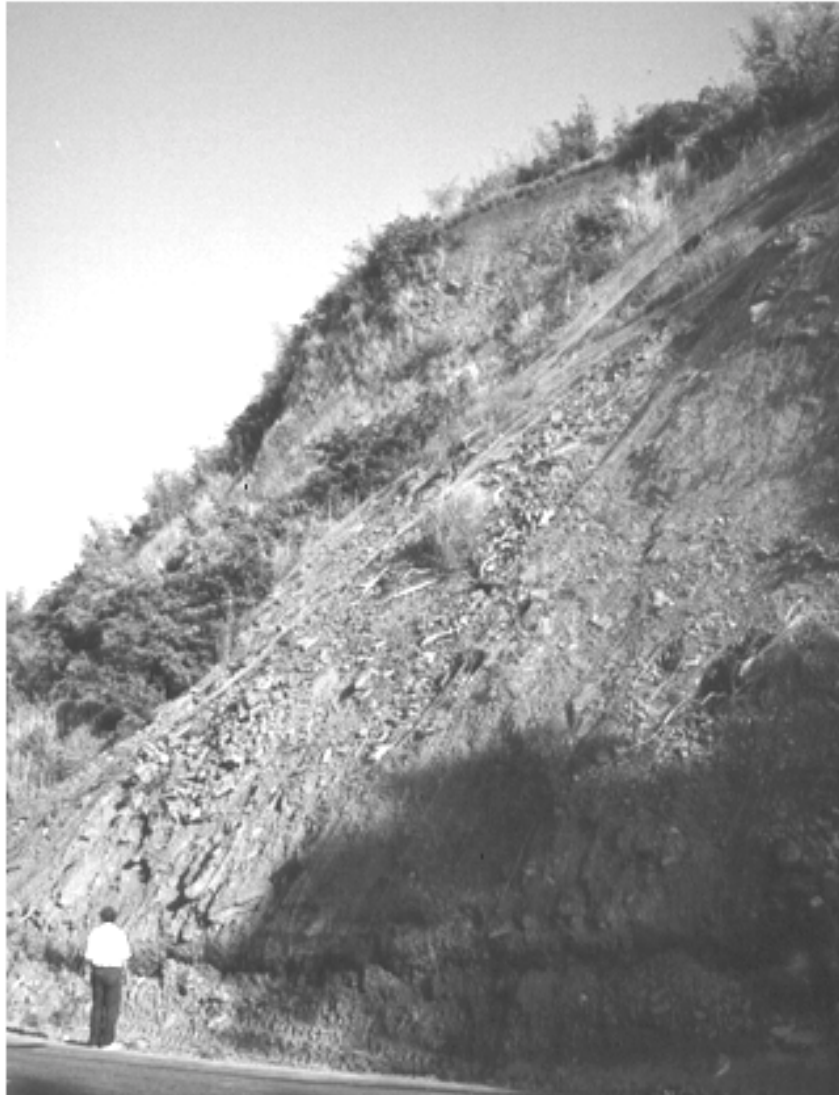
**Figure 3.1** Rock slope at km 16+450 (looking east). The rock is shale of Nam Duk Formation Middle Permian. Ravelling of soil/rock debris on the slope face found from the upper to the lower slope faces.

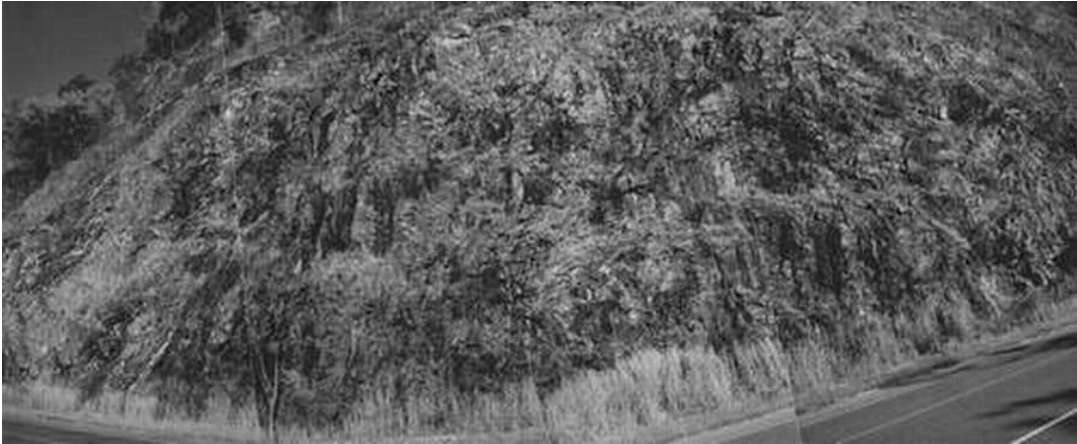
**Figure 3.2a** Rock slope at km 17+000 (looking east). The rock is shale.

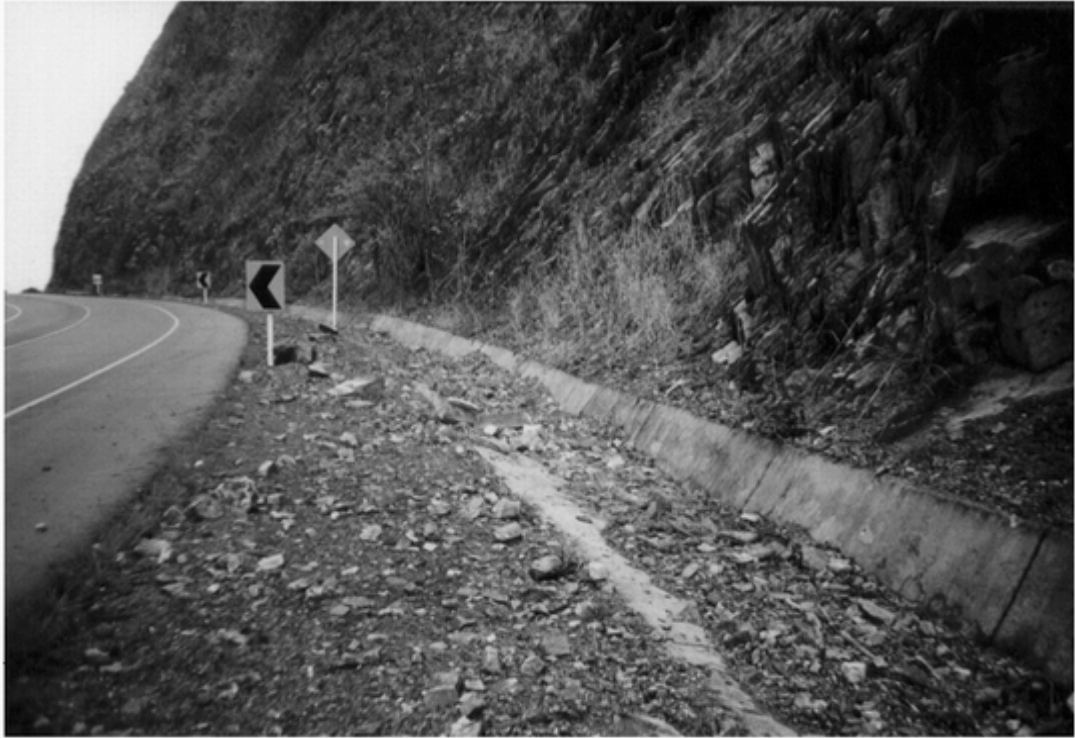
**Figure 3.2c** Rock falls at km 17+000 (looking east) during Rainy Season. Various block sizes cover the ditch and roll off the ditch to the rim of the highway.

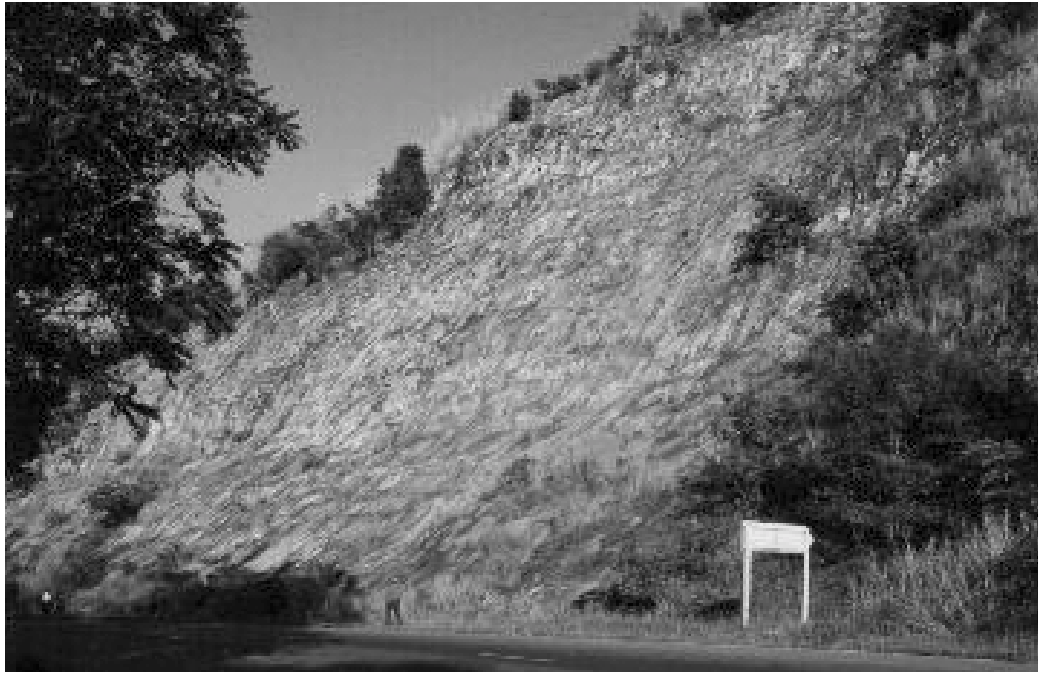
**Figure 3.3** Rock slope at km 18+200 (looking east). Shotcrete covers the slope face.

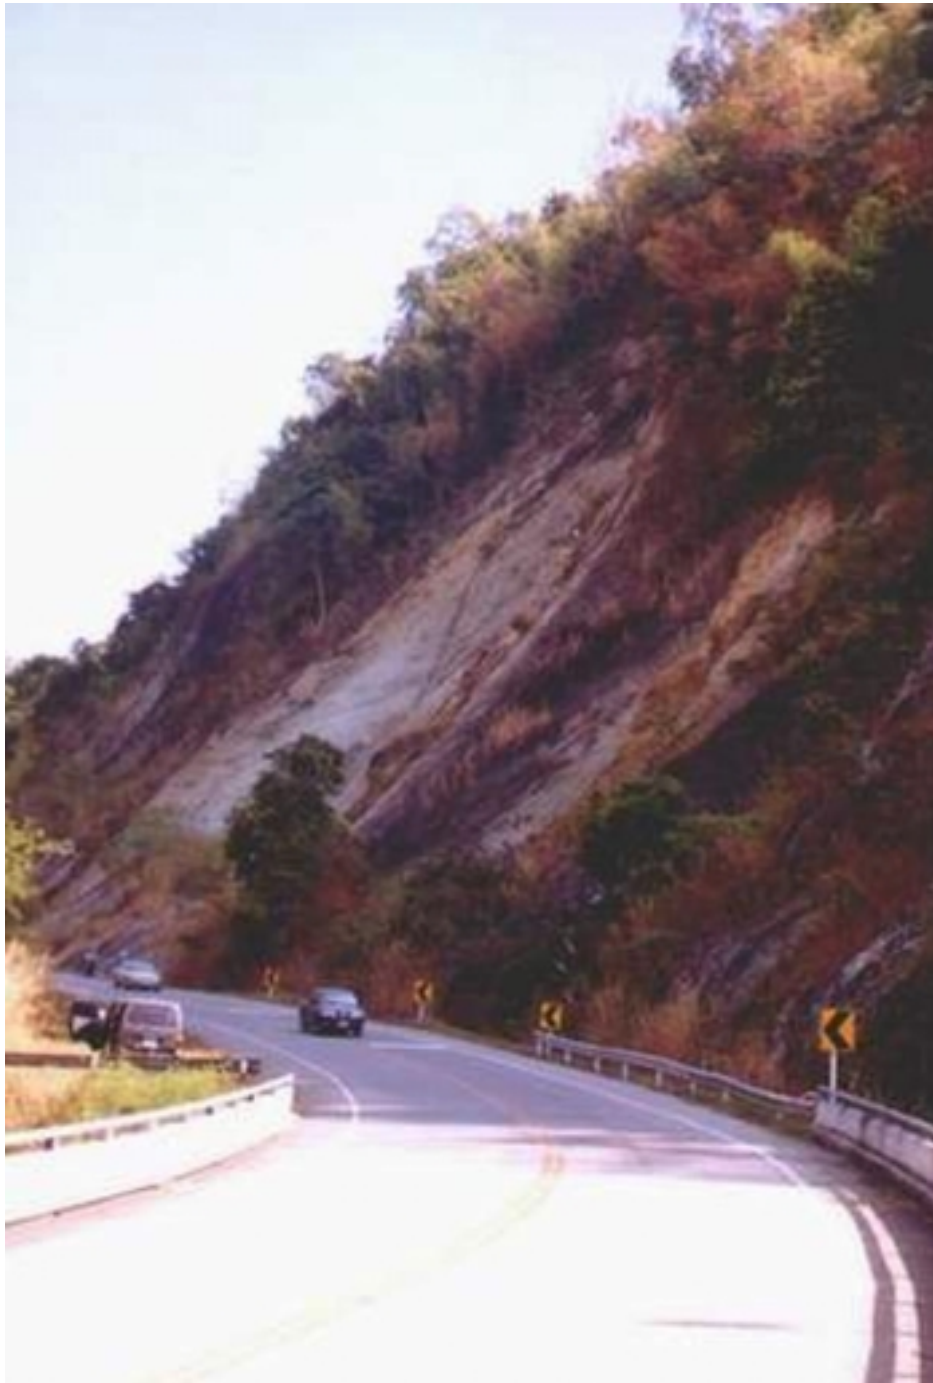
**Figure 3.4** Rock slope at km 18+550 (looking south). The rock is slaty shale of Nam Duk Formation in Middle Permian. The main discontinuity set forms the slope face.

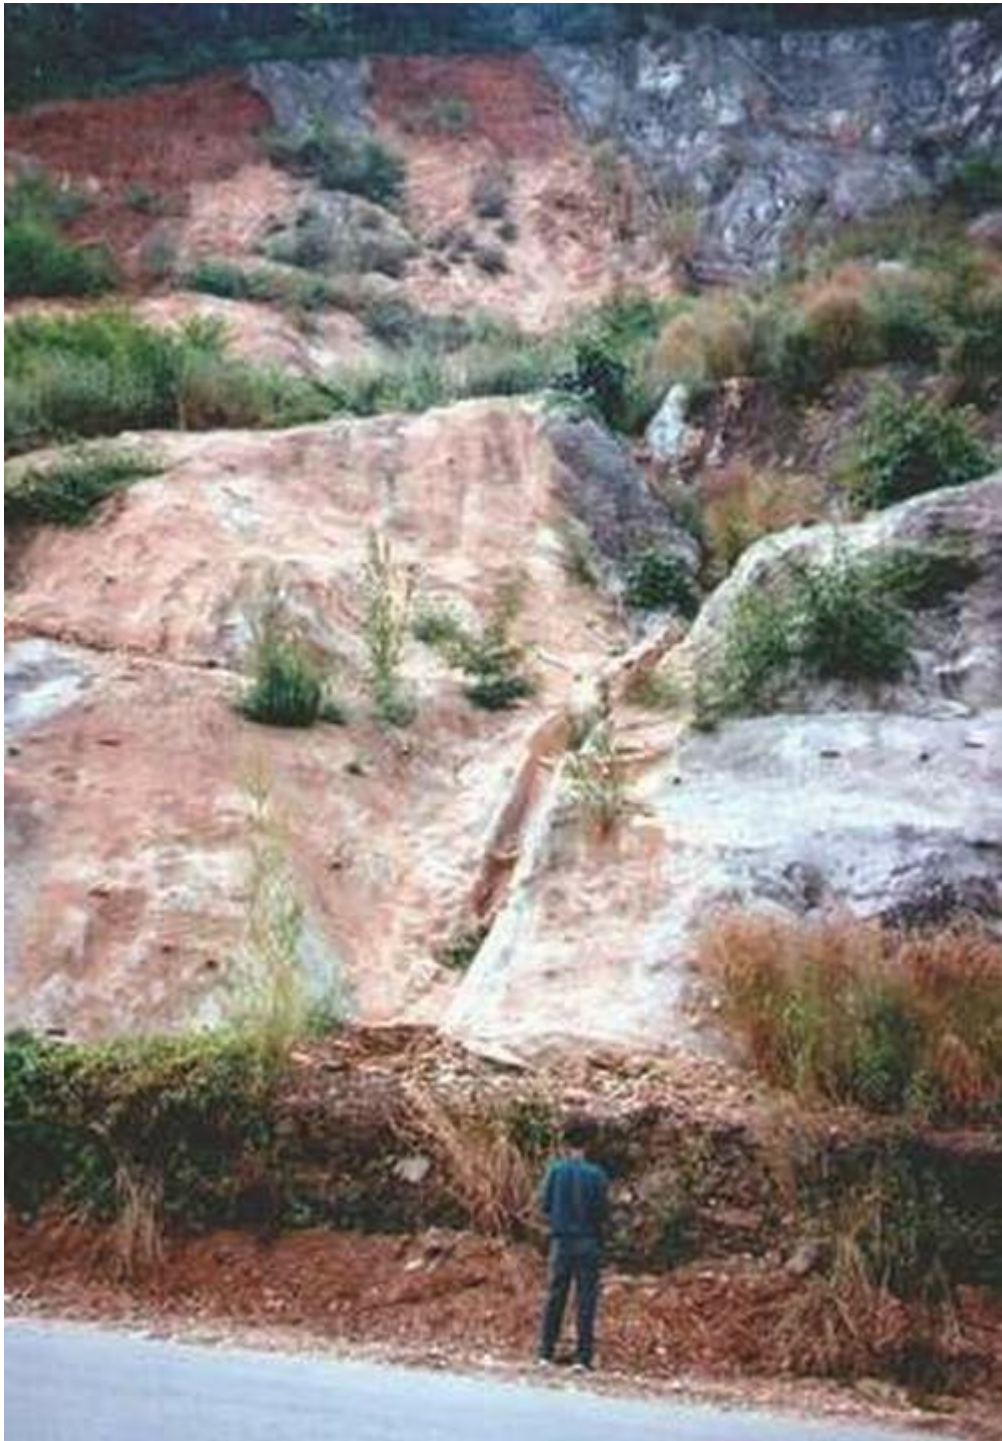
**Figure 3.5a** Rock slope at km 20+575 (looking south). The rock is shale of Nam Duk Formation in Middle Permian.

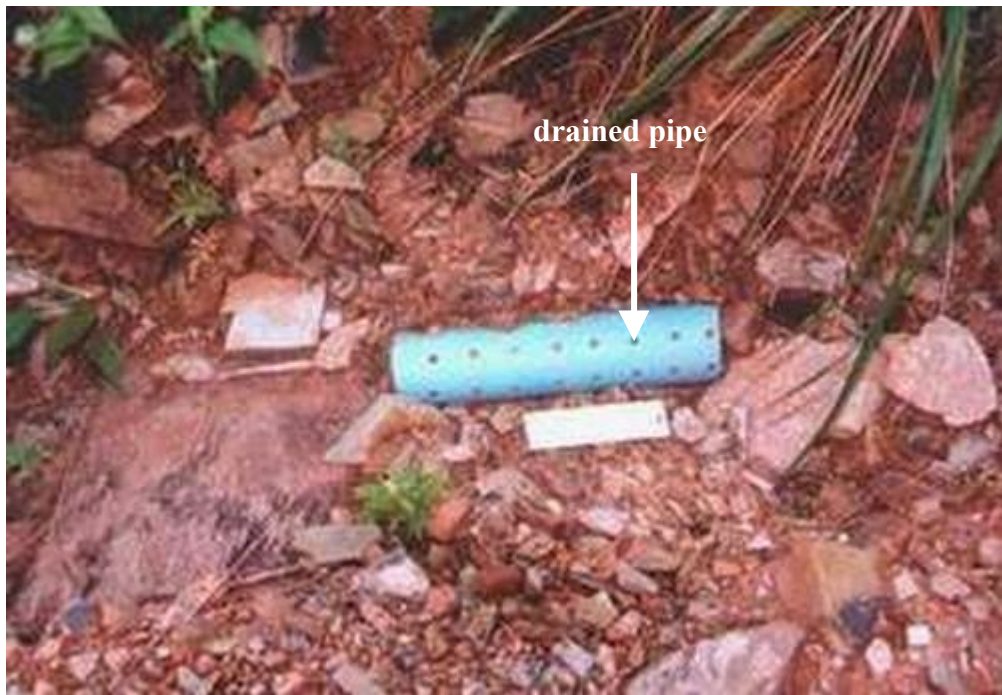
**Figure 3.5b** Drained pipe is found at km 20+575, in the pile of rock debris.

The common cause and the sequence of the massive failure for these slopes are that the full-face shotcrete with inappropriate drained pipes prevented the infiltrated water from seeping out of the slope. The shotcrete was not effective in preventing the rock fragments from dislodging from the slope face. It is observed that slabs of shotcrete in many areas were detached from the surface of the weathered rocks. The drained pipes were poorly designed. They were too short and were not effective in reducing the pore pressure.

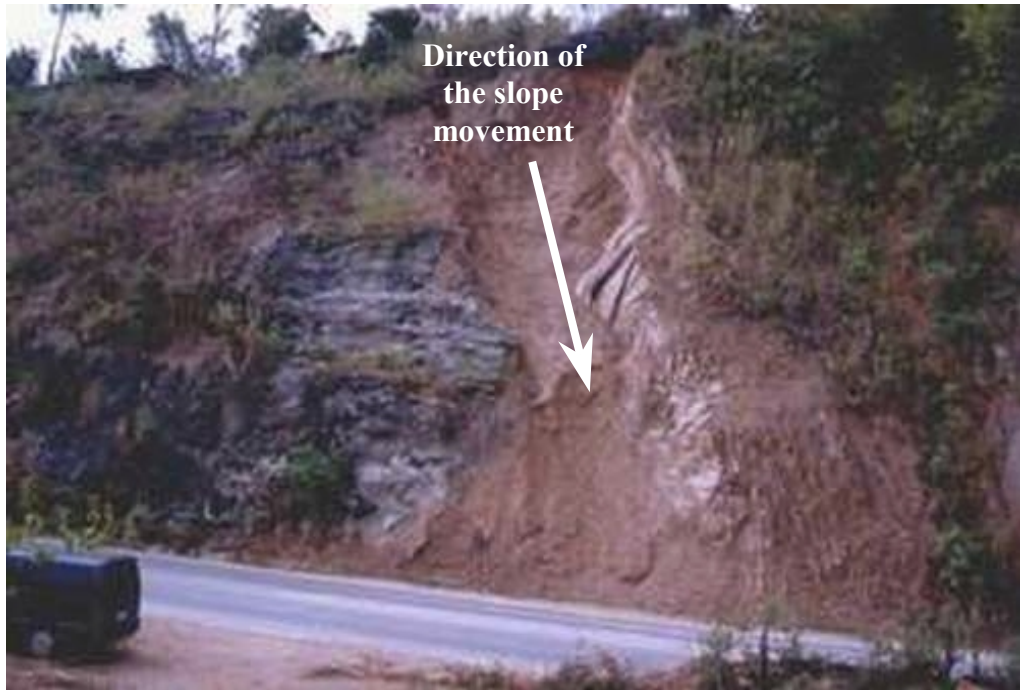
**Figure 3.8** Rock slope at km 36+120 (looking southwest). Massive failure occurred.

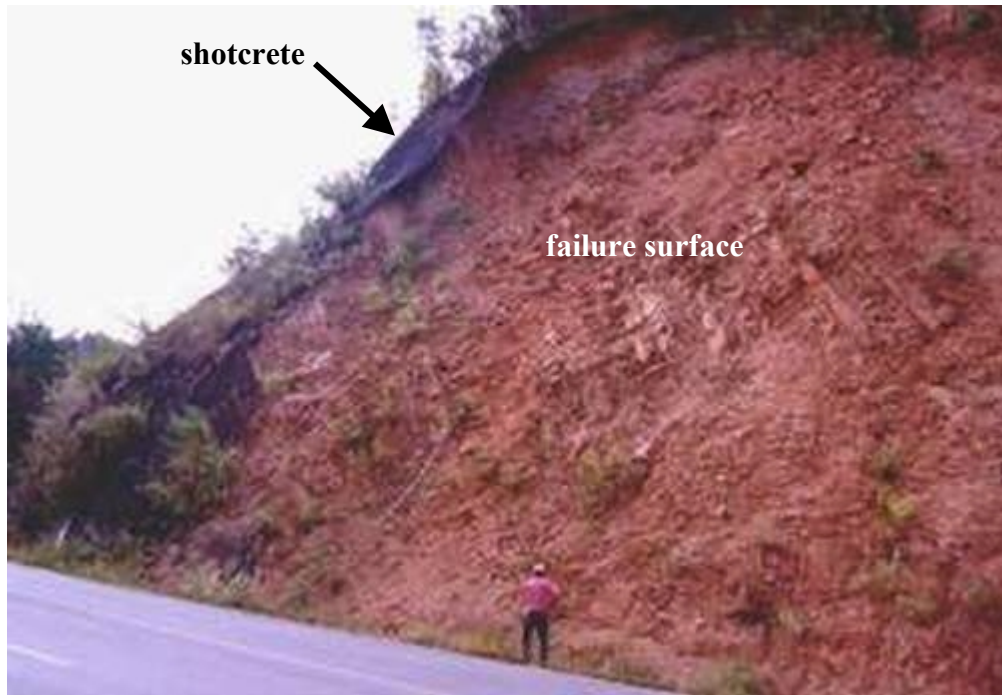
**Figure 3.9** Rock slope at km 36+750 (looking southwest). Failure surface exposed after massive slope failure. The failure brought down both earthen and installed materials. The remaining shotcrete appears on the left side of the slope face.

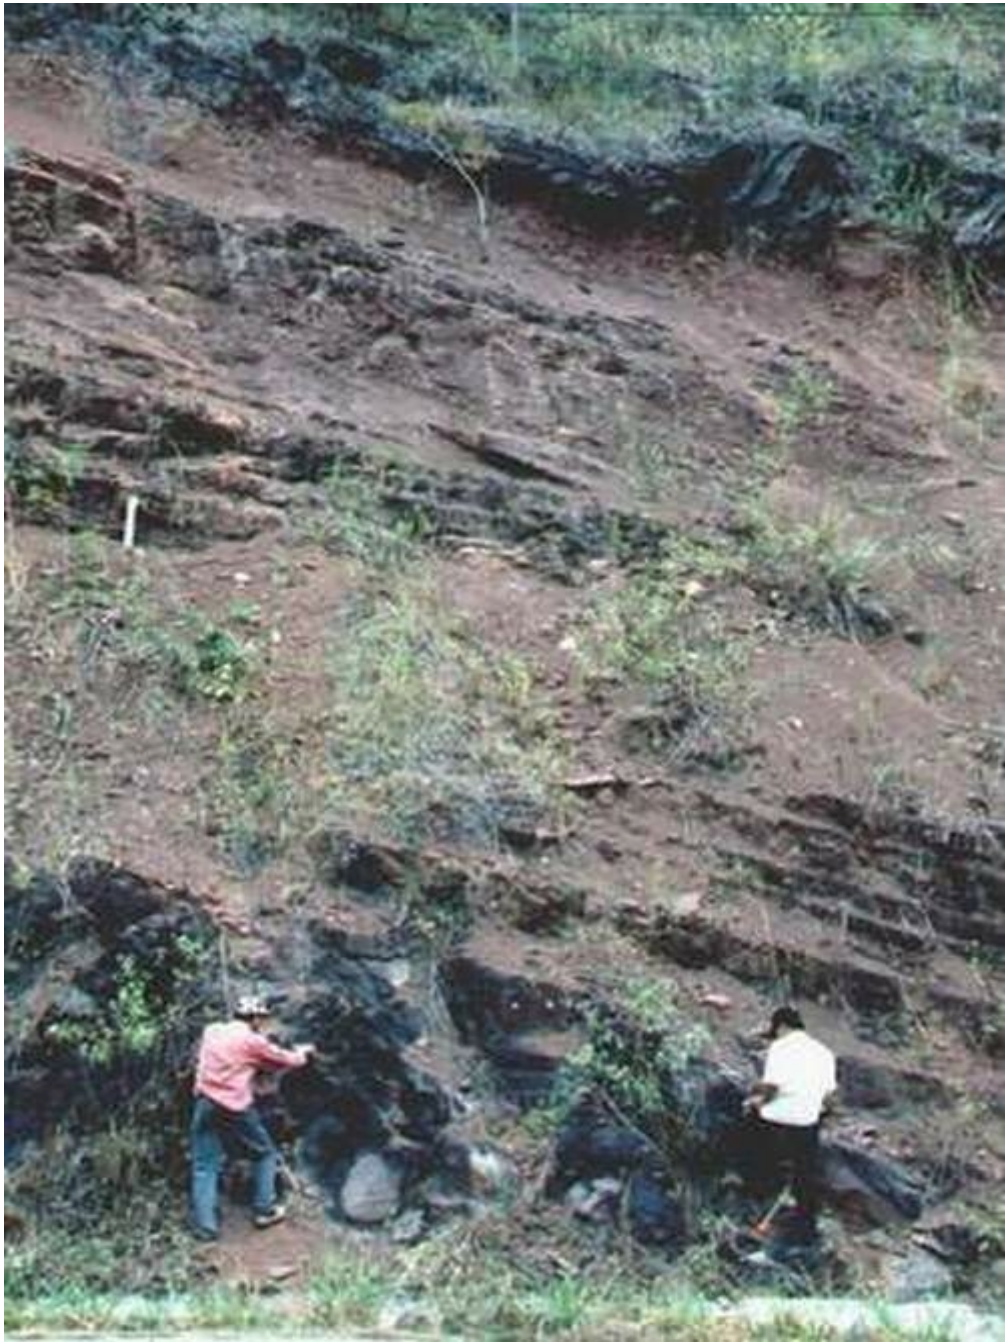
**Figure 3.10** Rock slope at km 62+950 (looking south). Sandstone interbedded with siltstone appeared on the slope face. The rock is Phu Kradung Formation in Lower Jurassic.

The slope location from km 62+950 to km 63+000 is on the right side of Lomsak-Chumpae highway. The rock is sandstone interbedded with siltstone of Phu Kradung Formation in Lower Jurassic. The uniaxial compressive strength of the intact rock is between 25 and 50 MPa. The slope height is 15 m. The joint orientation of the slope face is 156/55 degrees. There are four joint sets having the representative orientation equal 99/24 degrees, 135/80 degrees, 165/64 degrees, and 216/61 degrees. The average joint spacing is between 5 and 15 cm. The JRC is estimated as 5. The joint aperture is between 0.1 and 0.8 cm. Persistence of rock discontinuities is about 100 %. Filled material is clay. The joints are dry. Figure 3.10 shows the rock slope at km 62+950. The slope is stable.

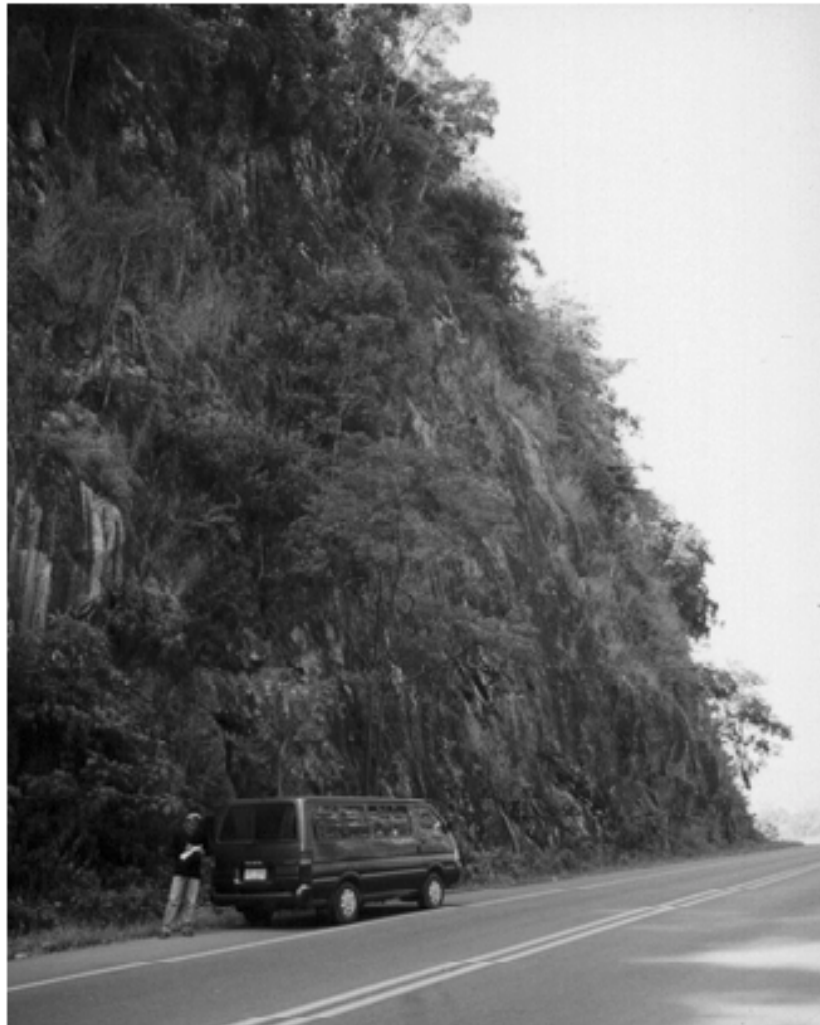
**Figure 3.11** Rock slope at km 78+680 (looking west). The rock is limestone of Pha Nok Khao Formation in Lower to Middle Permian. Rock falls are observed on the slope surface and the ditch.

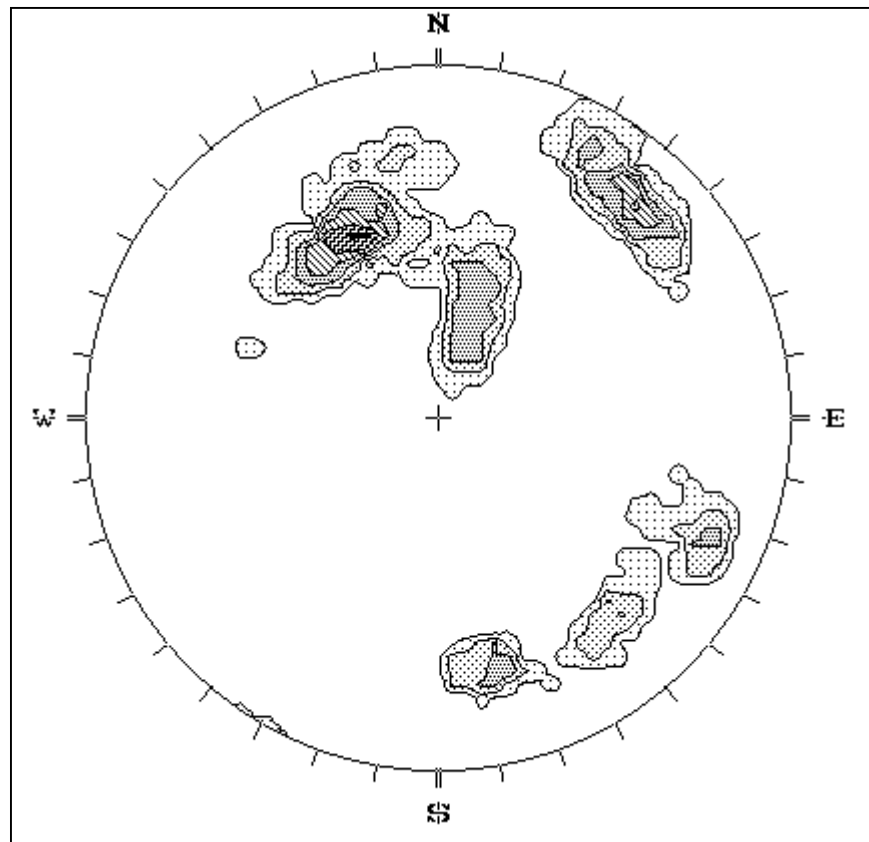
**Figure 5.15** Pole plots at km 78+680. There are five representative pole clusters on the stereonet.

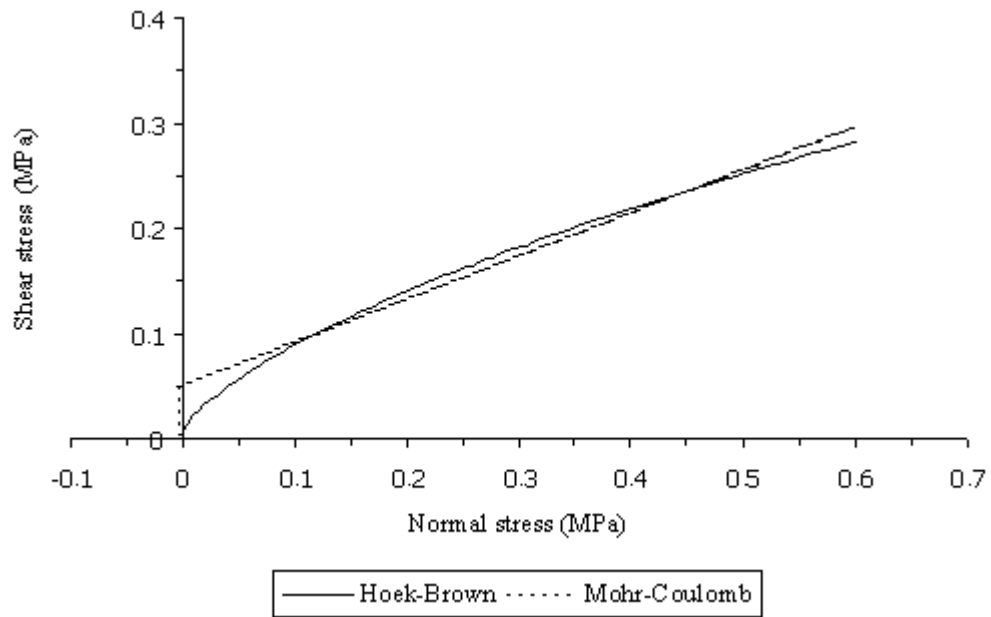
**Figure C.1** The estimates of the shale shear strength by using RocLab program at km 16+450. Hoek-Brown and equivalent Mohr-Coulomb failure envelope are plotted in shear-normal stress. The cohesion and the friction angle are 0.051 MPa and 22 degrees.

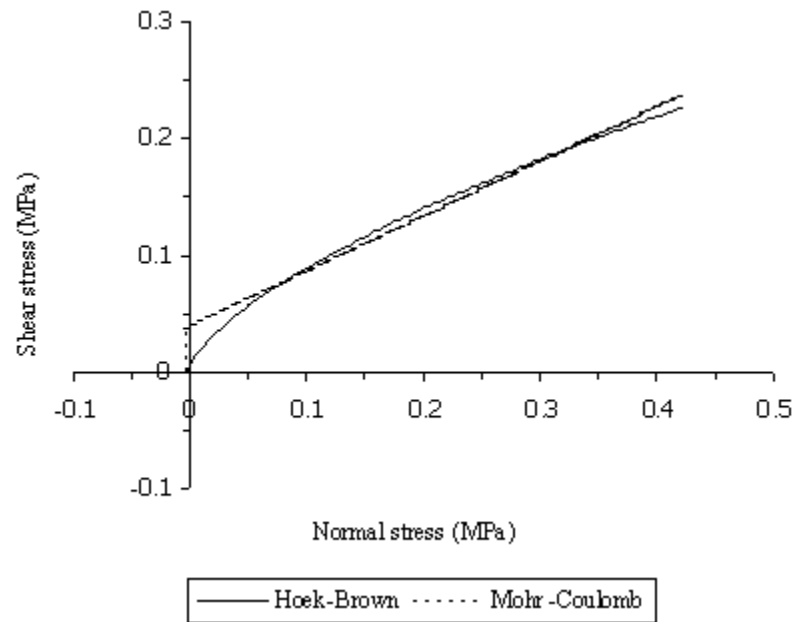
**Figure C.3** The estimates of the shale shear strength by using RocLab program at km 18+200. Hoek-Brown and equivalent Mohr-Coulomb failure envelope are plotted in shear-normal stress. The cohesion and the friction angle are 0.040 MPa and 25 degrees.

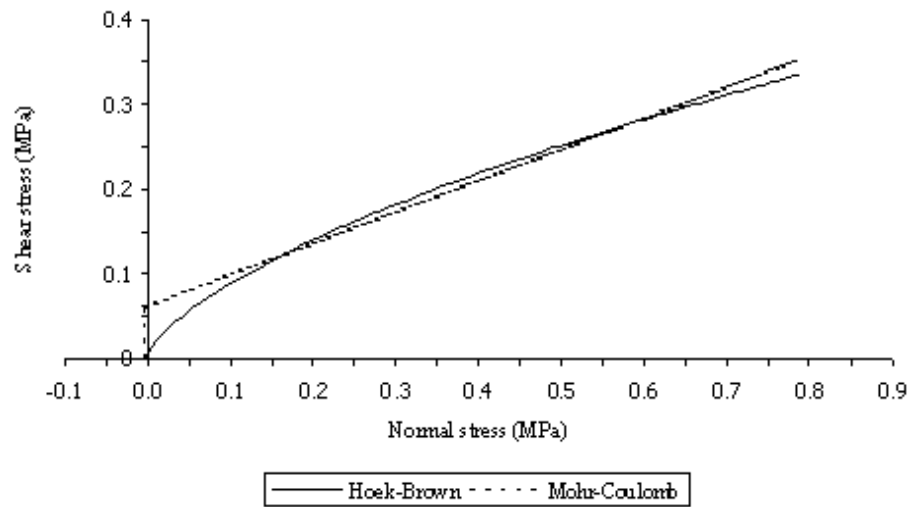
**Figure C.4** The estimates of the slaty shale shear strength by using RocLab program at km 18+550. Hoek-Brown and equivalent Mohr-Coulomb failure envelope are plotted in shear-normal stress. The cohesion and the friction angle are 0.061 MPa and 20 degrees.
