PROGRESS ON THE COMMISSIONING OF THE SIAM PHOTON SOURCE

Abstract

Various problems encountered in the commissioning and performance improving work for the accelerator complex of the Siam Photon Source are reported along with their cures. As representative examples, the irregular floor settlement, the effect of residual gas on the beam lifetime and undesirable noise are described. Since the original components were built about 15 year ago, we have found various problems inherent in an old and used machine and also in the infrastructure of the area during the course of component storage and machine commissioning. Experiences made here provide us with useful examples of trouble shooting covering various fields of accelerator technology.

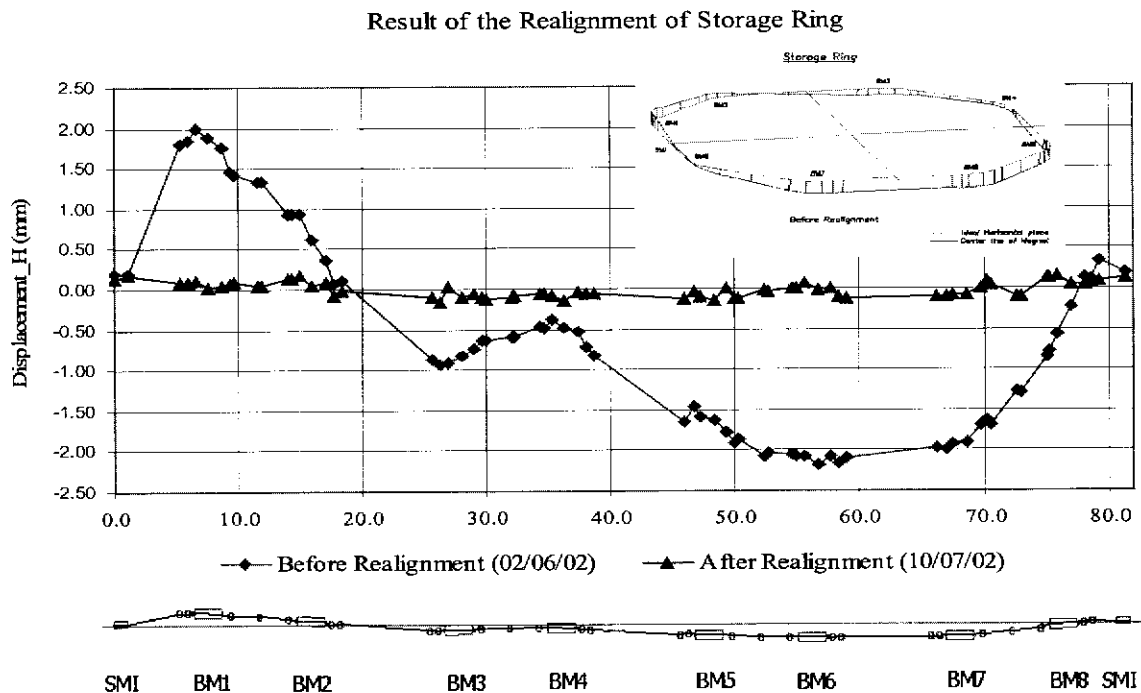
At the beginning, the progress of increasing stored current proceeded slowly. This was ascribed mainly to uneven floor settlement and instabilities of the electricity and water supplies^[1]. The vertical level difference was measured to be as large as 4.0 mm as shown in Fig 1.

Figure 1. The displacement of magnets in STR before and after the realignment.

In July 2002, the realignment of storage ring was conducted without breaking UHV^[2]. With help from Spring8's magnet group, the magnet vertical positions were brought back to the level with the required precision as shown in Fig.1. Although the vertical levels were moved back to the vicinity of the decided level, the horizontal positions of some multipole magnets from SORTEC could not be determined precisely owing to the displacement of the top target holes. Similarly, the locations of beam position monitors (BPM) cannot be aligned perfectly. Immediately after the realignment, the commissioning was resumed. The 1.0 GeV beam was re-stored within 1 month and the beam current increased gradually. In February 2003, a stored beam current of 155 mA was recorded and the beam lifetime was recorded to be about 50 min at 100 mA. With sufficient beam currents, the measurement of several beam parameters such as betatron tunes and COD shifts could be implemented. The beam lifetime increased also gradually, the accumulated beam dose became higher. In order to re-store the beam, several steering magnets had to be excited with large current. The inaccurate positions of multipole magnets could cause the electron trajectory to have large deviation from the ideal orbit. As a result, we observed very large COD ($(\Delta x(s))_{rms} \approx 3.6$ mm, $(\Delta y(s))_{rms} \approx 1.8$ mm). At this stage the beam lifetime was not long and the beam dump occurred from time to time. Thus, the major effort has been focused on the COD correction and the beam-based alignment. The goal of the next stage is to improve the beam stability and bring the beam lifetime up to the value that experiments can be carried out with high precision.

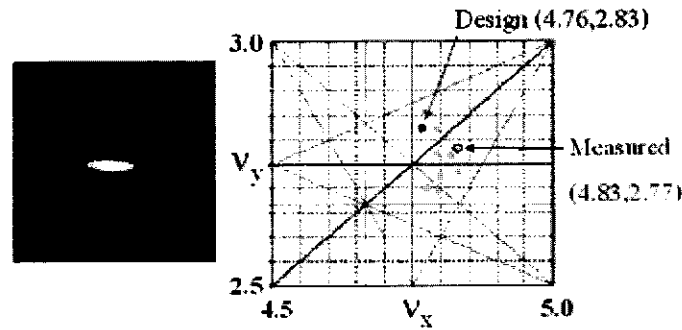
To improve the machine performance, measurements of some of the beam parameters must be carried out. STR machine studies have been performed during the last three months in 2002. This included the measurements of betatron tunes. The observed beam shapes and the working diagram are shown in Fig 2. The betatron tunes were measured to be $\nu_x = 4.83$, $\nu_y = 2.77$ for the most stable condition. This values are not much different from the designed values of $\nu_x = 4.76$, $\nu_y = 2.83$. However, several sources of instabilities exist. They make the betatron tunes shift during the operation and the beam moves suddenly. This reduces the beam lifetime and the beam dumps eventually.

Figure 2. Left: 1.0GeV beam shape, Right: working diagram.

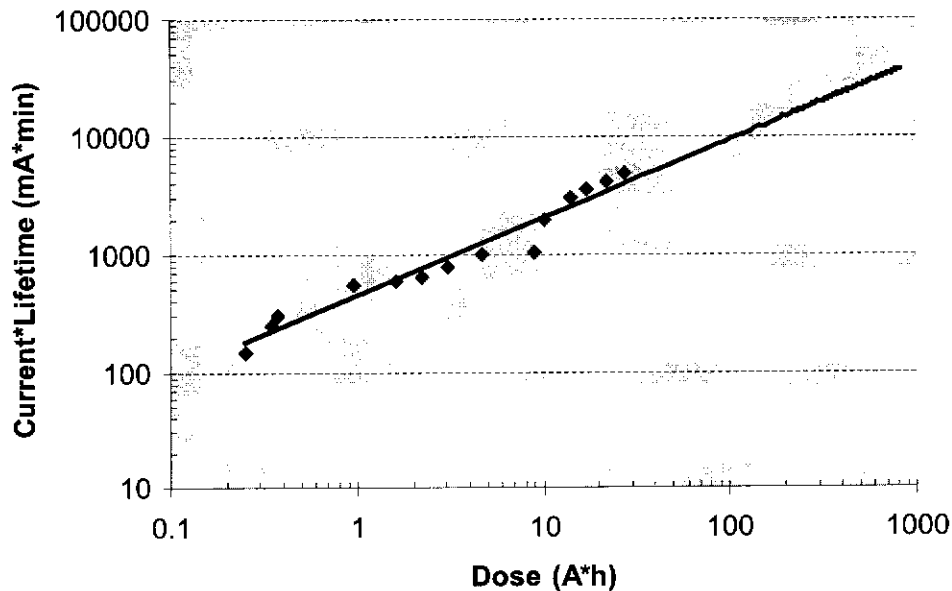
Apart from the beam instability effect described in the proceeding sections, the lifetime of the electron beam is mostly determined by the scattering with residual gas molecular ions in vacuum chamber. In the early period, when the beam was stored in the STR, the pressure was enhanced rapidly through the photodesorption process. This limited the initial stored beam current to a value below a few milliamperes. As the injection efficiency was improved and the beam dose increased, the stored current and lifetime increased gradually. Figure 3. shows the plot of the product of beam current and lifetime versus the integrated beam dose. From the data, the trend that the lifetime increases is roughly expressed as $y = 449.71x^{0.645}$ where y is a current-lifetime product and x is the integrated dose. This is similar to the published data of the other storage ring^{[3],[4]}. The instabilities arising from defects in hardware and environment such as cooling water temperature fluctuations, and noise prevent the lifetime improvement.

Figure 3. Plot of the beam current-lifetime product versus integrated beam dose

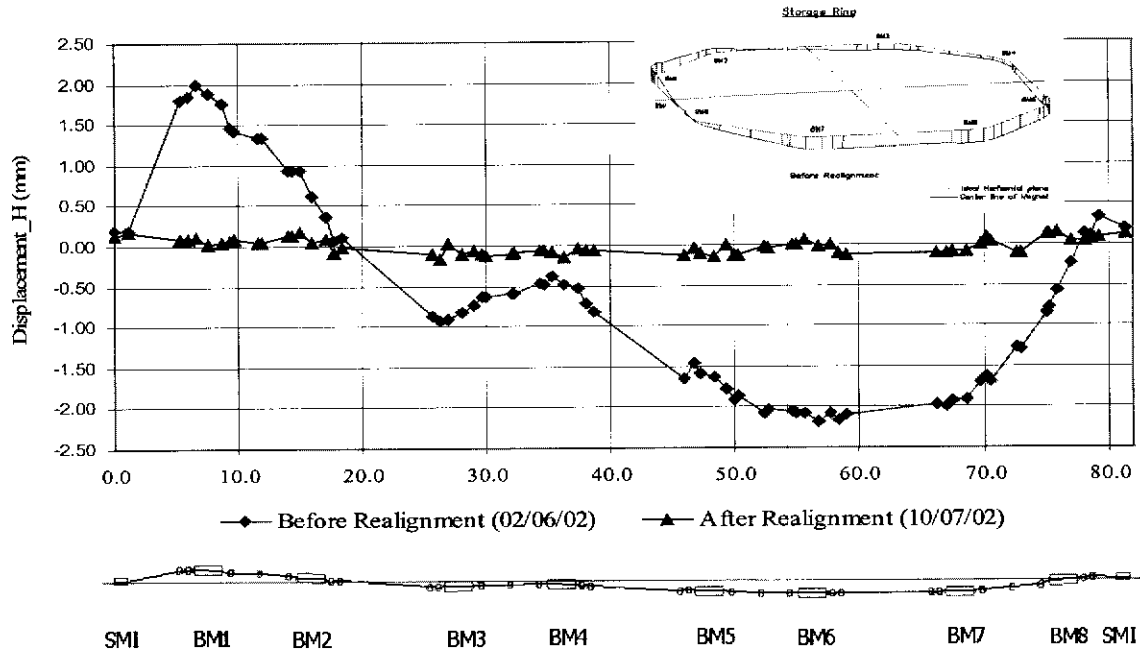
At the beginning, the progress of increasing stored current proceeded slowly. This was ascribed mainly to uneven floor settlement and instabilities of the electricity and water supplies^[1]. The vertical level difference was measured to be as large as 4.0 mm as shown in Fig 1.

Figure 1. The displacement of magnets in STR before and after the realignment.

In July 2002, the realignment of storage ring was conducted without breaking UHV^[2]. With help from Spring8's magnet group, the magnet vertical positions were brought back to the level with the required precision as shown in Fig.1. Although the vertical levels were moved back to the vicinity of the decided level, the horizontal positions of some multipole magnets from SORTEC could not be determined precisely owing to the displacement of the top target holes. Similarly, the locations of beam position monitors (BPM) cannot be aligned perfectly. Immediately after the realignment, the commissioning was resumed. The 1.0 GeV beam was re-stored within 1 month and the beam current increased gradually. In February 2003, a stored beam current of 155 mA was recorded and the beam lifetime was recorded to be about 50 min at 100 mA. With sufficient beam currents, the measurement of several beam parameters such as betatron tunes and COD shifts could be implemented. The beam lifetime increased also gradually, the accumulated beam dose became higher. In order to re-store the beam, several steering magnets had to be excited with large current. The inaccurate positions of multipole magnets could cause the electron trajectory to have large deviation from the ideal orbit. As a result, we observed very large COD ($(\Delta x(s))_{rms} \approx 3.6$ mm, $(\Delta y(s))_{rms} \approx 1.8$ mm). At this stage the beam lifetime was not long and the beam dump occurred from time to time. Thus, the major effort has been focused on the COD correction and the beam-based alignment. The goal of the next stage is to improve the beam stability and bring the beam lifetime up to the value that experiments can be carried out with high precision.

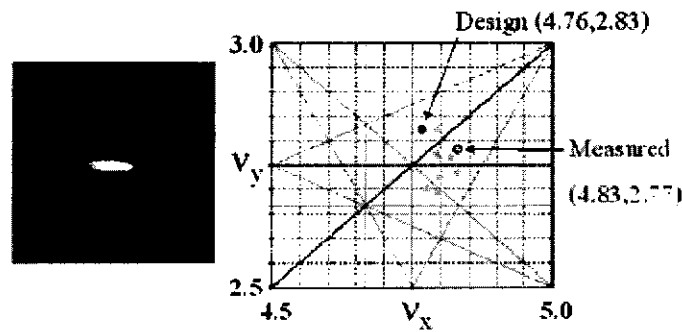
To improve the machine performance, measurements of some of the beam parameters must be carried out. STR machine studies have been performed during the last three months in 2002. This included the measurements of betatron tunes. The observed beam shapes and the working diagram are shown in Fig 2. The betatron tunes were measured to be $\nu_x = 4.83$, $\nu_y = 2.77$ for the most stable condition. This values are not much different from the designed values of $\nu_x = 4.76$, $\nu_y = 2.83$. However, several sources of instabilities exist. They make the betatron tunes shift during the operation and the beam moves suddenly. This reduces the beam lifetime and the beam dumps eventually.

Figure 2. Left: 1.0 GeV beam shape, Right: working diagram.

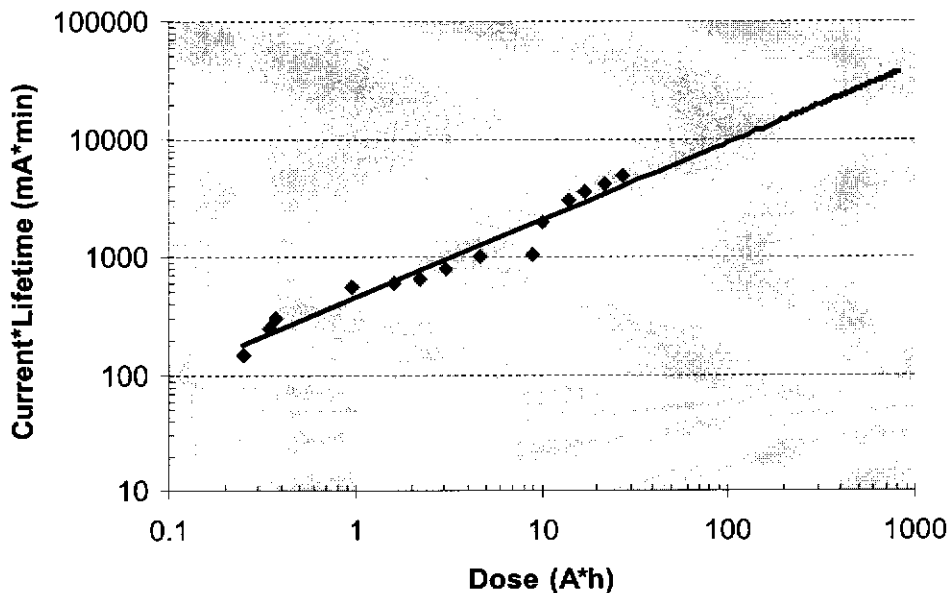
Apart from the beam instability effect described in the proceeding sections, the lifetime of the electron beam is mostly determined by the scattering with residual gas molecular ions in vacuum chamber. In the early period, when the beam was stored in the STR, the pressure was enhanced rapidly through the photodesorption process. This limited the initial stored beam current to a value below a few milliamperes. As the injection efficiency was improved and the beam dose increased, the stored current and lifetime increased gradually. Figure 3. shows the plot of the product of beam current and lifetime versus the integrated beam dose. From the data, the trend that the lifetime increases is roughly expressed as $y = 449.71x^{0.645}$ where y is a current-lifetime product and x is the integrated dose. This is similar to the published data of the other storage ring^{[3],[4]}. The instabilities arising from defects in hardware and environment such as cooling water temperature fluctuations, and noise prevent the lifetime improvement.

Figure 3. Plot of the beam current-lifetime product versus integrated beam dose
