EMPIRICAL EQUATION FOR DETERMINATION OF SAFE PIT SLOPE
GEOMETRY AT PHU KHAM MINING

A Thesis Submitted in Partial Fulfillment of the Requirements for the
Degree of Master of Engineering in Civil, Transportation
and Geo-Resources Engineering
Suranaree University of Technology
Academic Year 2022

WASAN SARANART : EMPIRICAL EQUATION FOR DETERMINATION OF SAFE PIT
SLOPE GEOMETRY AT PHU KHAM MINING. THESIS ADVISOR : THANITTHA
THONGPRAPHA, Ph.D., 93 PP.

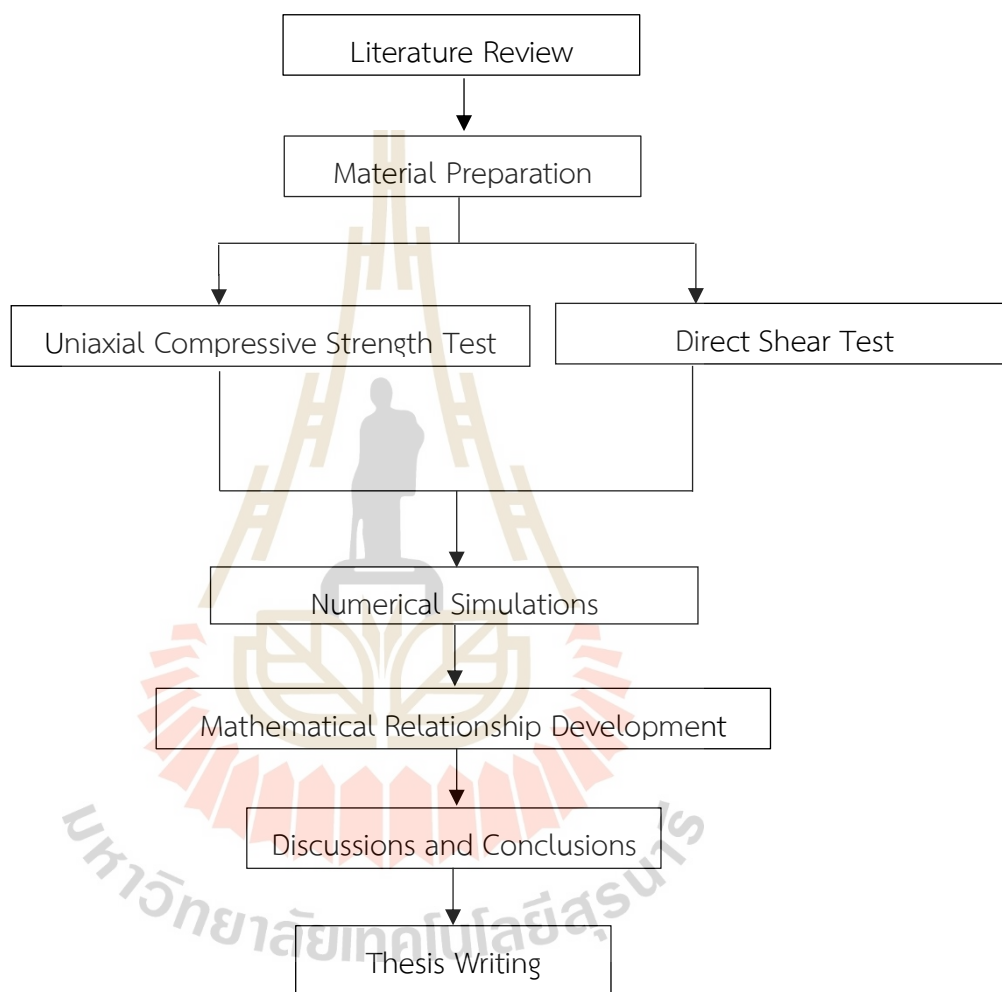
Figure 1.1 Research methodology

The methodology of research comprises 6 steps; including literature review, sample preparations and laboratory testing, numerical simulations, mathematical relationship development, discussions and conclusions, and thesis writing (Figure 1.1).

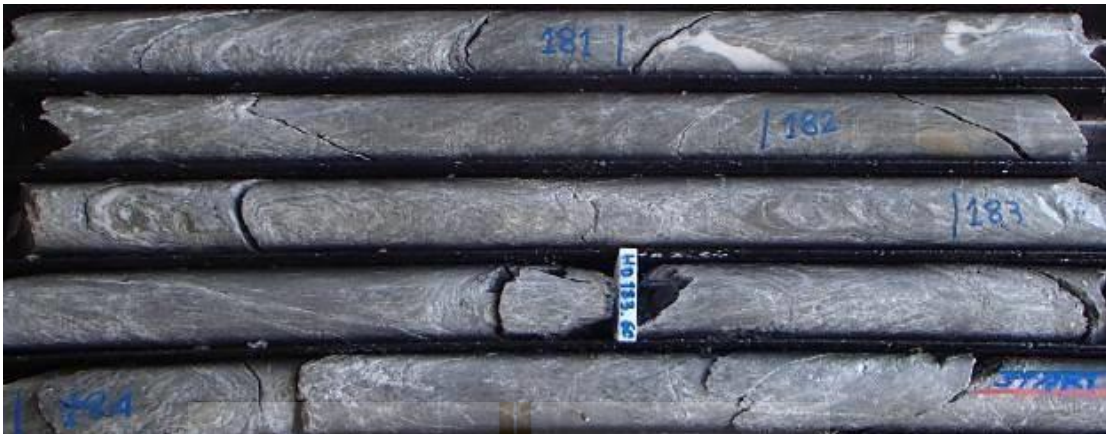
Figure 2.4 Typical VTF cores with characteristic foliation, local folding and quartz.

The VTF rock mass (Figure 2.4) is exposed in the lower southern slopes of the southern extension, and the lower northern slope. The rock mass is foliated and is expected to behave anisotropically. The direction of foliation is highly variable in the southern region of the mine, due to several major structures intercepting the rock mass.

The VTF rock mass away from fault induced degradation is expected to be of good quality, with rock mass rating index (σ) proposed by Bieniawski (1989) of between 60 to 80.94% of the recovered core has been logged as fresh. It is expected that large scale shearing through the competent VTF blocks are unlikely. However, blocks of fault bounded VTF may form unstable wedges, particularly within the southeastern slopes.

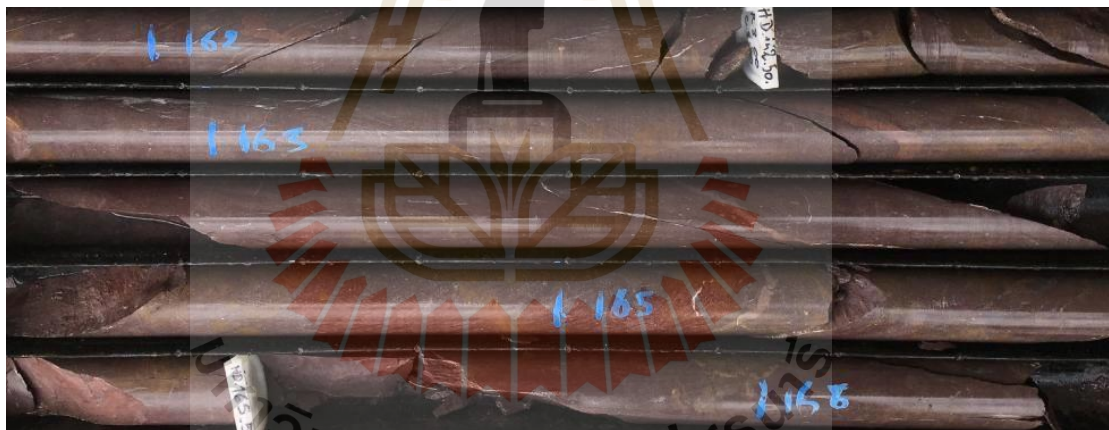
Figure 2.6 Typical SLR cores with characteristic bedding.

between 60 to 70.96% of the recovered core has been logged as fresh. It is expected that large scale shearing through the competent SLR blocks will be unlikely and failure may occur in the direction of bedding, with minor breakout at the slope toe.

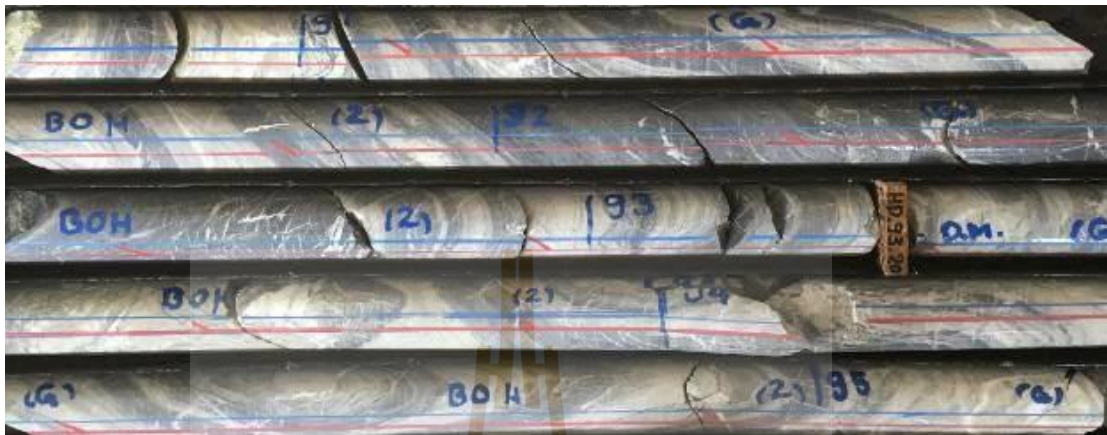
Figure 2.7 Typical SLS cores with characteristic foliation, local folding and carbonate.

will be unlikely. However as with the VTF material, blocks of fault bounded SLS may form unstable wedges, particularly within the south-eastern slopes.

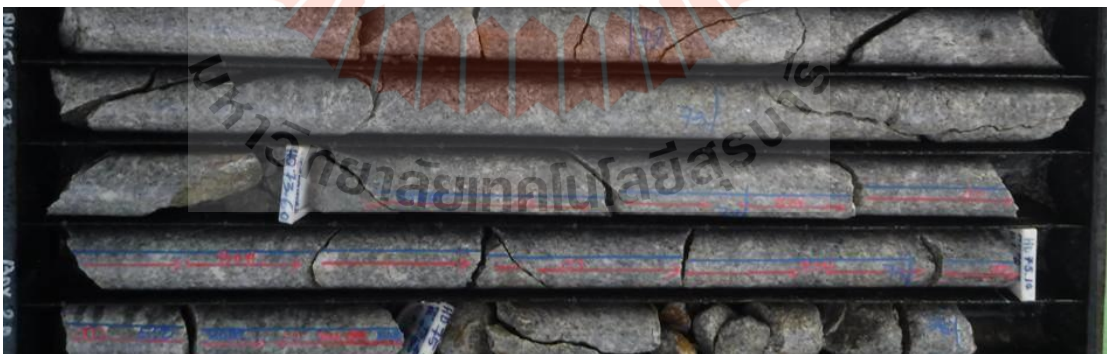
Figure 2.9 Typical IGN fresh cores with joints.

The upper half of the north eastern slope of PKM Design is formed within the granite rock mass (Figure 2.9). It is expected that this material will be important for slope stability both above and below the Nam San Channel. 19% of the total recovered core. It is expected that this region will mostly be formed within soil and weathered sediments, with low strengths limiting the achievable slope angle. The granite is foliated and is expected to behave anisotropically.

The direction of foliation is favorable for the northern wall stability, dipping into the slope. The rock mass is fair to good quality, with RMR89 of between 40 and 70.74% of the recovered core has been logged as slightly weathered or fresh. It is

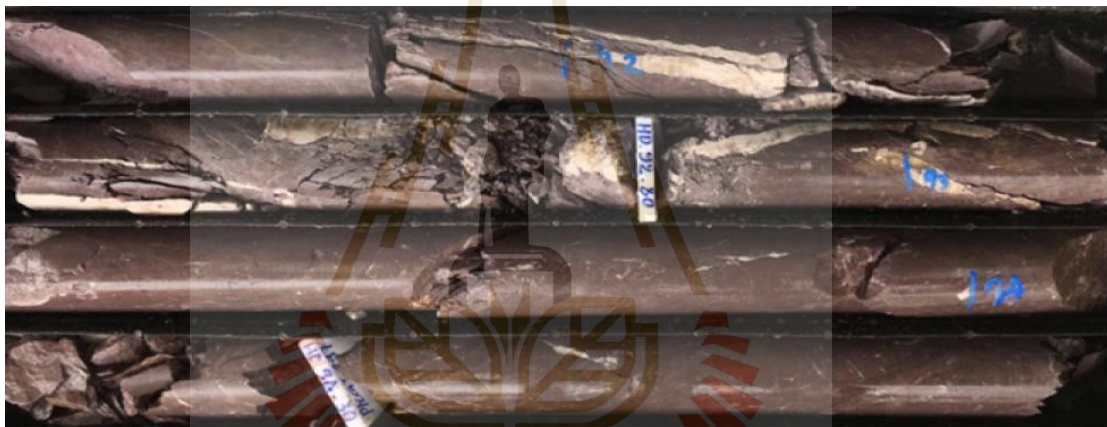
Figure 2.18 South Wall SLR Fault 07 presenting a clay gouge core, disjunctive cleavage.

The steep dipping South Wall SLR faults are characterized by zones of quartz veins, strong disjunctive cleavage and/or bedding parallel clayey gouge (Figure 2.18). These structures have likely contributed to several failures within the weathered material of the south wall during 2017 and 2018.

An approximately 20 m wide central zone of strong deformation comprising a broad zone of stranded shears is bound by the upper South Wall SLR Fault 08 and the lower South Wall SLR Fault 07 (Figure 2.12). Where the South Thrust intersects the South Wall SLR Faults, moderately to strongly jointed/fractured zones and quartz veins have developed.

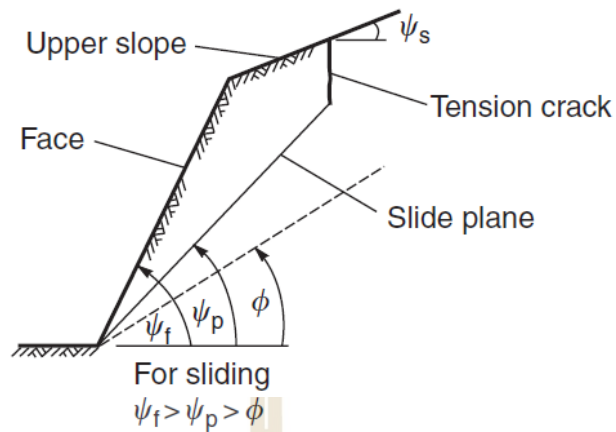
Figure 2.19 Plane failure (Wyllie and Mah, 2005).

Plane failure occurs when bedding planes or joint planes strike or nearly parallel to slope face (within approximately ± 20 degrees). The sliding plane must daylight in the slope face that indicates the plane dip angle (ψ_p) is smaller than the slope face angle (ψ_f). Furthermore, the plane dip angle be greater than the plane friction angle (ϕ), as shown in Figure 2.19.

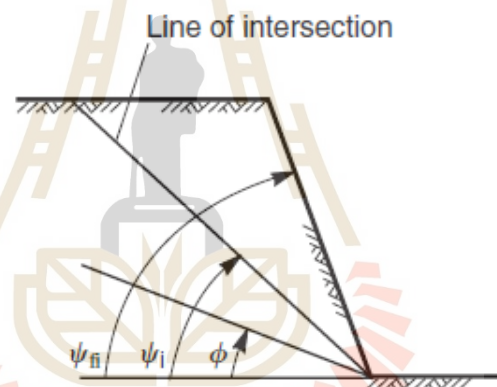
Figure 2.20 Wedge failure (Wyllie and Mah, 2005).

Wedge failure occurs when two discontinuity planes strike obliquely opposite the slope face where wedge takes place along the intersection line of two planes. The intersection line daylights in the slope face, plunge of the intersection line (ψ_i) is flatter than the slope face angle (ψ_f) and larger than the rock internal friction angle (ϕ), as illustrated in Figure 2.20.

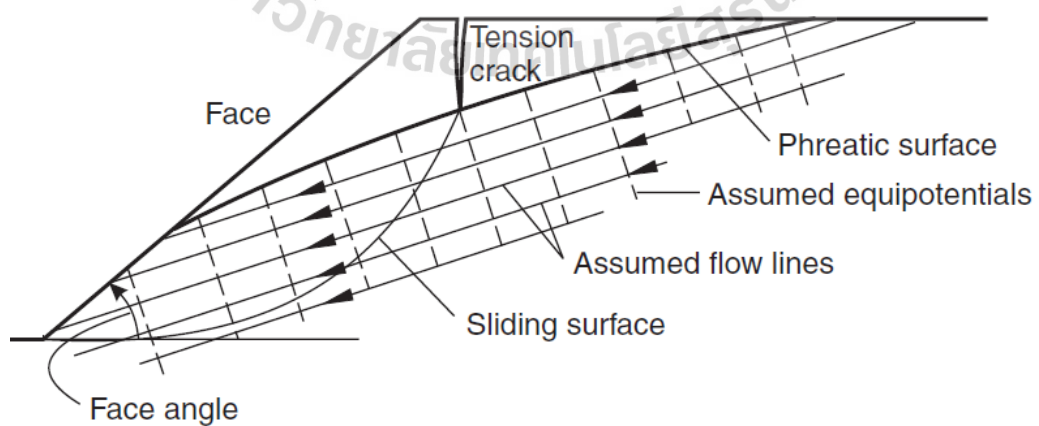
Figure 2.22 Circular failure (Wyllie and Mah, 2005).

The rock body is defined as a discontinuous rock mass. Circular failure occurs when the individual particles in rock mass or soil are very small compared with the slope size, then broken rock or soil fail in a circular mode (Figure 2.22).

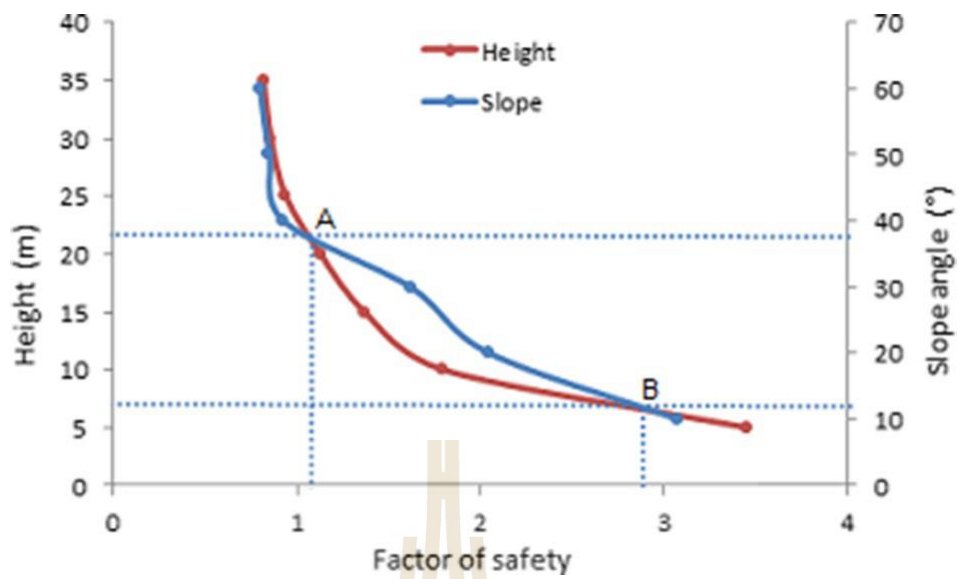
Figure 2.27 Effects of slope height and angle on factor of safety (Igwe and Chukwu, 2018).

Slope angle (°)	Slope height (m)	Cohesion (kPa)	Internal friction angle (°)	FS
10	35	32	14	3.08
20	35	32	14	2.05
30	35	32	14	1.42
40	35	32	14	0.96
50	35	32	14	0.85
60	35	32	14	0.80

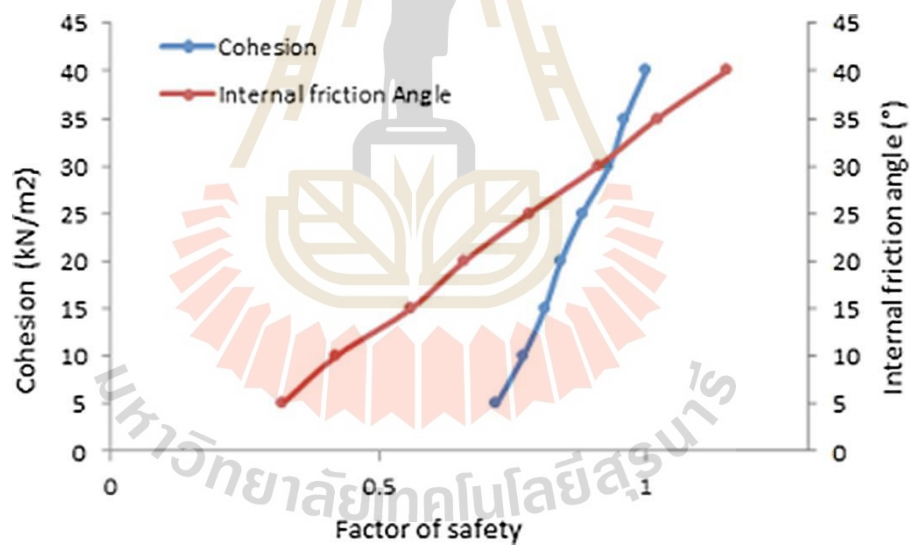
Figure 2.28 Relationship between shear strength parameters and factor of safety (Igwe and Chukwu, 2018).

Internal friction angle (°)	Cohesion (kPa)	Slope height (m)	Slope angle (°)	FS
5	32	35	40	0.32
10	32	35	40	0.42
15	32	35	40	0.56
20	32	35	40	0.66
25	32	35	40	0.78
30	32	35	40	0.91
35	32	35	40	1.02
40	32	35	40	1.15

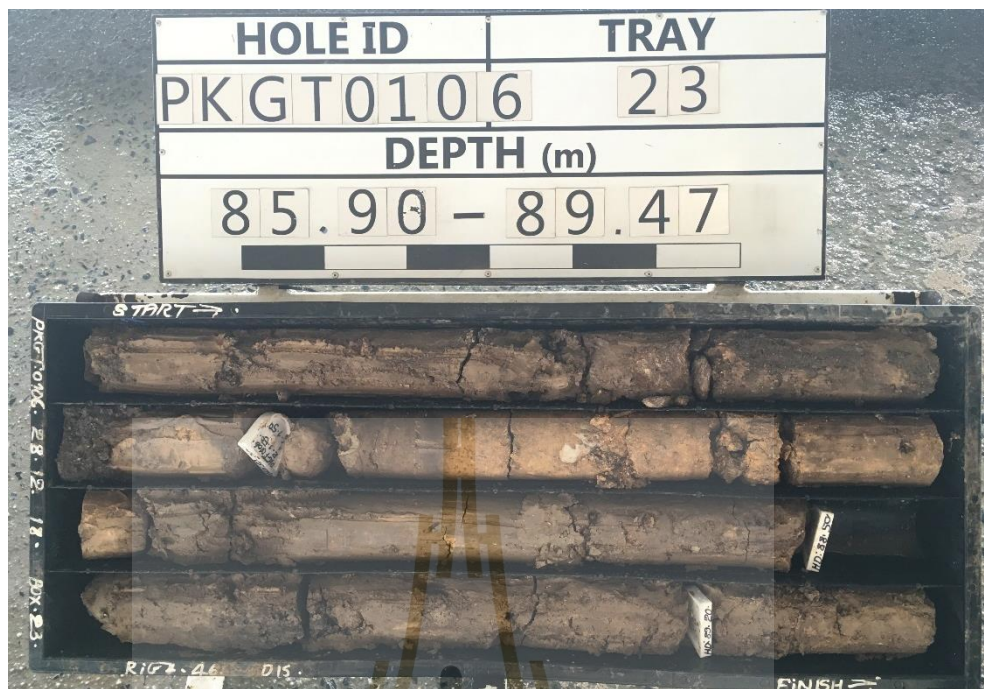
Figure 3.4 Fault samples

Three soil samples of fault for DS-soil test are collected. They are packed in plastic wrap to minimize disturbance, following the ASTM D3080 standard practice.

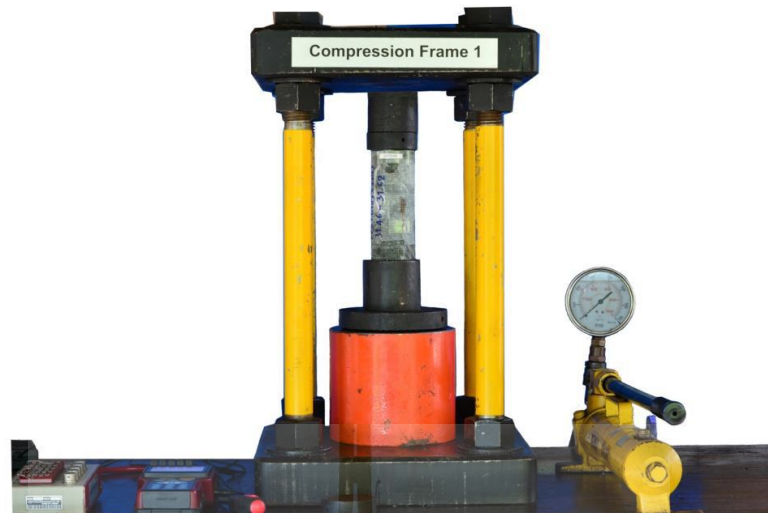
Figure 3.5 Uniaxial compressive strength test frame.

Rock strength or compressive strength of the joint walls is required as data input in numerical simulations. The laboratory testing procedure strictly follows the American Society for Testing and Materials (ASTM D7012-14). Compression load frame is shown in Figure 3.5. Cylindrical specimens of VTF and SLR with a diameter of 61 mm and L/D ratio between 2.0 to 2.5 are axially loaded to failure. Twenty-six VTF and twenty-seven SLR specimens have been tested. The UCS is calculated from the maximum load divided by the initial cross-sectional area. The elastic modulus (Young's modulus) is determined from the stress-strain curves at 50% of the maximum stress. Figures 3.6 and 3.7 show some pre-test and post-test of VTF and SLR samples. Figures 3.8 and 3.9 present the stress-strain relationships of some UCS test results. Sample dimensions and test results are summarized in Tables 3.1 through 3.4.

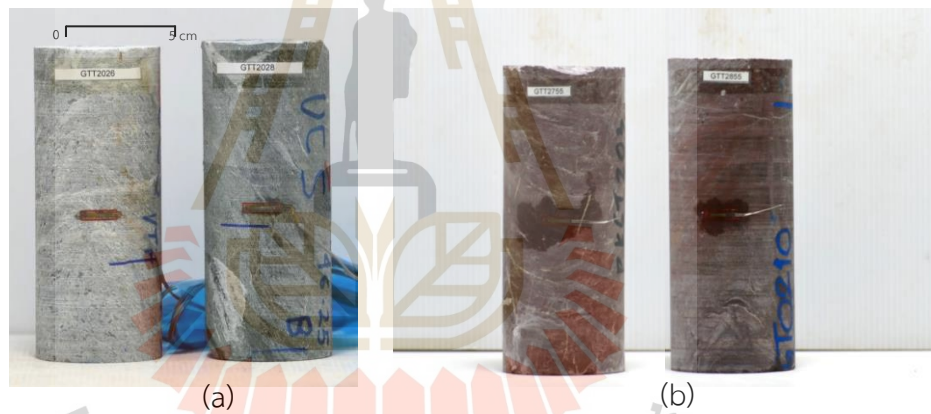
Figure 3.6 Some VTF (a) and SLR (b) specimens prepared for UCS testing.

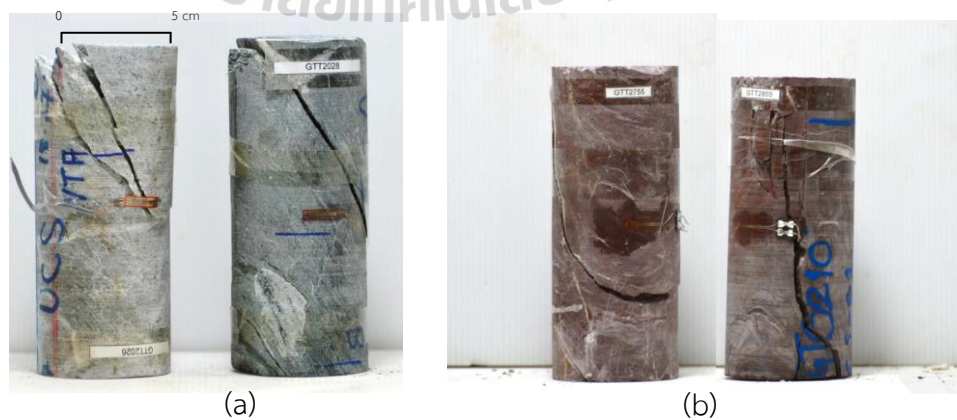
Figure 3.7 Post-test VTF (a) and SLR (b) specimens of UCS testing.

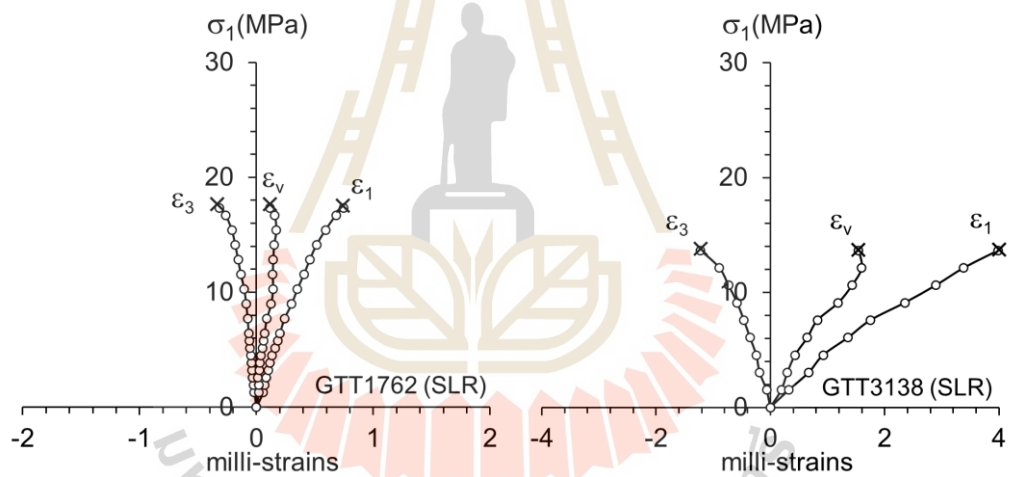
Figure 3.9 Some stress-strain curves of uniaxial compression test (SLR).

Sample No.	Strength (MPa)	Elastic Modulus (GPa)	Poisson's Ratio	Mode of Failure
GTT1730	93.1	25.5	0.22	Longitudinal Spitting
GTT1756	38.5	18.0	0.26	Weak Plane Failure
GTT1760	22.4	11.3	0.30	Weak Plane Failure
GTT1761	7.9	7.0	0.17	Weak Plane Failure
GTT1762	3.8	4.1	0.21	Weak Plane Failure
GTT1792	2.5	11.1	0.25	Weak Plane Failure
GTT1906	11.2	25.2	0.22	Weak Plane Failure
GTT1907	5.7	3.2	0.26	Weak Plane Failure
GTT1908	8.3	4.7	0.25	Longitudinal Spitting
GTT1909	4.4	5.6	0.23	Weak Plane Failure
GTT1920	5.7	6.1	0.22	Shear Failure
GTT1980	8.2	7.1	0.22	Weak Plane Failure
GTT1981	5.1	7.5	0.28	Weak Plane Failure
GTT1998	20.5	19.8	0.25	Weak Plane Failure
GTT2000	22.4	15.0	0.24	Longitudinal Spitting
GTT2002	3.0	9.0	0.10	Weak Failure
GTT2004	39.4	22.2	0.13	Longitudinal Spitting
GTT2005	13.7	4.4	0.28	Longitudinal Spitting
GTT2006	8.7	15.9	0.27	Weak Plane Failure
GTT2031	17.3	26.1	0.24	Longitudinal Spitting
GTT2032	17.3	26.6	0.22	Longitudinal Spitting

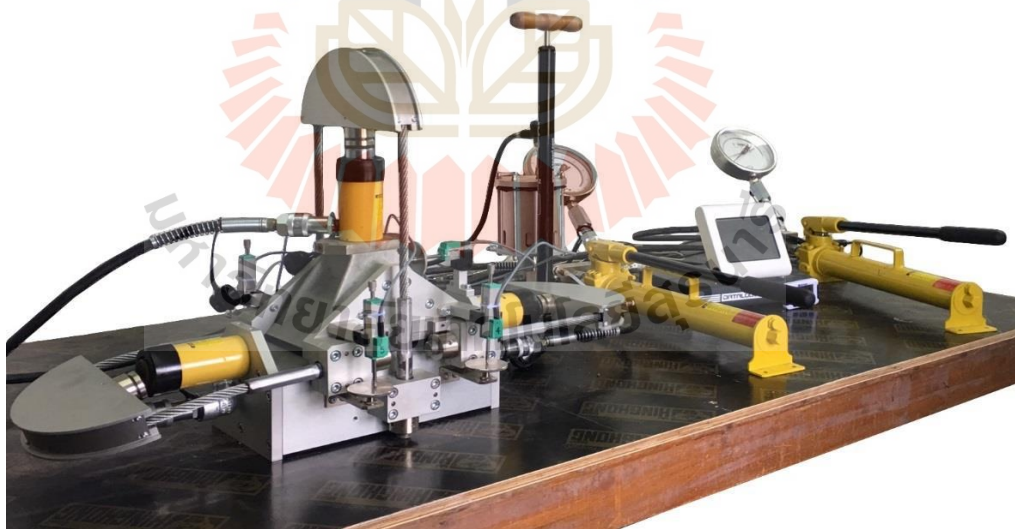
Figure 3.10 Direct shear test frame

Nine pairs of VTF specimens and nine pairs of SLR specimens with a nominal length 10 cm contain discontinuities (i.e., bedding, joint), and are separated into upper and lower halves of the encapsulated cement molds. The shear displacement is applied under constant rate of 0.2 mm/min. A minimum of 10 sets of monitoring and recording data points is suggested to be taken before obtaining the peak shear strength. The loading continues until a residual shear strength is established. Post-test VTF and SLR specimens are shown in Figure 3.11 and 3.12. Figure 3.13 and 3.14 show the stress-displacement relationships of some DS test results. Sample dimensions and test results are summarized in Table 3.5 through 3.8.

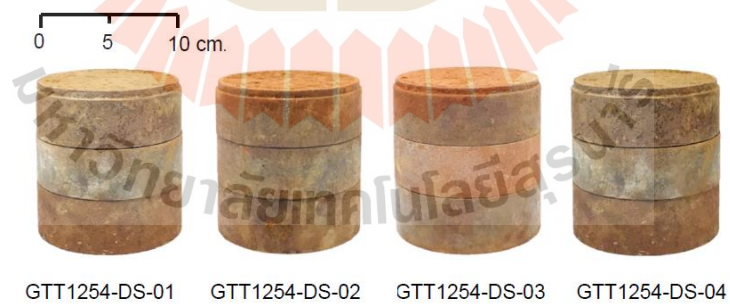
Figure 3.18 Soil samples before testing

A set of direct shear tests on compacted soil samples has been conducted on fault samples. After compaction, the soil samples are placed and set up in a direct shear load box and frame (Figure 3.17). All samples are sheared under a constant displacement rate of 0.1 mm/min. Figures 3.18 and 3.19 show pre-test and post-test of soil direct shear test. Normal stresses are determined from in-situ pressures. The sample descriptions and test results are shown in Tables 3.10 and 3.11.

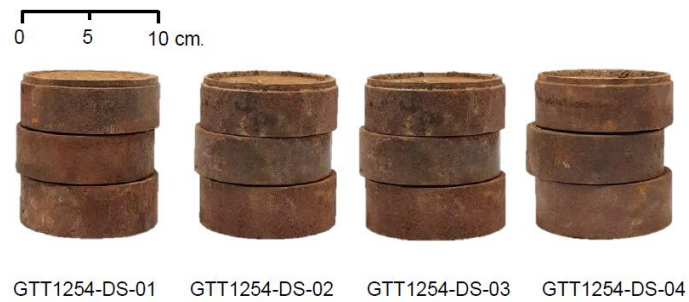
Figure 3.19 Soil samples after testing

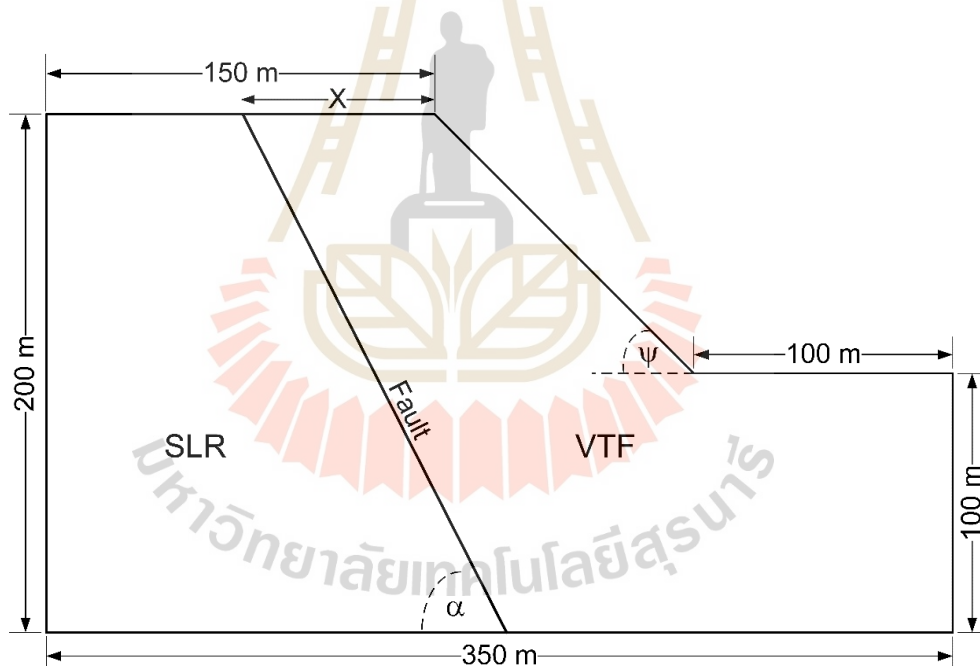
Figure 4.1 Boundary conditions and geometry of the representative slope model.

The slope height, fault width, and fault angle are maintained constant at 100 m, 10 m and 63 degrees. The distance between the toe and right boundary is 100 m and between the crest and left boundary is 150 m. The cohesion and friction angle of VTF (hanging wall) are assumed in models to determine effect of shear strength and maintained constant shear strength of SLR (footwall) and fault. The test variables include slope face angle (ψ), distance X , fault angle (α), hanging wall cohesion (c_{hang}) and friction angle (ϕ_{hang}), as shown in Table 4.2. Initial stress due to gravitational loading is first calculated from the density of the overburden. All computer models assume plane strain condition. To cover the entire range of the slope dimensions, over 3,000 triangular elements have been performed to obtain correct simulation results. The data iteration of about 19,600 cycles are performed. Figures 4.1 and 4.2 illustrate representative boundary conditions and meshes of slope model.

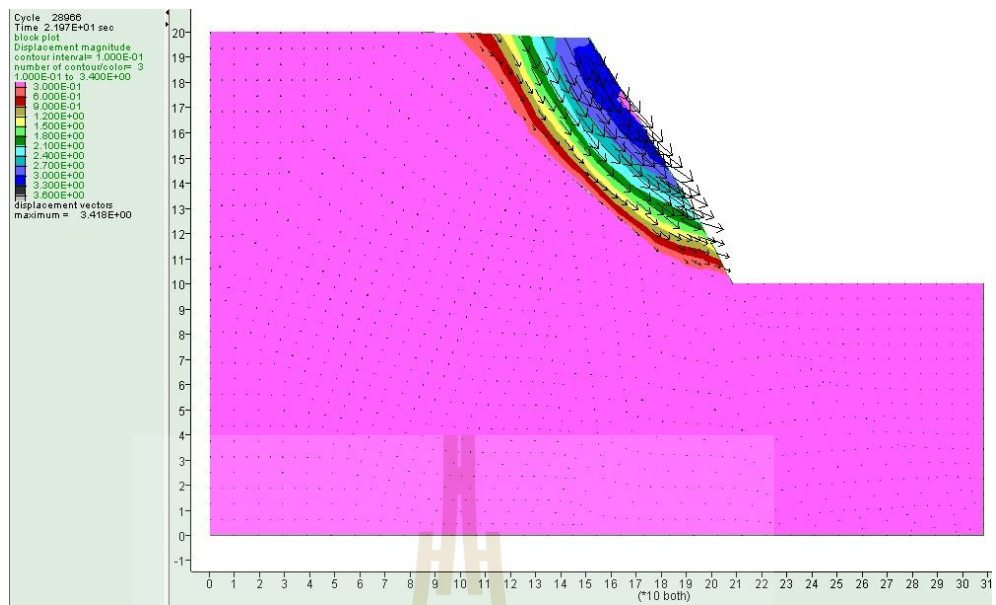
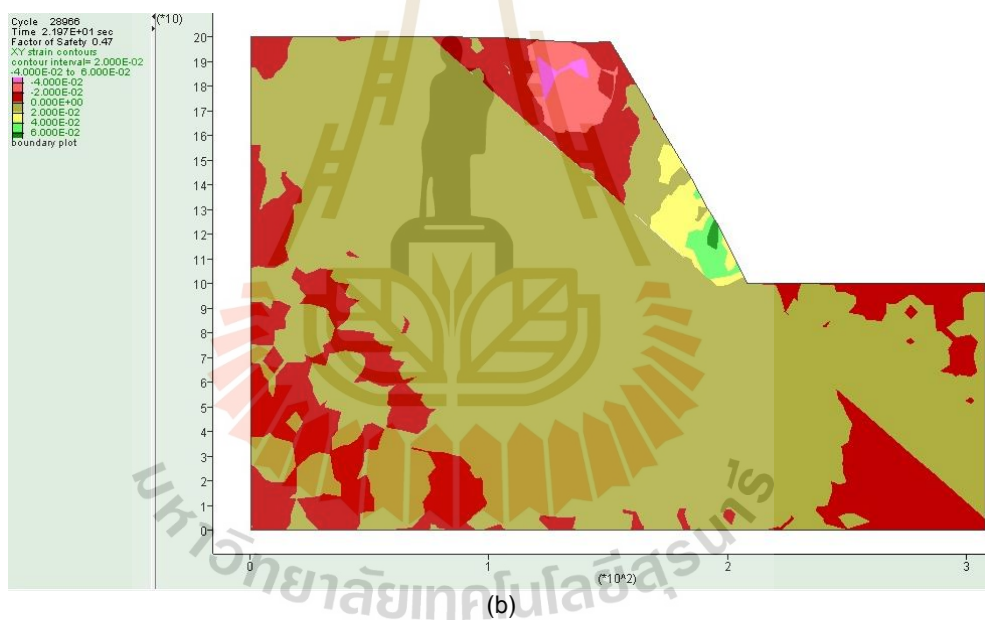
Figures 4.9 Displacement vectors (a), shear strains and factor of safety (b) of fault angle 40 degrees.

The fault angle (α) are varied from 40, 50, 63, 70 and 80 degrees. The slope height and slope face angle are constant at 100 m and 60° , respectively. The mechanical properties of footwall, hanging wall and fault are maintained constant. Figures 4.9 and 4.10 show displacement vectors, shear strains and factor of safety of α 40 and 80 degrees, respectively. Figure 4.11 shows the factor of safety (FS) as a function of α . The results indicate that α is not sensitive to the FS.

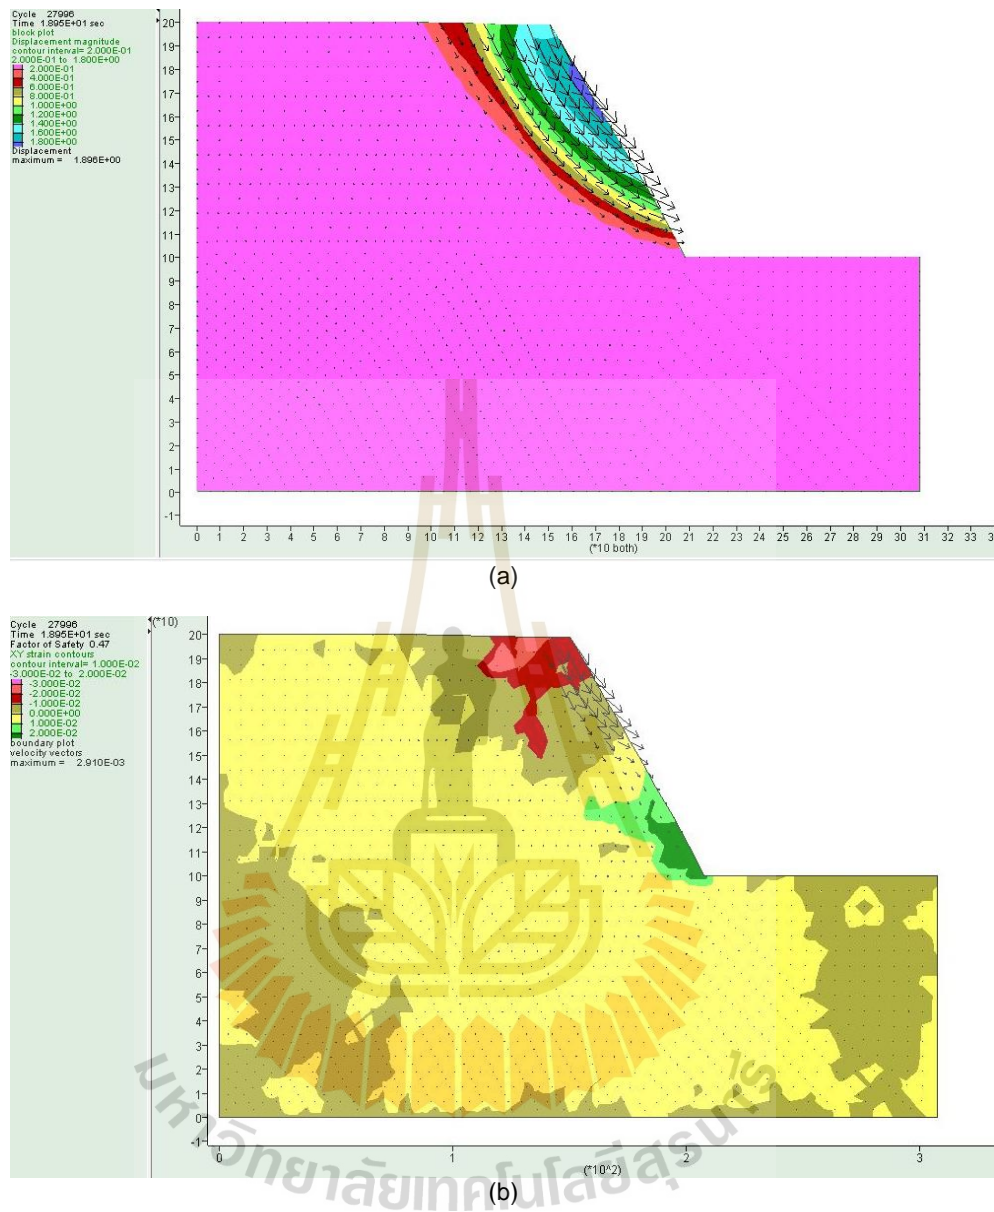
Figures 4.12 Displacement vectors (a), shear strains and factor of safety (b) of c_{hang} 0.01 MPa.

The cohesions of hanging rock (c_{hang}) are assumed varying from 0.01, 0.05, 0.10, 0.20, 0.30, 0.50, 1.00 to 2.00 MPa. The friction angles (ϕ_{hang}) are varied from 22.5°, 25.0°, 28.4°, 30.0°, 32.5° to 35°. The slope face angle and height are constant at 60° and 100 m, respectively. The mechanical properties of footwall and fault are constant. Figures 4.12 and 4.13 show displacement vectors, shear strains and factor of safety of c_{hang} 0.01 and 2.00 MPa, respectively. Figures 4.14 and 4.15 show displacement vectors, shear strains and factor of safety of ϕ_{hang} 22.5 and 35.0 degrees, respectively. Figure 4.16 illustrates FS as a function of ϕ_{hang} under various c_{hang} . The results show that FS increase with increasing ϕ_{hang} and c_{hang} . The results are consistent with Abramson et al. (2001), Muthreja (2012), Coulibaly et al. (2017) and Kumnadi (2017) that increasing of both strength parameters (cohesion and friction angle) have been reported to increase the slope stability.

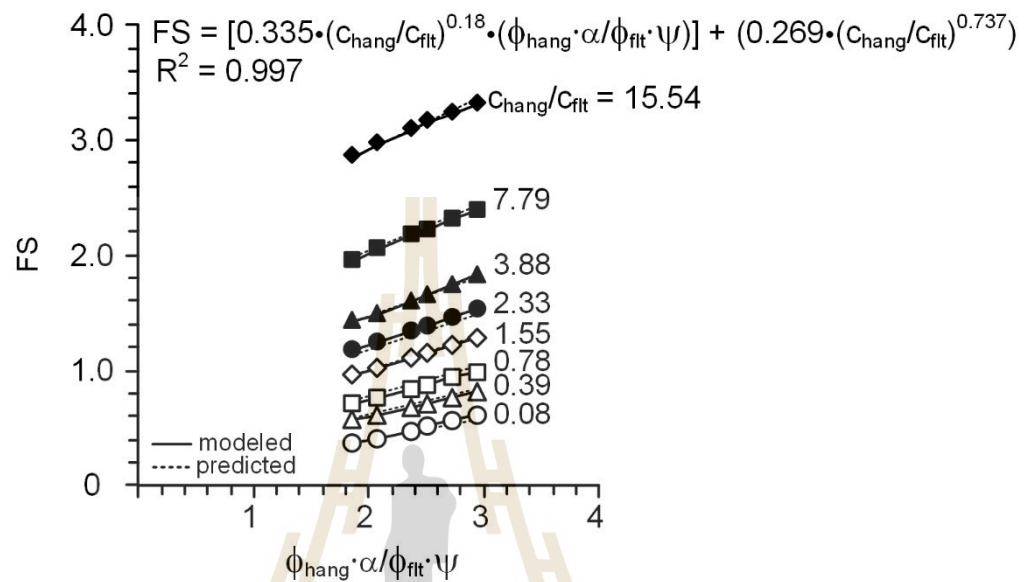
Figure 4.17 Predicted FS as a function of $\phi_{hang} \cdot \alpha / \phi_{fit} \cdot \psi$ under various C_{hang}/C_{fit}

The empirical constants in the equation above are generated from the linear regression analysis of the model simulation results. The R^2 of 0.997 indicates a good correlation with the data.
