**PERFORMANCE EVALUATION OF PAVEMENT  
REHABILITATION BY POLYURETHANE FOAM  
INJECTION : A CASE STUDY OF CONCRETE ROADS  
IN SURANAREE UNIVERSITY OF TECHNOLOGY**

**Sangey Pasang**

**A Thesis Submitted in Fulfillment of the Requirements for the**

**Degree of Master of Engineering in Transportation**

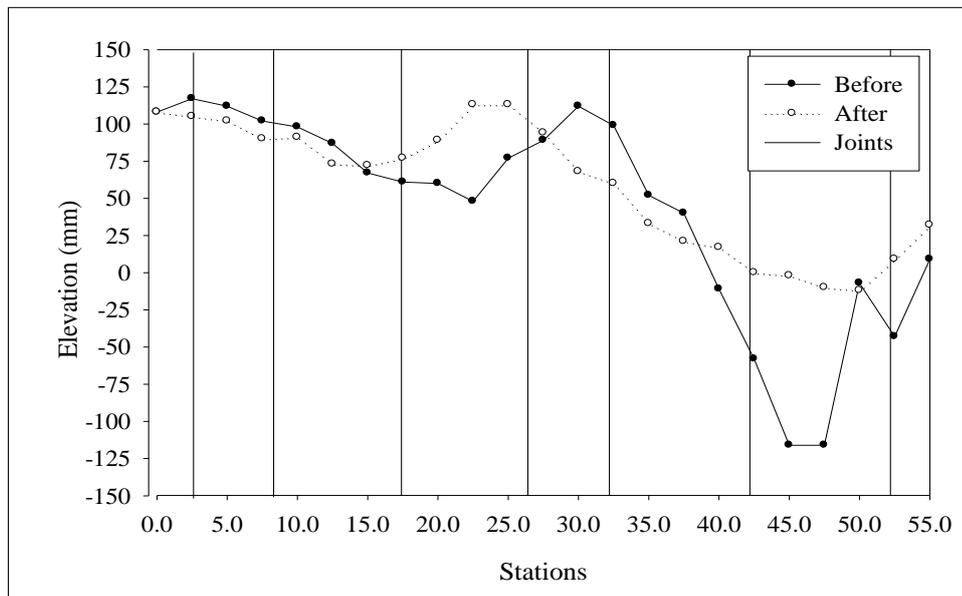
On July 19<sup>th</sup> 2009, a day before the polyurethane foam injection, profile level of the road section was carried out and another level was taken just after the injection. It was found that pavement was lifted by the polyurethane foam by a maximum lift of 114 mm at the middle of the lane through 45 m distance from the beginning of the section (i.e. station 0.0) as shown in Figure 4.3. For left and right lane, there was a maximum lift of 79 mm and 99 mm respectively at station 47.5 m. In addition, settlements of pavement were also noticed at certain areas just next to sections lifted by polyurethane foam. The maximum settlement for the right lane was 66 mm at station 37.5 m, 44 mm for the middle at station 30 m and 42 mm for left lane at station 37.5 m. The settlement might be because of some hard support acting as pivot which transfers lifts at one section to settlement at another end.

**Figure 4.3** Profile leveling before and after polyurethane foam injection on the middle of lanes of Withayawithee 2 Road.

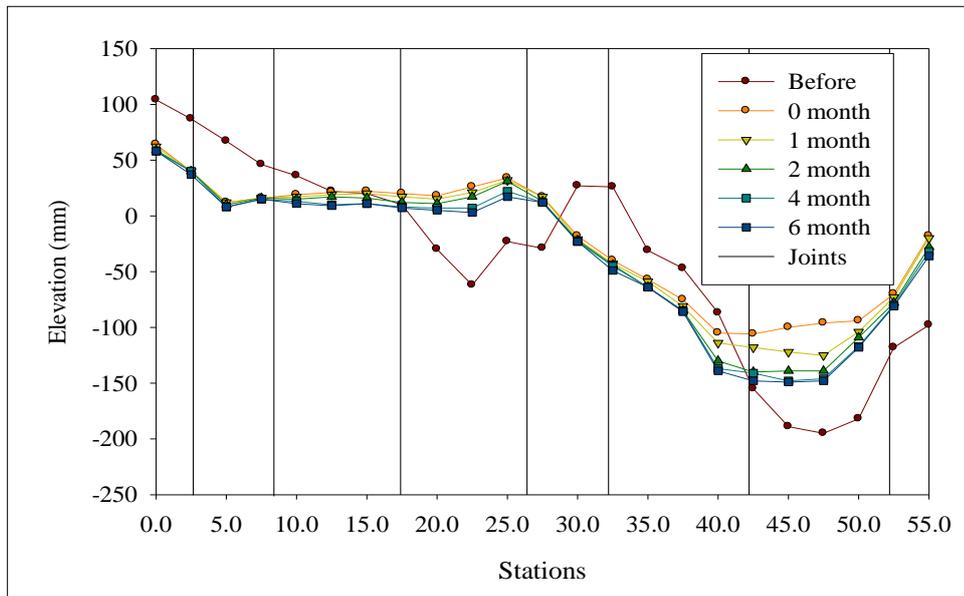
The pavement profile measurements were carried out multiple times during the period of 6 months and the conclusion drawn from the data were inconsistent. There were minimal settlements of 2 mm at the left lane and middle of lanes. As for the right lane, large amount of settlement was observed with maximum of 52 mm at station 47.5 m as shown in Figure 4.4. The settlements were more at the right lane because loaded trucks for ongoing construction passed through the right lane while the return trip of empty trucks were through the left lane. Figures 4.5 and 4.6 showed the differential settlement of the road section during the study period. In Figure 4.5, a large settlement was caused by disturbance to the station marked. The additional graphs from this site location were attached in Appendix (A).

**Figure 4.4** Settlements on right lane of Withayawithee 2 Road during the study period.

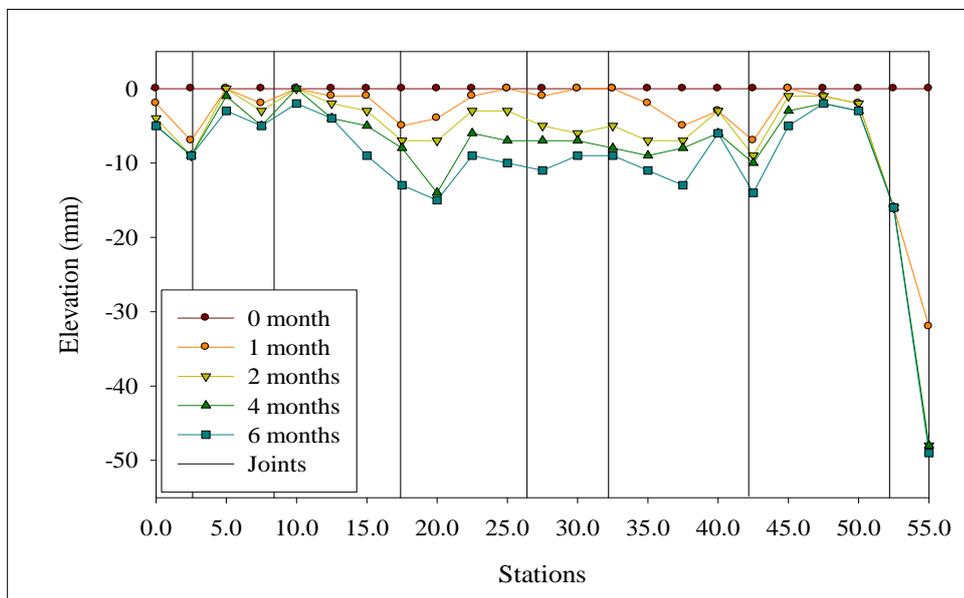
**Figure 4.5** Differential settlement on left lane of Withayawithee 2 Road during the study period.

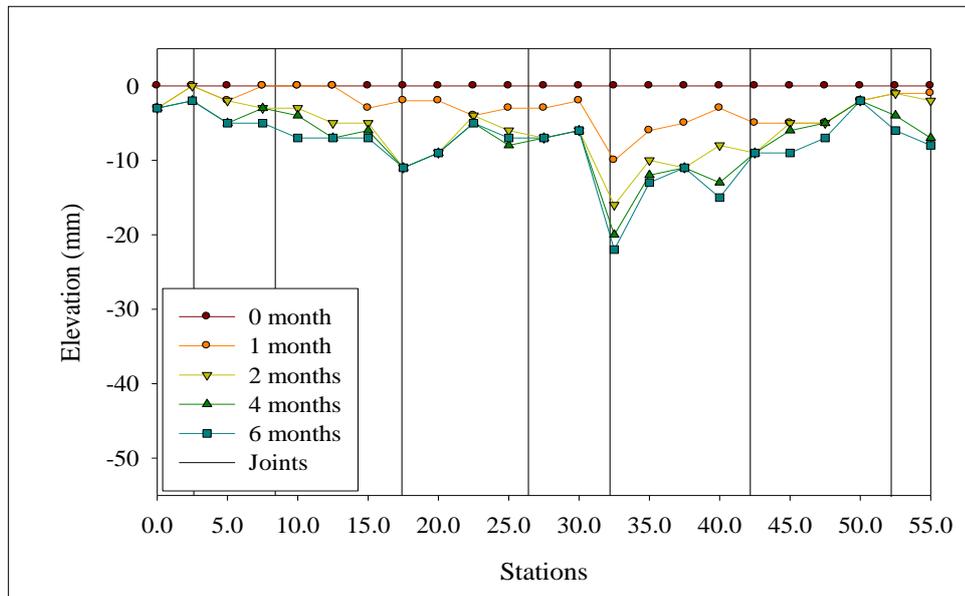
**Figure 4.6** Differential settlement at the middle of lanes of Withayawithee 2 Road during the study period.

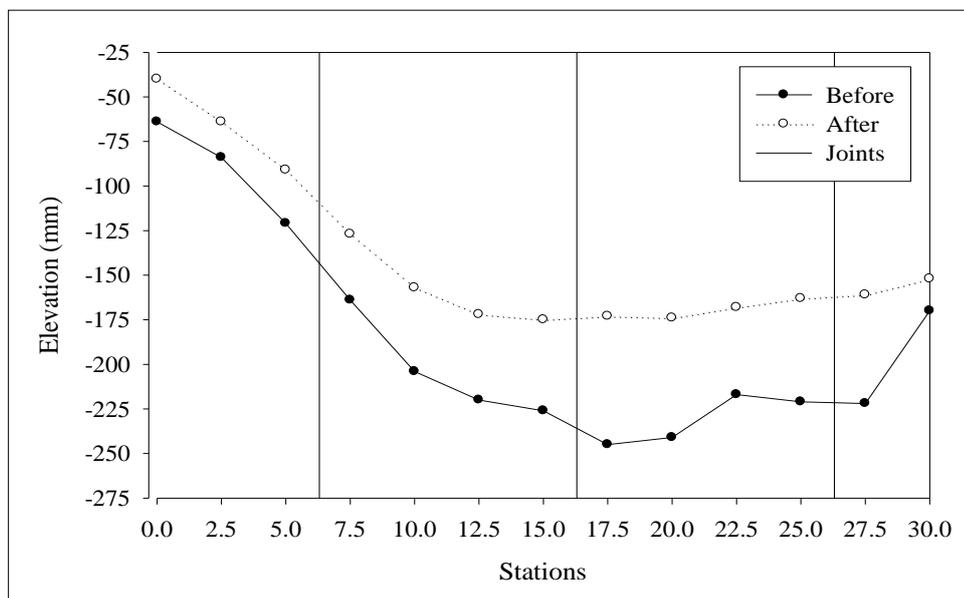
The distressed section on Withayawithee 3 Road, on July 14<sup>th</sup> 2009, was injected with polyurethane foam to rehabilitate the pavement and to improve the ride quality. The polyurethane foam lifted the pavement and there was improvement to the ride quality. To measure the performance of polyurethane foam injection, before and after the injection, the profile level was measured. Figure 4.7 shows the lift provided to pavement by the injection.

**Figure 4.7** Profile leveling before and after polyurethane foam injection at right lane of Withyawithee 3 Road.

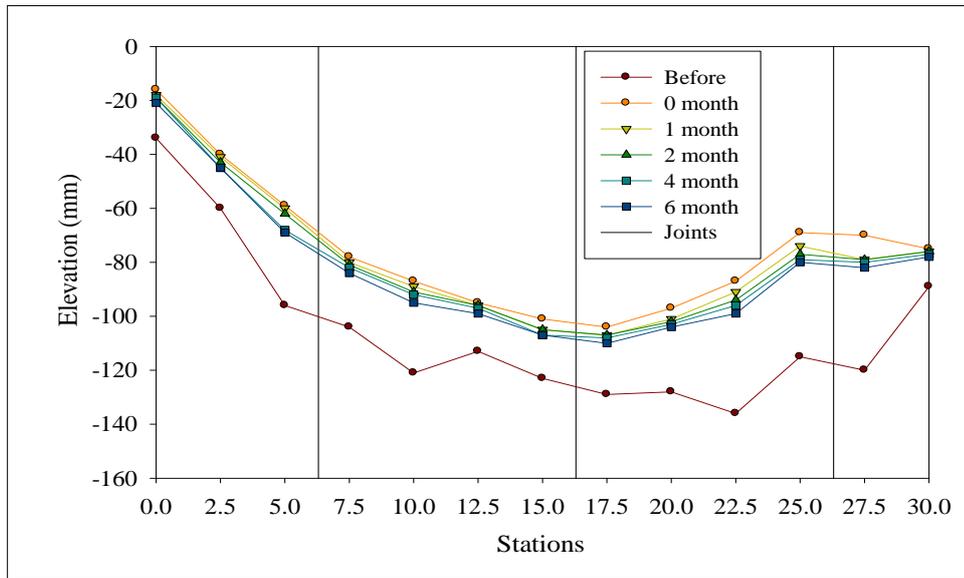
**Figure 4.8** Settlements at the middle of lanes of Withayawithee 3 Road during the study period.

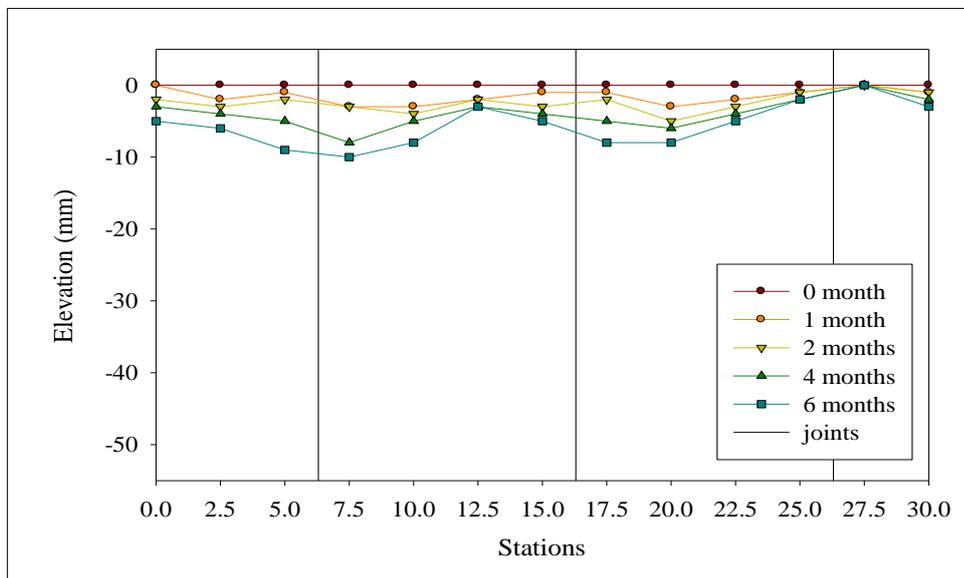
During the six months of observations of the pavement leveling, a maximum settlement of 12 mm was found at the middle of lanes and right lane at station 22.5 m and station 10.0 m respectively, whereas 10 mm settlement was seen at station 25.0 m on right lane. Minimum of 2 mm settlement was observed in all the stations except on one station at the left lane as shown in Figure 4.9.

**Figure 4.9** Differential settlement on the left lane of Withayawithee 3 Road during the study period.

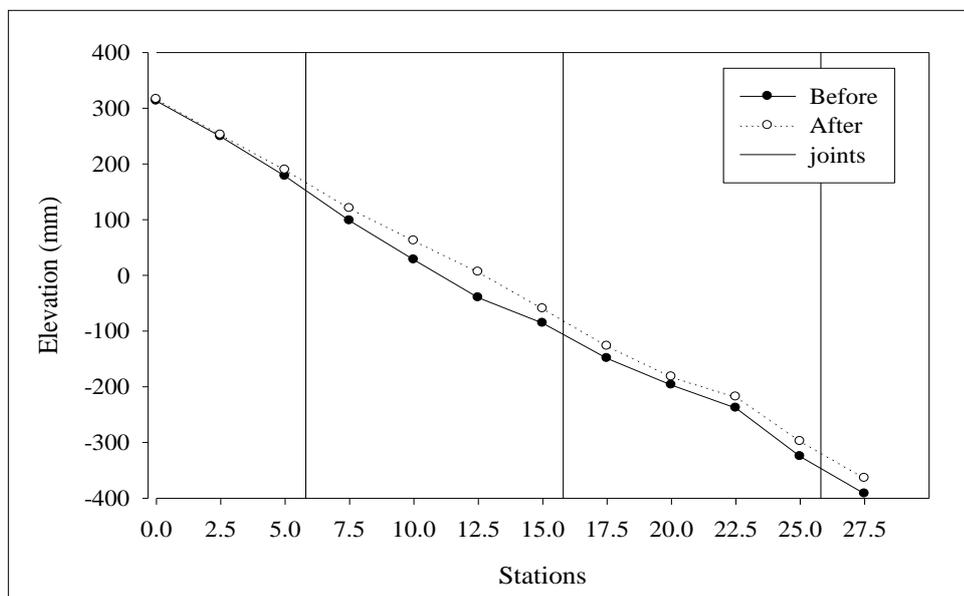
On July 12<sup>th</sup> 2009, the first road in Suranaree University to experience polyurethane foam injection was Sikkhawithee 1(a) Road. To evaluate the settlement of the road, surveys were conducted and the results were given in the following paragraphs. The survey before/after the injection shows that the pavement has been lifted and aligned to a desired level as in Figure 4.10.

**Figure 4.10** Profile leveling before and after polyurethane foam injection on the right lane of Sikkhawithee 1(a) Road.

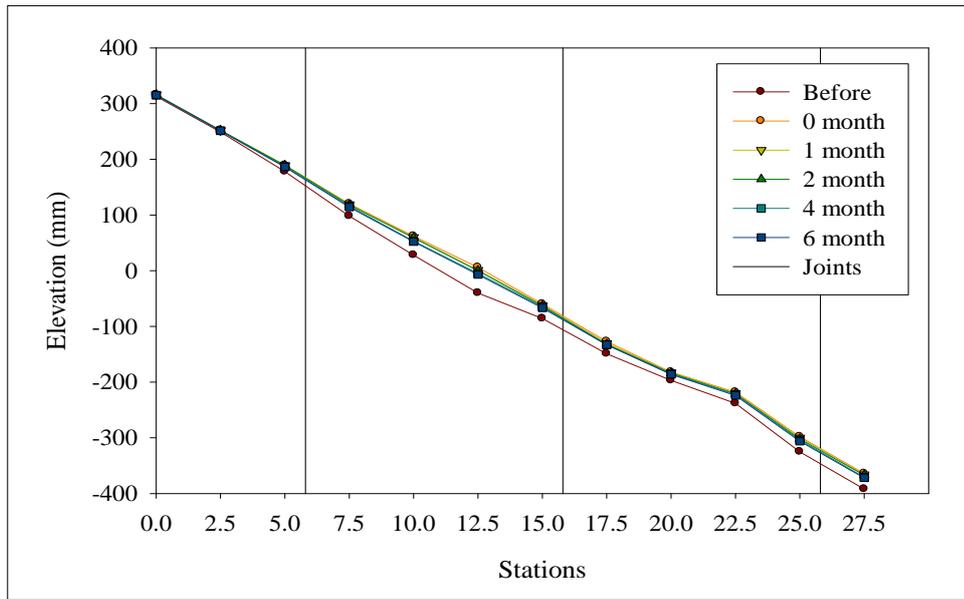
Figure 4.11 and 4.12 show the settlement during the study period as profile level and differential settlement. Settlements at the middle of lanes show maximum of 13 mm at station 12.5 m. It was also observed that all the stations suffer at least 2 mm of settlement.

**Figure 4.11** Settlements on the right lane of Sikkhawithee 1(a) Road during the study period.

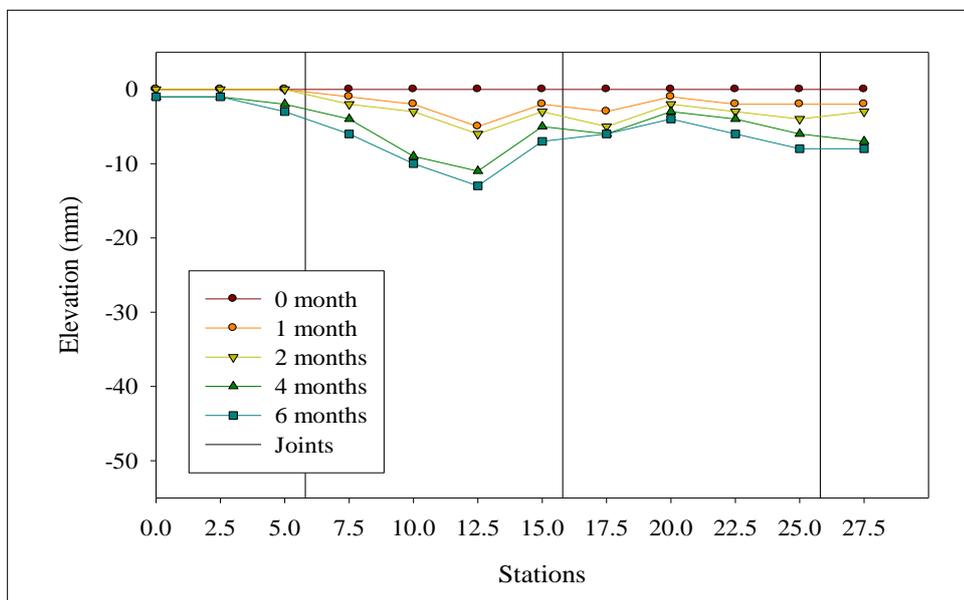
**Figure 4.12** Differential settlement on the middle of lanes of Sikkhawithee 1(a) Road during the study period.

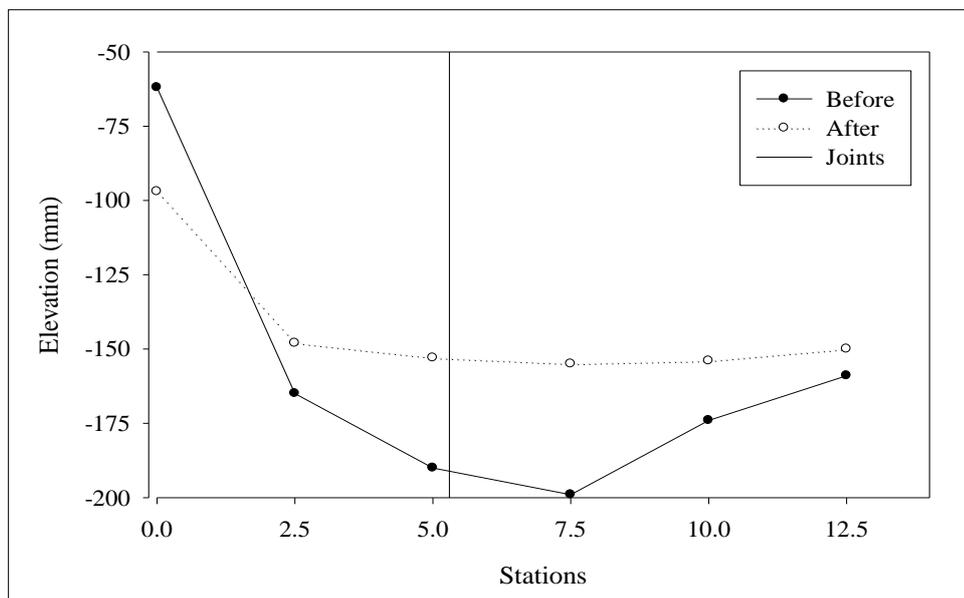
There was a maximum raise of 44 mm on the middle of the lanes at station 7.5 m and a 42 mm raise of pavement on right lane at station 5.0 m while on left lane there was 39 mm raise at station 7.5 m. The Figure 4.13 shows the raise in the pavement and portions of settlements during the polyurethane foam injection. This might be due to the same reason as stated at Withayawithee 2 Road.

**Figure 4.13** Profile leveling before and after polyurethane foam injection at the middle of lanes of Sikkhawithee 1(b) Road.

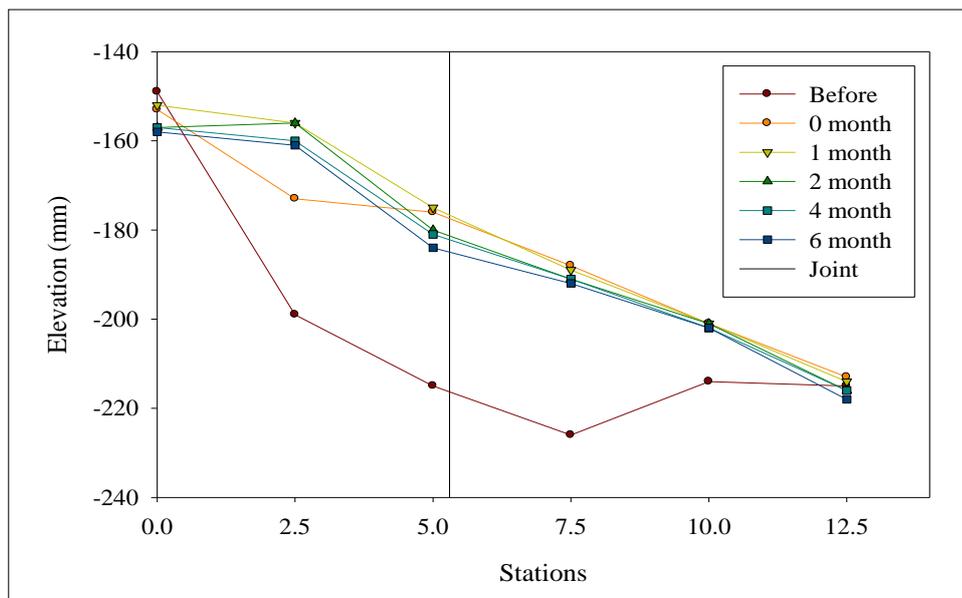
**Figure 4.14** Settlements on the left lane of Sikkhawithee 1(b) Road during the study period.

The settlement during the study period was varying from 3 mm to 9 mm with highest on the middle of lane at station 12.5 m followed by 8 mm settlement on the left lane at station 5.0 m. There was a sudden lift in the pavement between the 0<sup>th</sup> month and the first month and this was due to the pavement repair stitching. However, after the first month a gradual minimal settlement was observed. Figure 4.14 shows the disruption in the graph by the pavement stitching along with the settlements at different stations while Figure 4.15 shows a differential settlement on the right lane of the road.

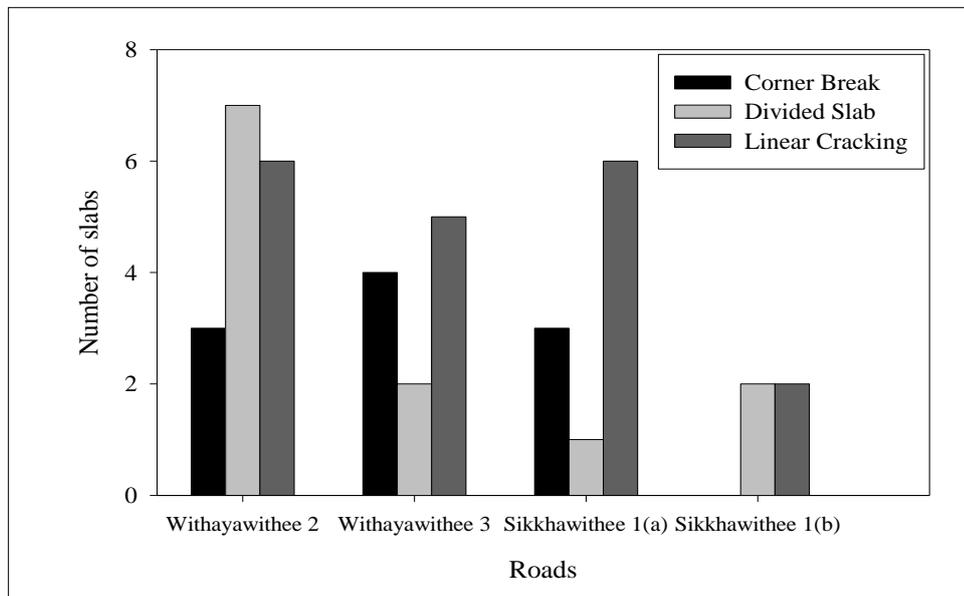
**Figure 4.19** Number of slab affected by distresses at each site.

From the Figures 4.19 and 4.20, it is clear that Withayawithee 2 Road suffered mainly from divided slab while Withayawithee 3 Road and Sikkhawithee 1(a) Road suffered from linear cracking. All the sites contain corner breaks except at Sikkhawithee 1(b) Road with equal number of slabs suffering divided slab and linear cracking.

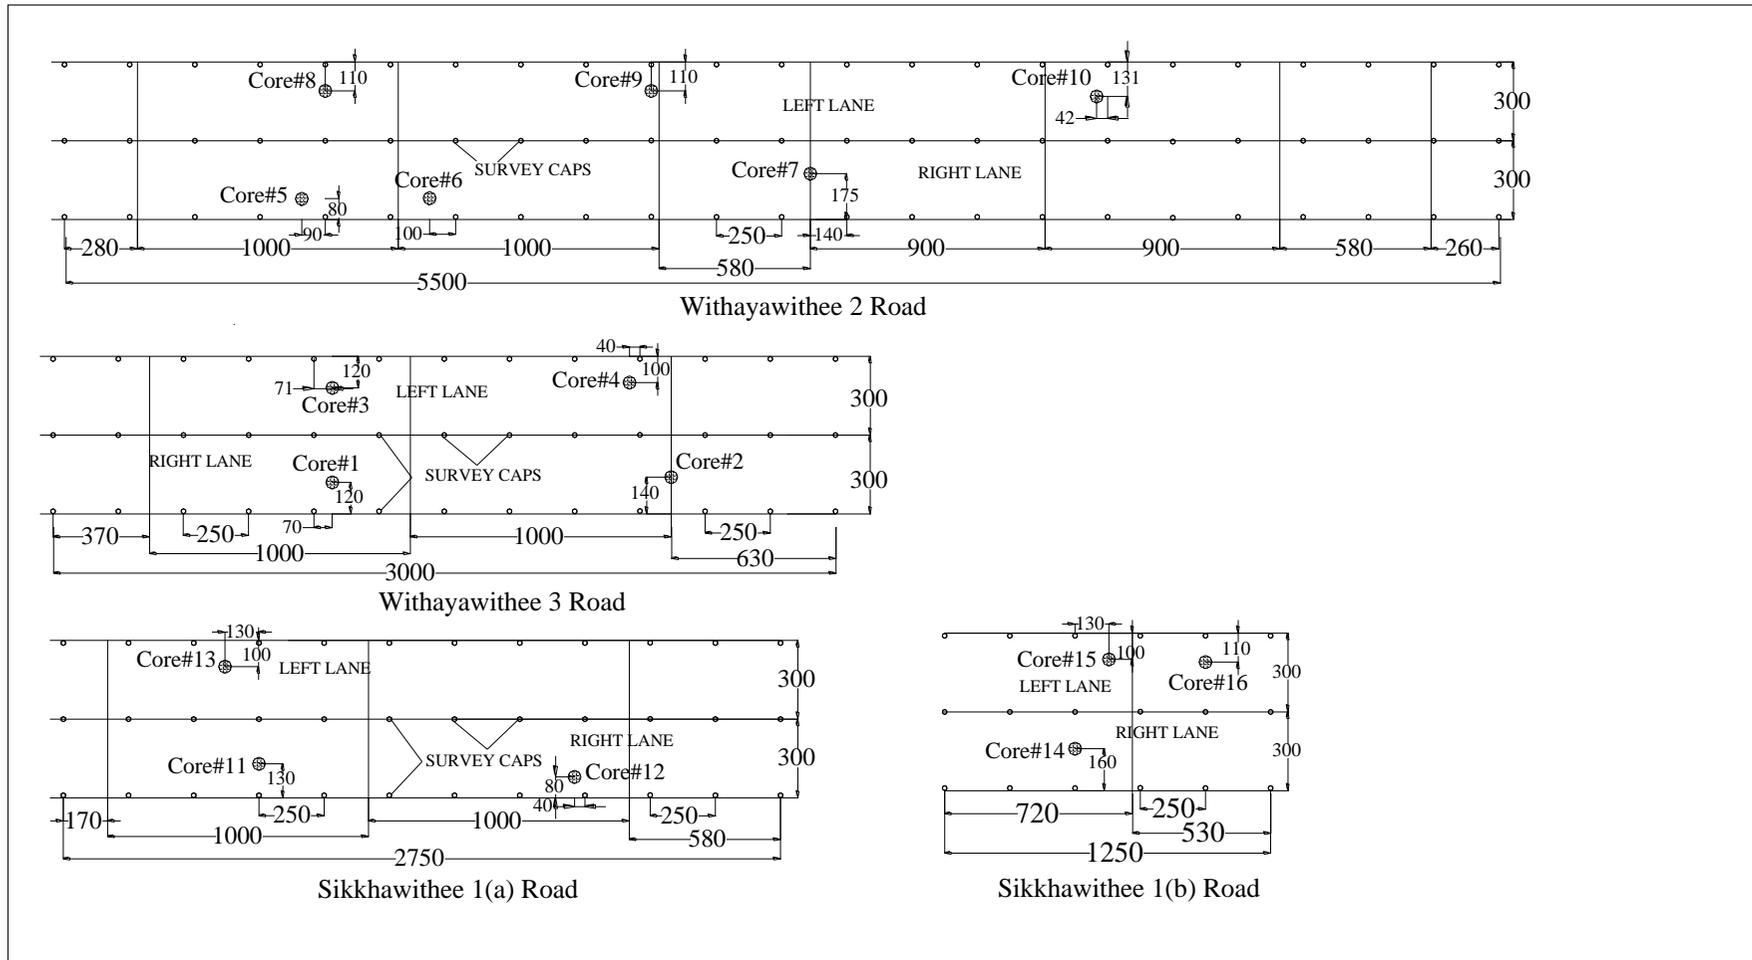
**Figure 4.21** Layout of the core locations at each site locations.

Several 10.0 cm diameter concrete cores were extracted from the study sites for the purposes of conducting DCP testing and to study the conditions of the pavement and the polyurethane foam. Three cores each from Sikkhawithee 1(a) and 1(b) road, 4 cores from Withayawithee 3 Road, and 6 cores from Withayawithee 2 Road were extracted. The layout of the core locations are shown in Figure 4.21. The number of cores extracted from each sites were estimated depending on the differential settlement and the distresses on the pavement sections. These cores were measured to determine the thickness of pavement at the coring locations and studied the location of steel reinforcements found on the cores. The cores extraction also confirmed diameters of the tie bar and the dowel bar along with the diameter of the steel reinforcement. Moreover, coring confirmed the presence of the polyurethane foam beneath the pavements.

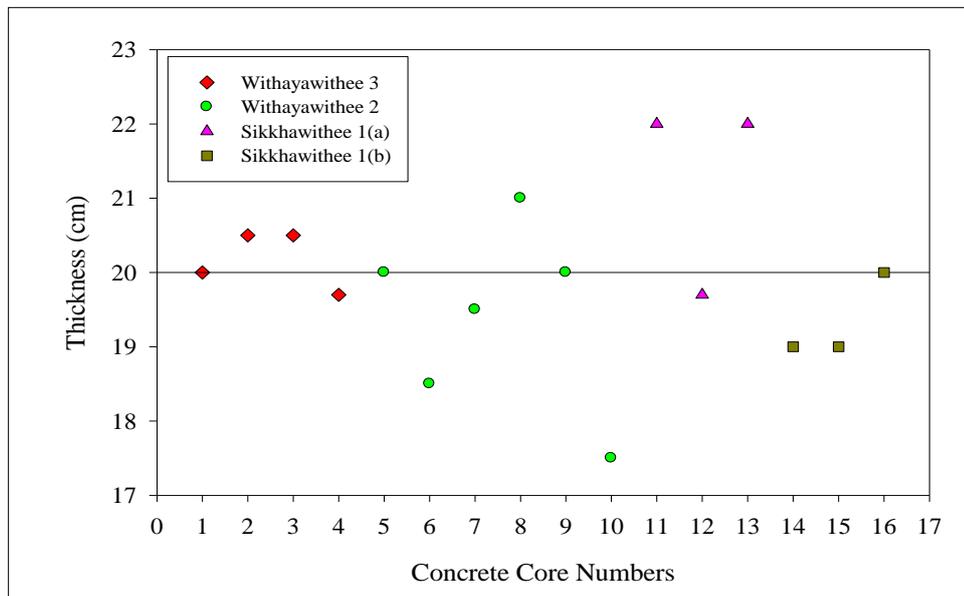
**Figure 4.22** Variation of concrete core thickness.

The designed thickness for the existing concrete pavement was 20.0 cm and the extracted cores deviated considerably from this value. The thickness of the cores across all four sites varied from 17.5 cm to 22.0 cm, however a mean thickness 19.9331 cm was found throughout the sections. It was noted that the cores from Withayawithee 2 Road had lesser number of cores, thinner than the designed thickness while the cores from Sikkhawithee 1(a) Road had more cores thicker than the designed thickness. The cores from Withayawithee 3 Road and Sikkhawithee 1(b) Road had more core equivalent to the designed value. Figure 4.22 shows the variation of thickness for all the cores from the designed value. Table 4.2 illustrates the cores from the respective site locations and the mean core thickness of each site location. Graphs showing the mean thickness of cores at each site are given in Appendix (C).

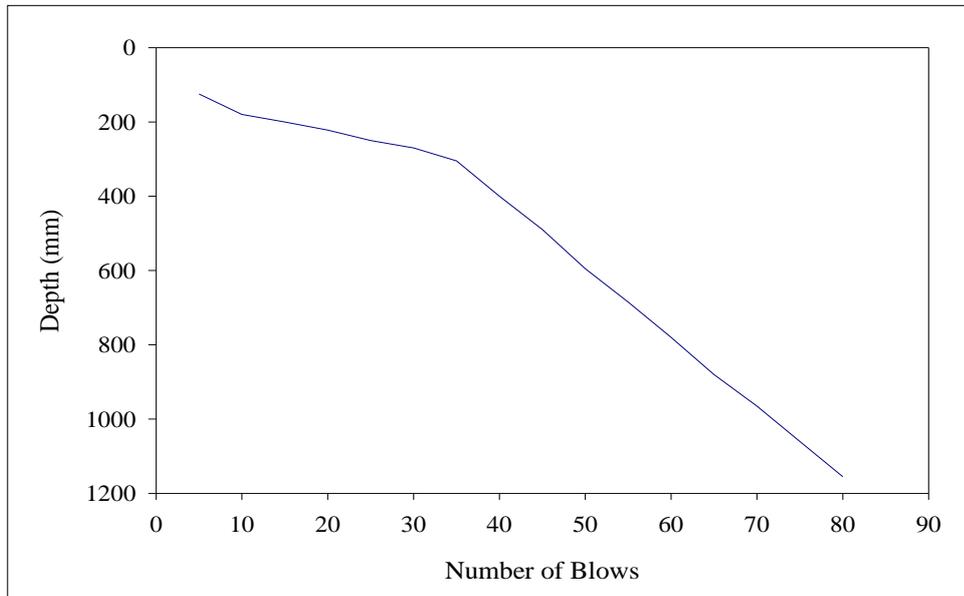
**Figure 4.27** Blow vs. depth graph for Core #1 at Withayawithee 3 Road.

On March 20<sup>th</sup> and 21<sup>st</sup>, 2010 the subgrades of the four rehabilitated roads were examined using manual Dynamic Cone Penetrometer, as described in the previous chapter. The DCP testing was conducted on the exposed subgrade by the coring and the data of number of blows and penetrated depth for each blow were recorded. Out of 16 DCP tests couples of tests have extraneous data due to the existence of hard surface in the subgrade. The Penetration Index (PI) which indicates the support condition under the concrete slab was computed from the data recorded, and plots were constructed. The plots showed a non-uniformity of the subgrade soils, which was common throughout all section as shown in Figure 4.27 and Figure 4.28 showing Blow vs. depth plots for Core#1 at Withayawithee 3 Road and PI vs. depth for Core#9 at Withayathe 2 Road respectively.

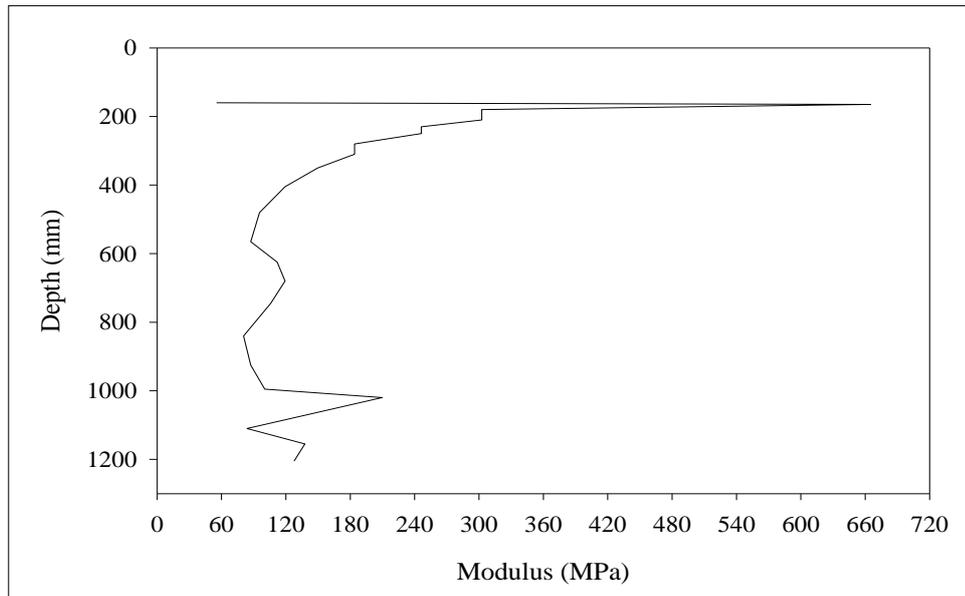
**Figure 4.29** Modulus of subgrade reaction from Core#5 at Withayawithee 2 Road.

DCP tests from Withayawithee 2 Road contained some graphs displaying portions of extraneous data due to the presence of rocks in the subgrade as shown in Figure 4.29. However, it was observed that the modulus at upper portion of the subgrade was higher than the lower portion except for DCP test at Core#7 which was vice versa as shown in Figures 4.30 and 4.31. Core#7 was located at the faulted joint of the slab where more settlements were noticed. In addition, average modulus was only 98.8 MPa with modulus varying from 55 to 149 MPa at Core#7 whereas other areas have at least 120 MPa with each modulus more than 90 MPa. It might be because the subgrade at Core#7 areas was losing its stiffness at the upper portion due to scouring.

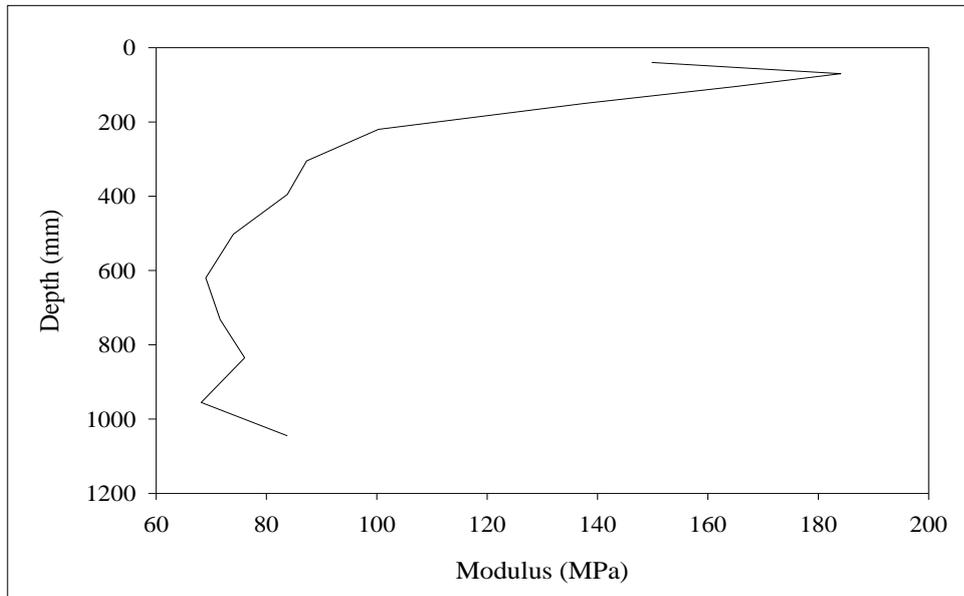
**Figure 4.32** Modulus of subgrade reaction from Core#4 at Withayawithee 3 Road.

In Withayawithee 3 Road, similar patterns of weak layer just around 30 cm beneath the pavement as show in Figure 4.32 were observed in all the four core locations. Moduli from all the four areas were almost same with average around 100 MPa and CBR around 17%.

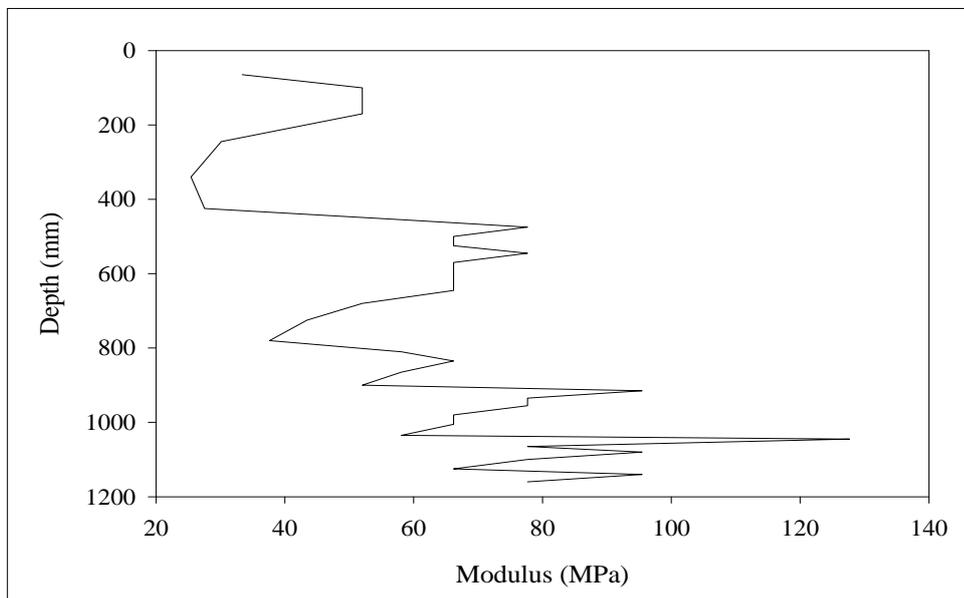
**Figure 4.33** Modulus of subgrade reaction from Core#13 at Sikkhawithee 1(a) Road.

The profile monitoring test showed lesser settlements at this location compared to Withayawithee 2 and 3 Road, however DCP test showed that the subgrade at this location were very weak with average CBR 7.9% and modulus 64.15 MPa at Core#13 (Figure 4.33). Other DCP test at this road showed slightly higher parameters without much significance.

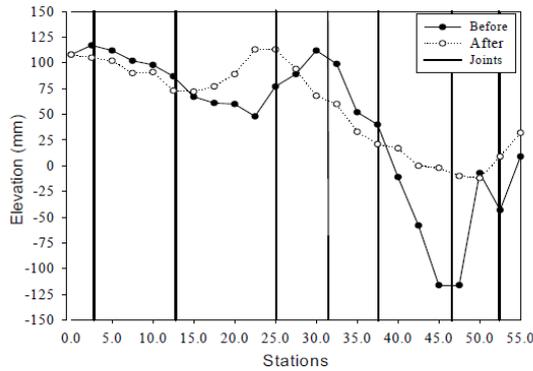
The PFI proved to be an effective method to lift and align the pavement to a desired level. Figure 2 showed the lift provided by the foam at Withayawithee 2 Road where the maximum lift was 114 mm on the middle of the lanes at 45 m from the beginning of the pavement section (i.e. station 0). In some part of the road, settlements were seen at some portions of the road while injecting polyurethane foam which may be due to presences of hard support acting as pivot which transfers lifts at one section to settlement in another.

**Figure 2:** Profile leveling before and after polyurethane foam injection on the middle of lanes of Withayawithee 2 Road.

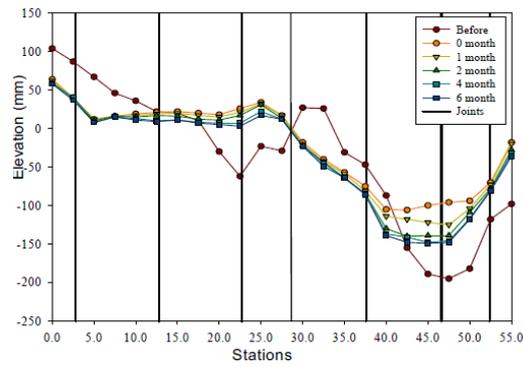
**Figure 3:** Settlements on right lane of Withayawithee 2 Road during the study period.

After six months of profile survey, maximum settlement was observed on the right lane of Withayawithee 2 Road with 52 mm as highest at station 47.5 m (Figure 3). In the other locations also settlements were noticed varying from 2-10 mm.

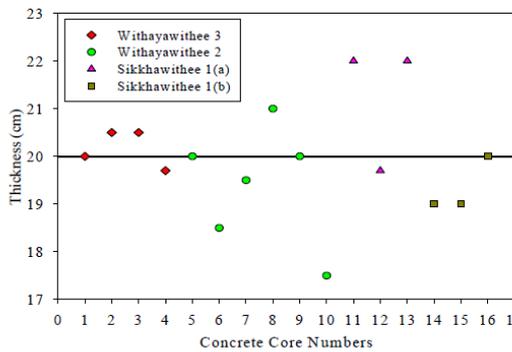
Even though designed thickness for the existing concrete pavement was 20 cm and the extracted cores deviated considerably from this value, the thickness of the cores across all four sites varied from 17.5 cm to 22 cm. However a mean thickness of 19.9331 cm was found throughout the sections.

**Figure 4:** The pavement thickness variation as per the cores from all the sites.

It was noted that the cores from Withayawithee 2 Road had lesser number of cores, thinner than the designed thickness while the cores from Sikkhawithee 1 (a) Road had more cores thicker than the designed

thickness. The cores from Withayawithee 3 Road and Sikkhawithee 1 (b) Road had more core equivalent to the designed value. The Figure 4 illustrated the variation of thickness for all the cores from the designed value.

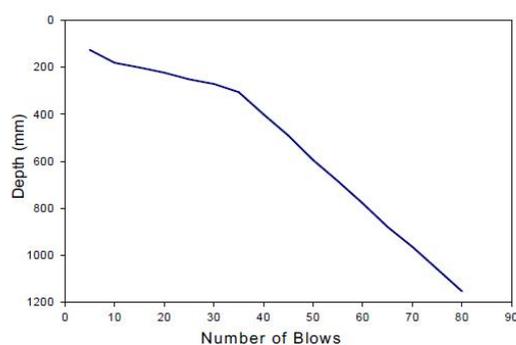
Figures 7 and 8 showed the non-uniformity of the subgrade soils, which was common throughout all section. The required number blow and the PI increased as the DCP went dipper.

**Figure 7:** Blow vs. depth graph for core #1 at Withayawithee 3 Road.

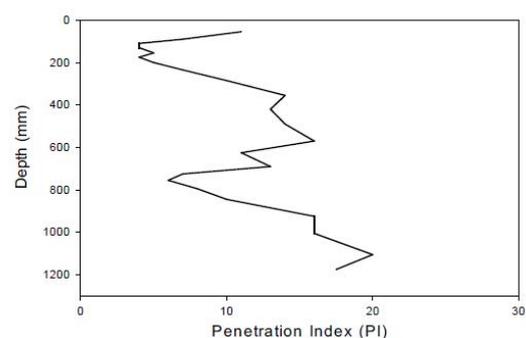
**Figure 8:** PI vs. depth graph for core #9 at Withayawithee 2 Road.

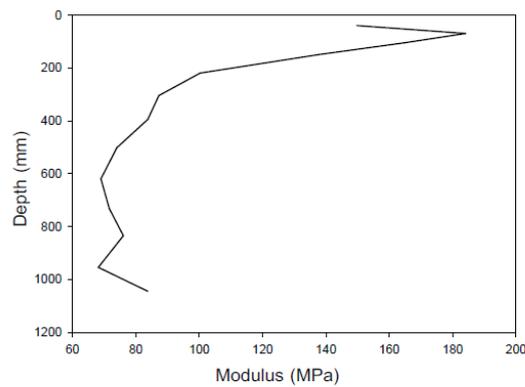
In Withayawithee 3 Road, a similar pattern of weak layer just beneath the pavement were observed in all the four core locations, as shown in Figure 9 while in Withayawithee 2 Road, some graphs displayed portions of extraneous data due to the presence of rocks in the subgrade as shown in Figure 10.

**Figure 9:** Modulus of subgrade reaction from core #4 at Withayawithee 3 Road.

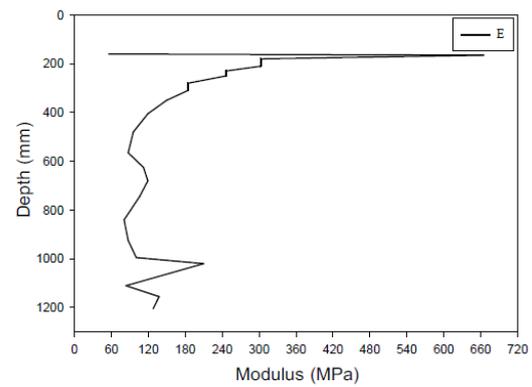
**Figure 10:** Modulus of subgrade reaction from core #5 at Withayawithee 2 Road.

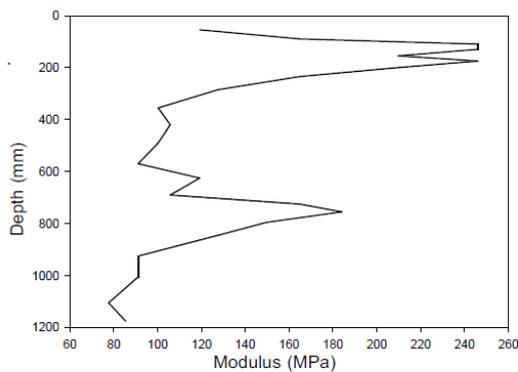
However, the DCP result showed that the base and subgrade at the cracked areas were slightly weaker than in non-cracked areas. The average modulus exceeds 100 MPa in non-cracked area while Modulus is below 100 MPa in cracked area as shown in Figure 11 and 12 respectively.

**Figure 11:** Modulus of subgrade reaction from core #9 at Withayawithee 2 Road on noncracked area.

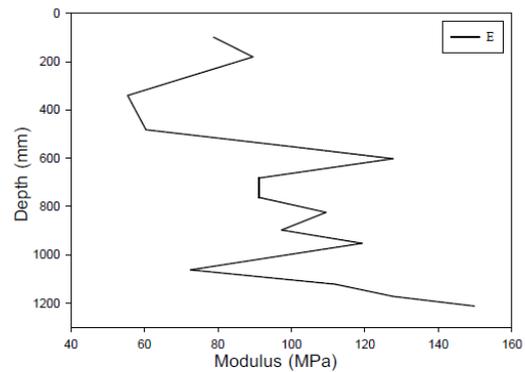
**Figure 12:** Modulus of subgrade reaction from core #7 at Withayawithee 2 Road at cracked location.
