Slope failure along Lomsak-Chumpae Highway, Thailand

K Fuenkajorn, Suranaree University of Technology, Thailand
P Thongthiangdee*, Suranaree University of Technology, Thailand

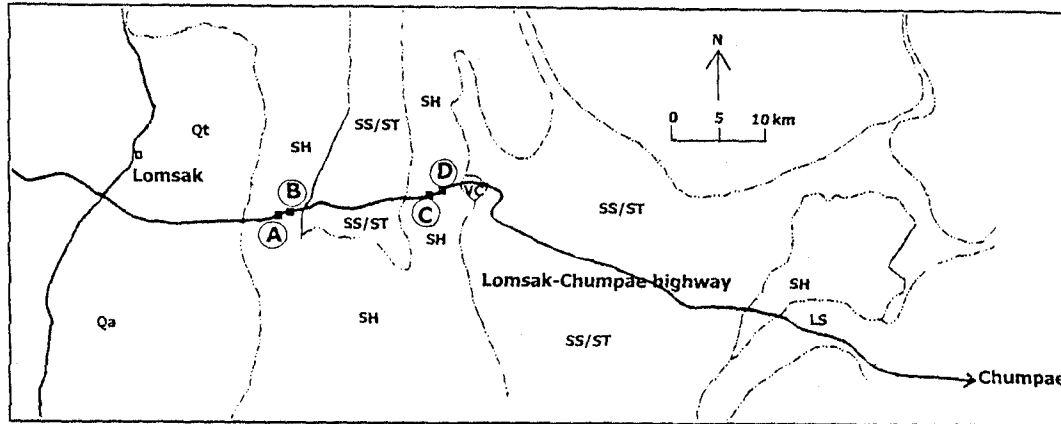
Figure 3 Locations of the studied slopes (A, B, C and D) along Lomsak –Chumpae highway. SH = Shale, LS = Limestone, SS/ST = Sandstone-Siltstone Interbed.
